North Carolina Department of Natural and Cultural Resources
State Historic Preservation Office

August 4, 2022

RE: Wilmington Rail Realignment, Final Intensive-Level Historic Architecture Survey Report,
Brunswick and New Hanover Counties, ER 19-2629

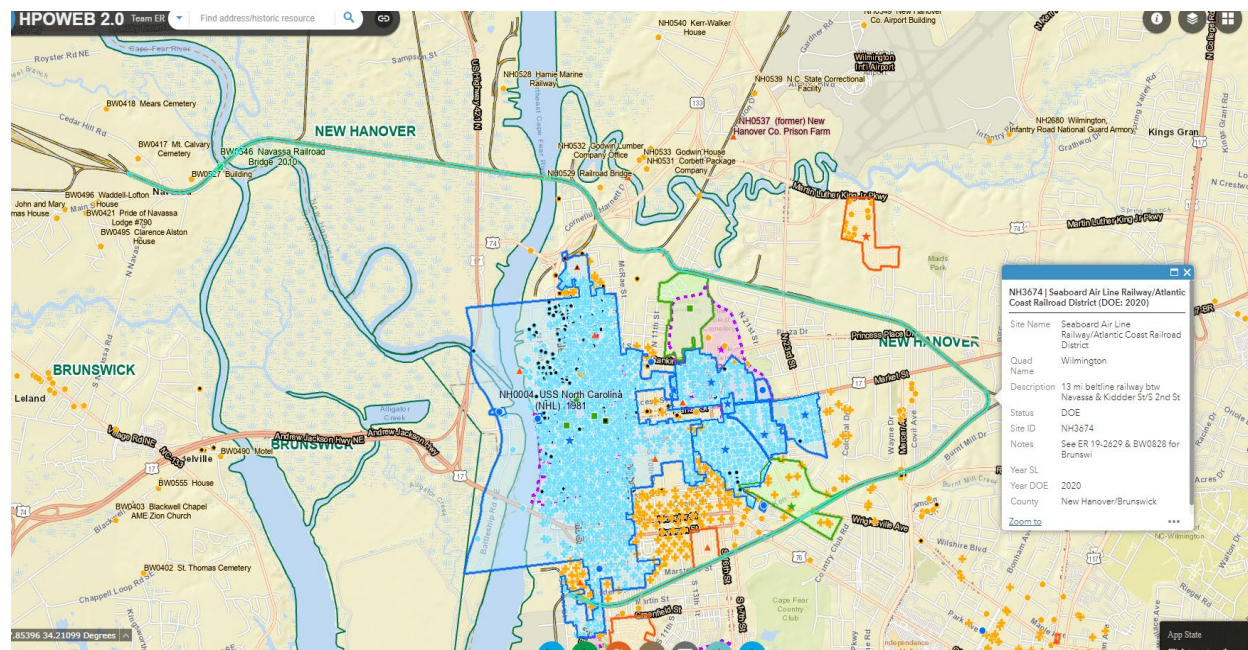
The North Carolina State Historic Preservation Office considers the **Seaboard Air Line Railway/Atlantic Coast Railroad Beltline with its connection to Navassa (NH3674)** (as shown on the map below) a linear historic district eligible for listing in the National Register of Historic Places under Criterion A for Transportation, Development, and Industry. The system through various mergers and consolidations provided trade and transportation routes mainly to southern and middle Atlantic seaboard states and early

NH3674 | Seaboard Air Line Railway/Atlantic Coast Railroad Historic District (DOE 2020) - in turquoise

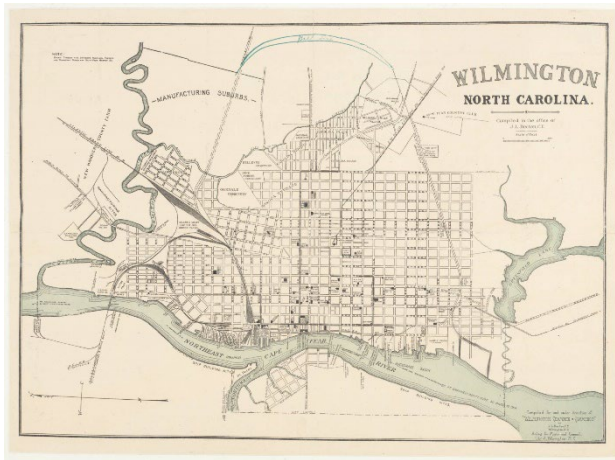
2. A map of Wilmington from the NC Maps website, undated but believed to be about 1918, shows the configuration of the railroad encircling Wilmington at that time, including the "Belt Line" (drawn and labeled in pencil on the far east side, at the top of the map). It largely follows the Beltline as it is today, with changes on the north side, mostly in removal of some track that extended into the north side of downtown to Water Street, and some realignment. (**Note:** The map is turned so east is at the top.)

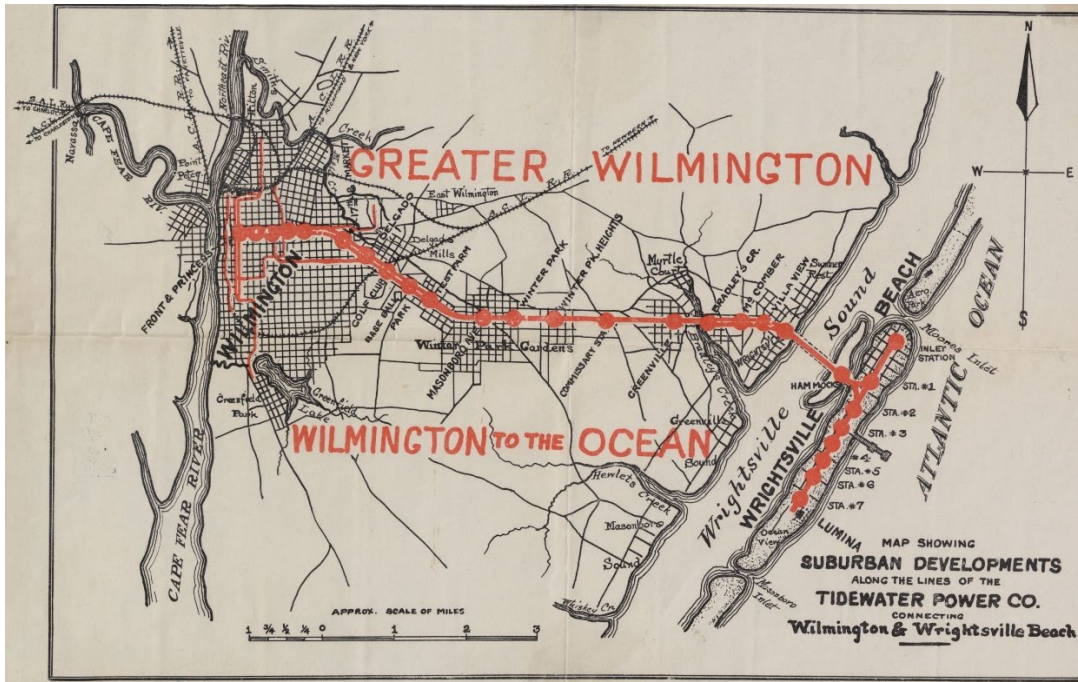
3. A circa 1940 streetcar map that shows essentially the same configuration.

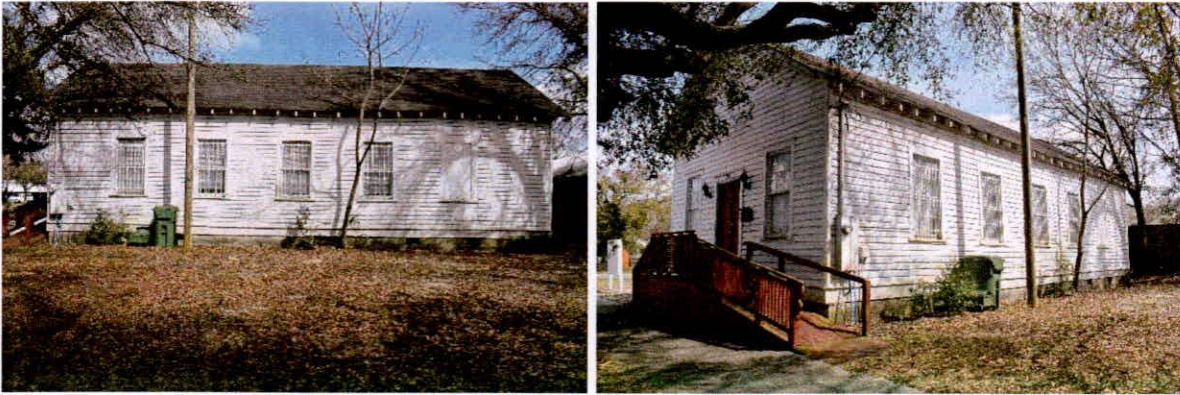
Exhibit 1: Former Holy Church of Jesus Christ, west side elevation, at left; north façade and west elevation, at right

The former Holy Church of Jesus Christ (currently Spirit of Truth Ministries – NH3680) is a little-altered, rectangular, one-story frame building (Exhibit 1 through Exhibit 4). Clad in original German siding, it is edged by wooden cornerboards that rise from a single-board plinth to the eaves. A stuccoed masonry foundation supports the building and an asphalt-shingled, gable-front roof underpinned by exposed rafter tails tops it. The church has a north-facing front elevation and is three bays wide. A pair of doors, each with five stacked flat panels, is centered in the facade. A wooden stoop with a stair climbing from the east and a ramp from the west provides access to the entry. Single wooden, six-over-six, double-hung sash windows are set to either side of the entry. Plain surrounds frame the double doors and these windows.

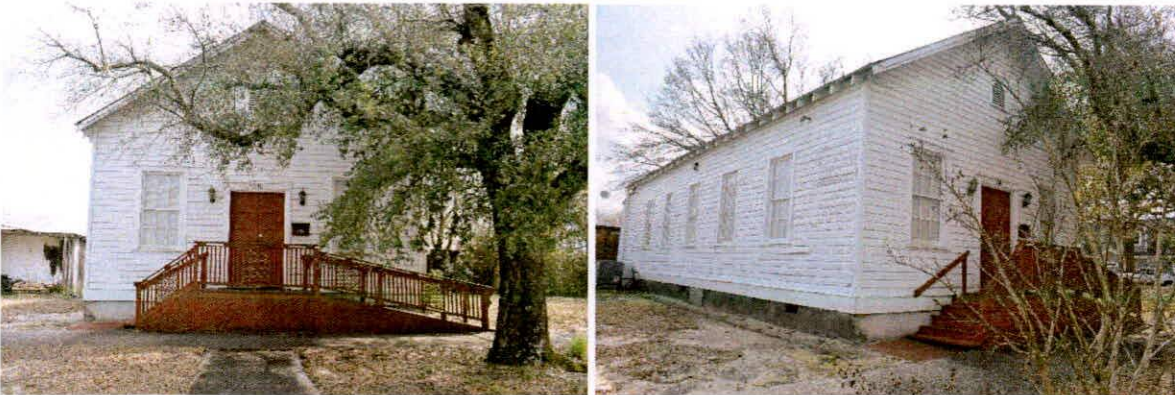
Exhibit 2: Former Holy Church of Jesus Christ, north facade, at left; east side elevation and north facade, at right

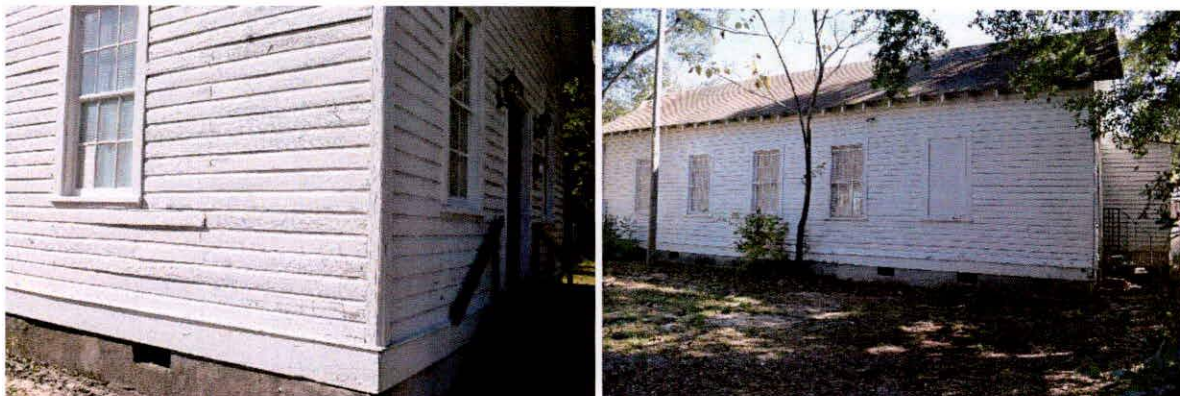
Exhibit 3: Former Holy Church of Jesus Christ, façade and east side elevation, at left; rear and west side elevations, at right

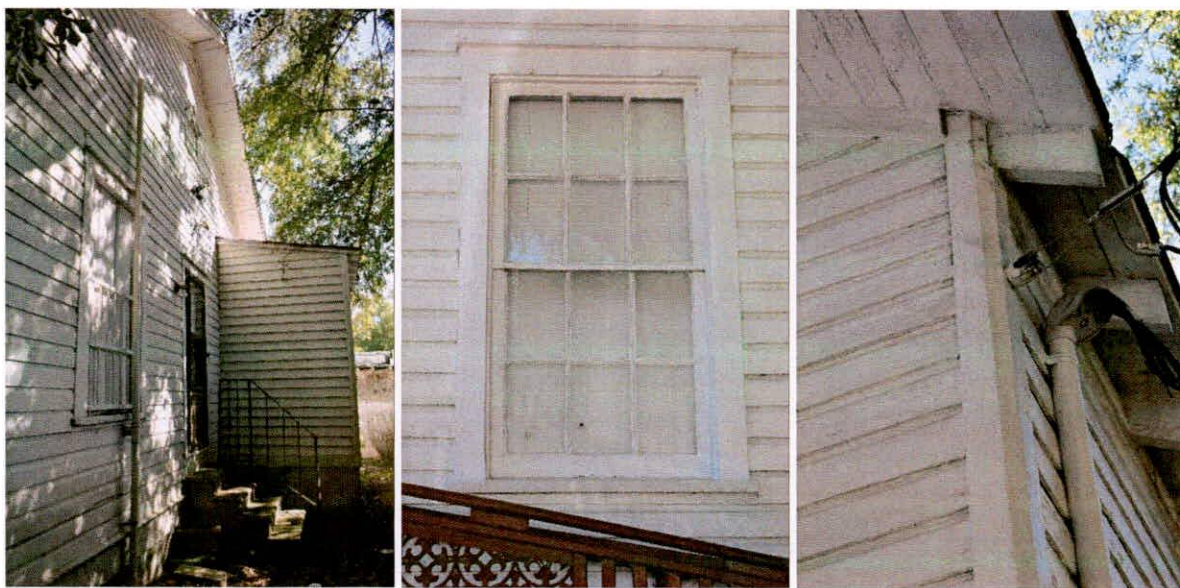
Exhibit 4: Former Holy Church of Jesus Christ, south rear elevation facade, at left; facade window, surround, and ramp railing, at center; German siding and eaves at southwest corner of facade, at right

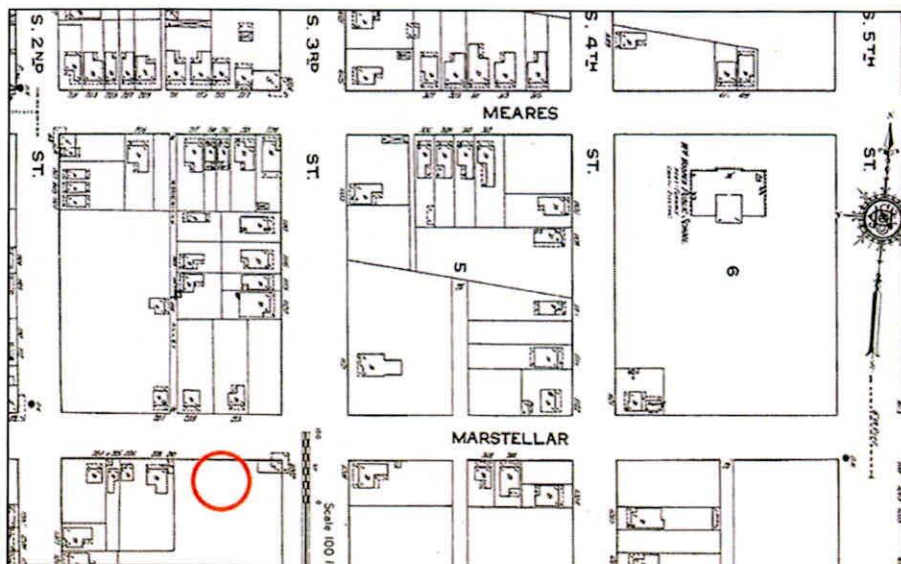
Figure 4: 1915 Wilmington Sanborn Map, Sheet 41, with Vacant Site of Church Circled in Red

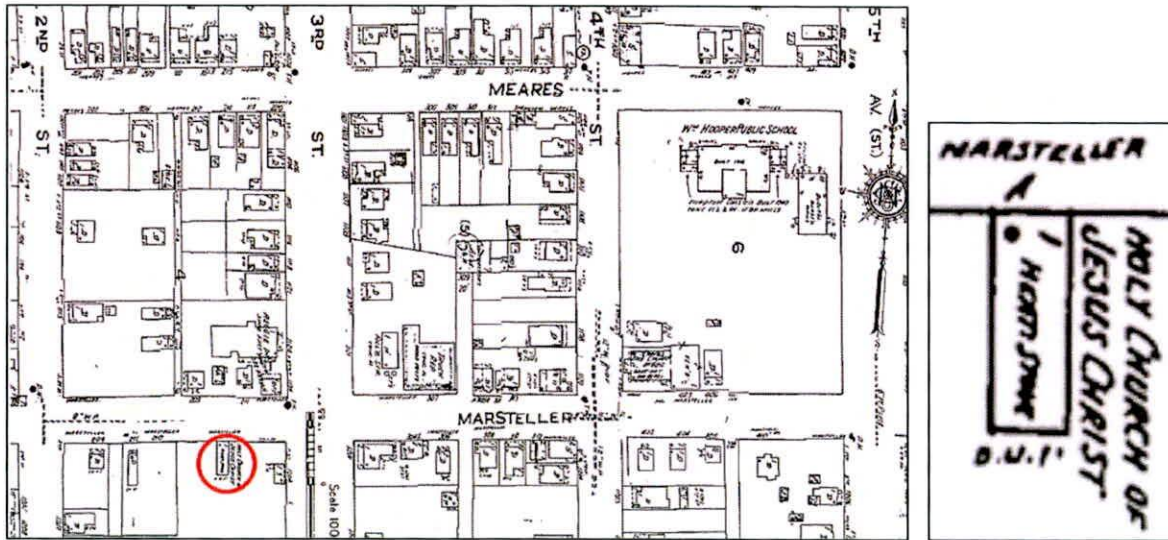
Figure 5: 1951 Update of 1915 Wilmington Sanborn Map, Sheet 41, with Church Circled in Red, at Left, and Blown-Up Section, at Right

The first non-directory mention of the church is found in Raleigh's *News and Observer* of December 31, 1926.¹² It notes that the Holy Church of Jesus Christ of Wilmington had been incorporated as a non-stock entity by five Wilmington men, including pastor Garris L. Pridgen. The Raleigh paper mentioned the church again in an announcement of a wedding held there on February 28, 1927.¹³ The first two mentions of the church identified in Wilmington newspapers date from 1935 and 1940. Both call it the Holy Church of Christ, as does the 1951 Sanborn map.¹⁴

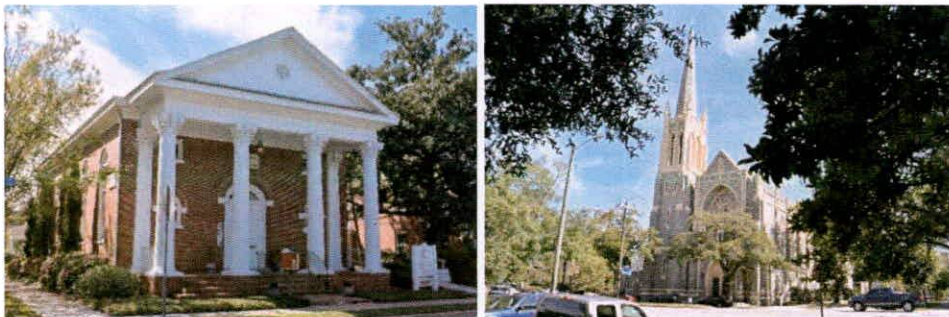
Exhibit 6: First Church of Christ, Scientist (1928), at left, and First Presbyterian Church (1927), at right

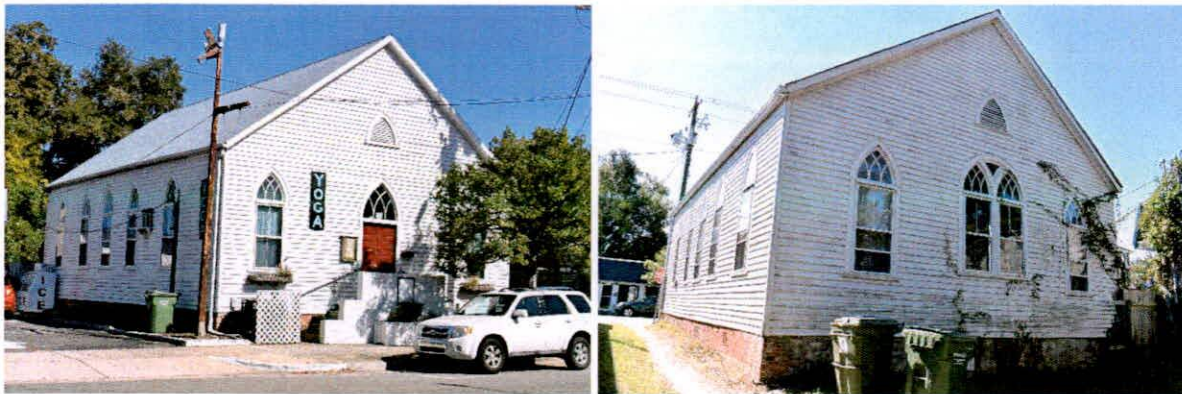
Exhibit 7: Former Ironside Baptist or Primitive Baptist Church, west side and south front elevations, at right, and west side and north rear elevations, at left

The former Ironside Baptist or Primitive Baptist Church (NH0170) was erected at 507 Castle Street between about 1877 and 1882.¹⁷ In form, materials, and finish, it is more comparable to the Holy Church of Jesus Christ than any other church identified in the city, even though it is almost a half-century older. The frame building is a one-story, gable-front rectangle clad in weatherboards. Its pointed-arch transoms, filled with tracery, are relatively stylish, but its wood floors and beaded-board walls and ceilings are similar to those inside the Holy Church of Jesus Christ (Exhibit 7 and Exhibit 8). It currently houses the Tierra Sol Sanctuary (a yoga studio) and lacks pews, but otherwise appears to be remarkably intact.

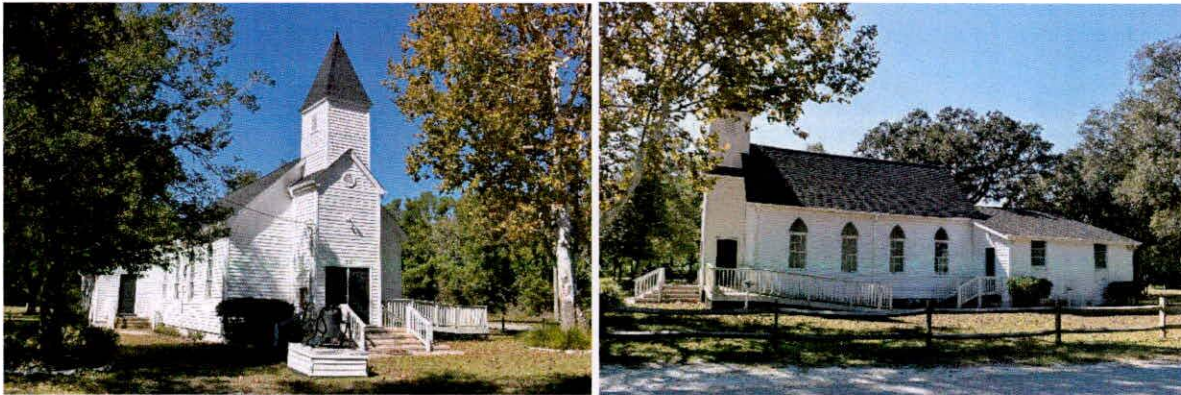
Exhibit 9: Mt. Ararat AME Zion Church, southwest side and southeast front elevation, at left; southeast front and northeast side elevations, at right

Mt. Ararat AME Zion Church (NH0565) at 7061 Market Street is a frame, one-story, gable-front rectangular church like the Holy Church of Jesus Christ (Exhibit 9 and Exhibit 10). It additionally has pointed-arch transoms and a central projecting entrance tower crowned by a pyramidal-roofed steeple. Its original weatherboards are vinyl-sided and its interior, in 2010, retained original wood trim, original wood floors beneath carpeting and altered paneled walls. A concrete-block wing was extended across its rear in 1973. A cornerstone dates the church to 1878. Some of the graves in its associated cemetery have in the past been decorated with shells and shards of glass which was a common African American practice along the Southeast coast. The church was determined eligible for NRHP-listing in 2010.¹⁸

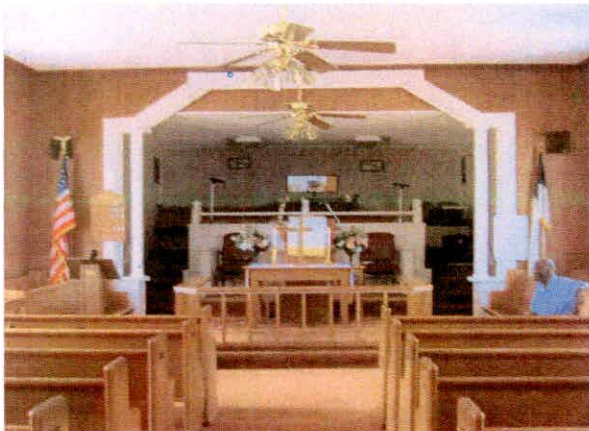
Exhibit 10: Mt. Ararat AME Zion Church, interior in 2010 (photographer: Kate Husband)

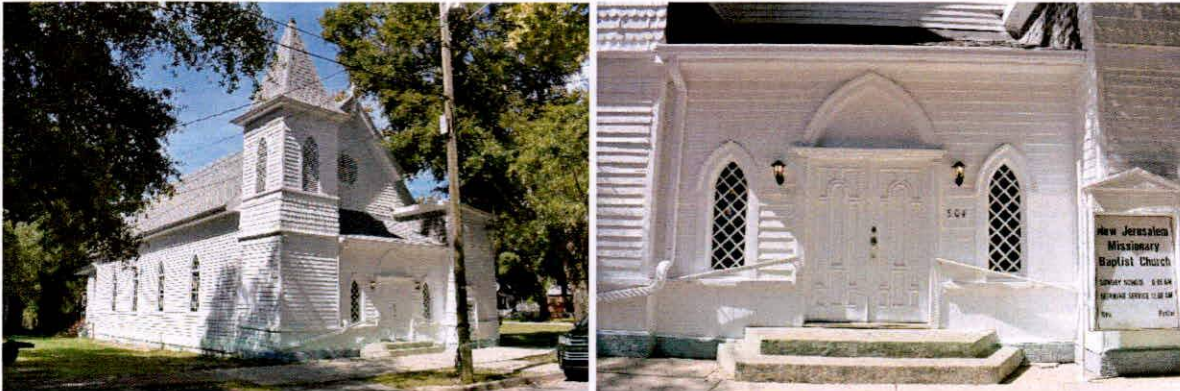
Exhibit 11: New Jerusalem Missionary Baptist Church, south side and east front elevations, at left; detail of east-facing façade, at right

New Jerusalem Missionary Baptist Church was built at 540 6th Street in about 1895. Its basic, rectangular, gable-front form and frame construction is like that of the others in the group of eight churches discussed here (Exhibit 11 and Exhibit 12). More finely finished and quite intact on the exterior, it retains a corner tower, weatherboard and scalloped-shingle siding, pointed-arched windows and transoms with tracery and an ornate facade. An undated online image depicts an altered interior with acoustic ceiling tiles, paneled walls and carpeting. The church is a contributing resource to the Wilmington Historic District.¹⁹

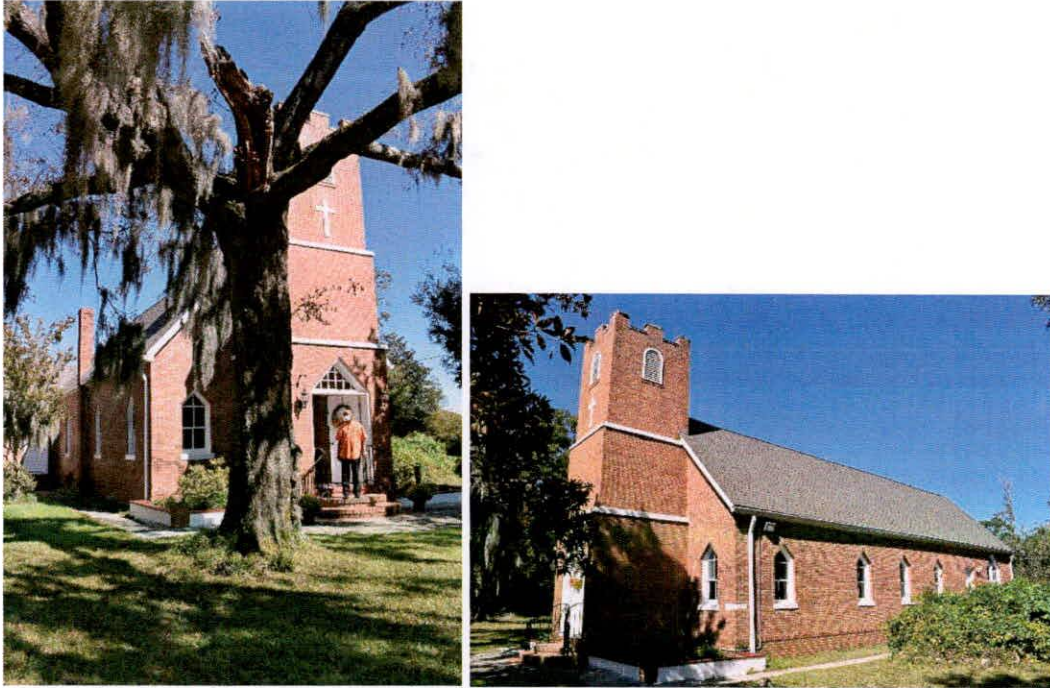
rectangular church building, along with its more than 70-year-old brick veneer is considerably intact.

Exhibit 13: St. Matthews AME Church, northwest side and southwest front elevations, at left; southwest front and northeast side elevations, at right

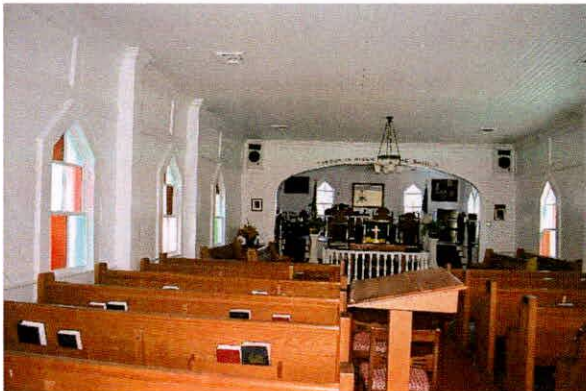
Exhibit 14: St. Matthews AME Church, interior

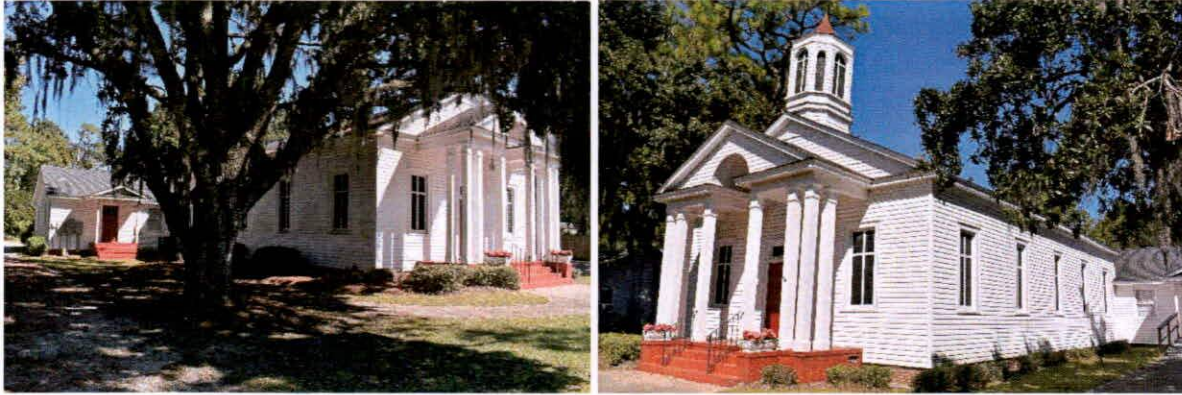
Exhibit 15: Federal Point Pentecostal Church, west side and south front elevations, at left; south front and east side elevations, at right

A largely altered example of the type is Federal Point Pentecostal Church (NH3654) at 629 Piner Road (Exhibit 15). Its frame rectangular body has been vinyl sided and its windows replaced; a tall columned portico has been added to its façade along with a large lantern atop its gable-front façade; and a wing larger than its original block wings has been extended across its rear,

giving it a T-shaped footprint. Nonetheless, the church retains its basic, gable-front, rectangular frame form. The building was erected in 1930 according to tax records.

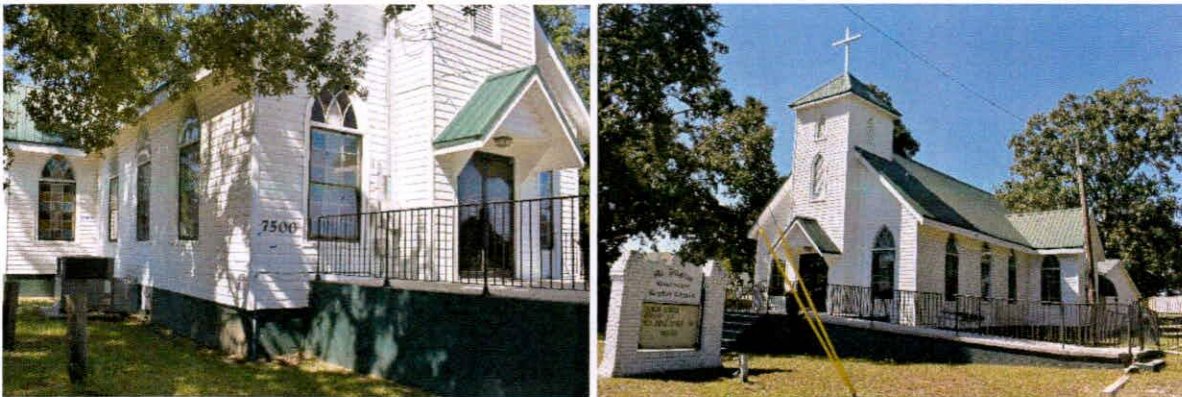
Exhibit 16: Mt. Pilgrim Missionary Baptist Church, south side and east front elevations, at left; south front and west side elevations, at right

Mt. Pilgrim Baptist Church at 7500 Carolina Beach Road is also assigned a 1930 construction date by tax records. However, it may date to as early as 1922, the year the parcel was donated to the congregation for a "permanent church site."²⁰ The one-story, frame, gable-front building is vinyl sided, but retains pointed-arch transoms with tracery topping double-hung sash with colored-glass panes (Exhibit 16). The original or early ell across the rear retains matching windows and transoms. A large later addition extends to its rear.

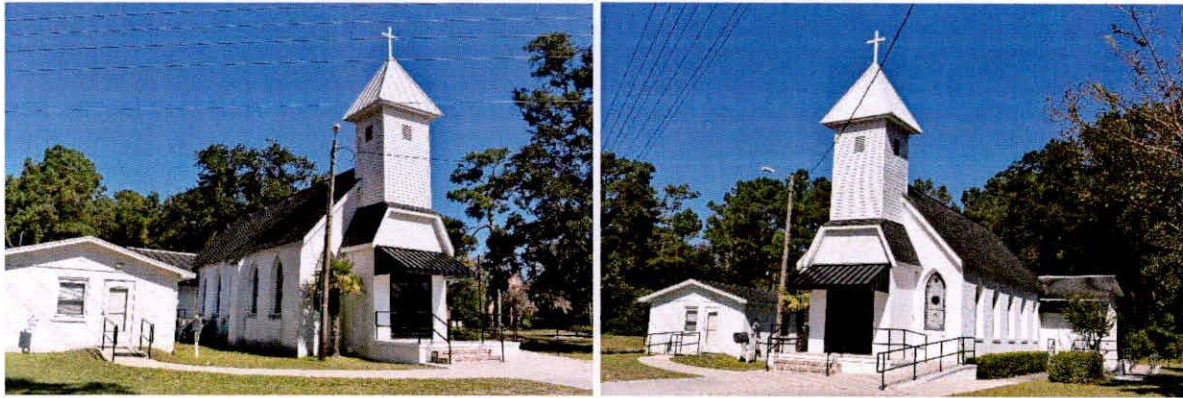
Exhibit 17: Pilgrim Rest Baptist Church: northwest side and southwest front elevations, at left; southwest front and southeast side elevations, at right

addition to its gable-front, rectangular body, it has pointed-arch windows and a projecting front tower topped by a pyramidal roof (Exhibit 17). A mid-twentieth-century photograph indicates changes to windows and the entry as well as the early presence of the northwest addition.²¹

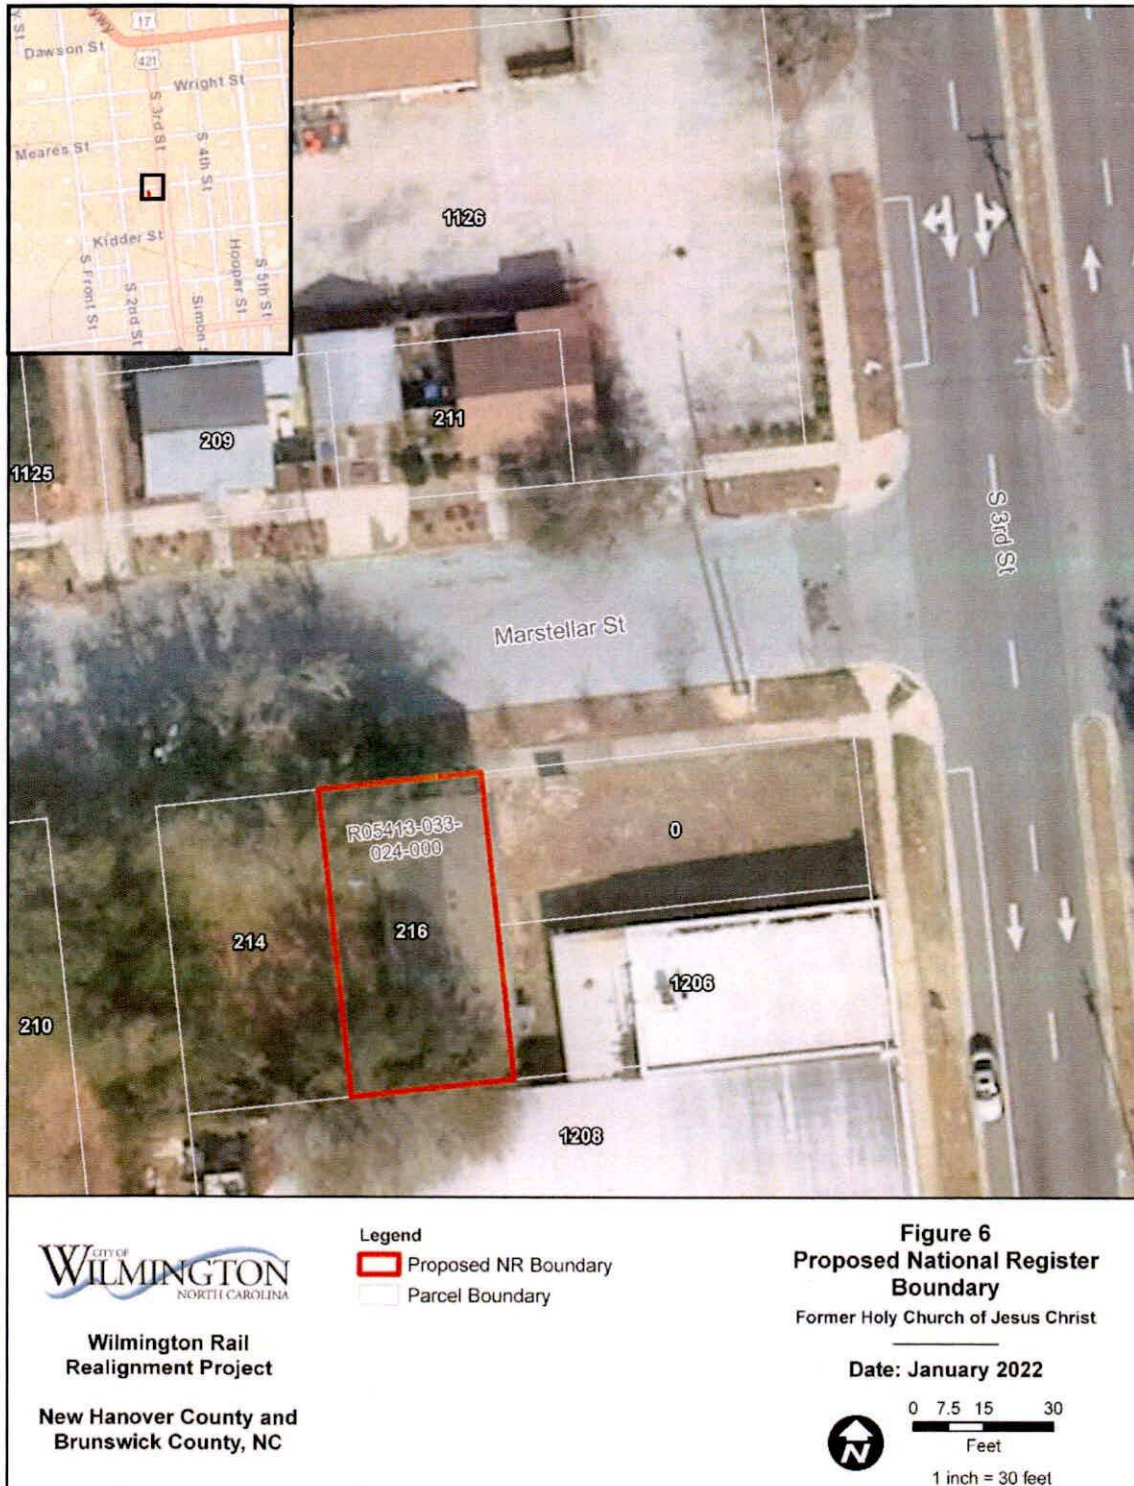
Figure 6: Proposed NRHP Boundary Former Church of Jesus Christ, New Hanover County

The recommended NRHP boundary of the former Holy Church of Jesus Christ encompasses the 0.053-acre parcel (ID# R05413-033-024-000) that the church trustees acquired in 1925 and upon which they erected the church building ca.1926 (Figure 6). Associated with the church since its beginnings, the parcel includes a grassy area framing the church building and no resources other than that building which provides the former Holy Church of Jesus Christ with an appropriate historic setting.

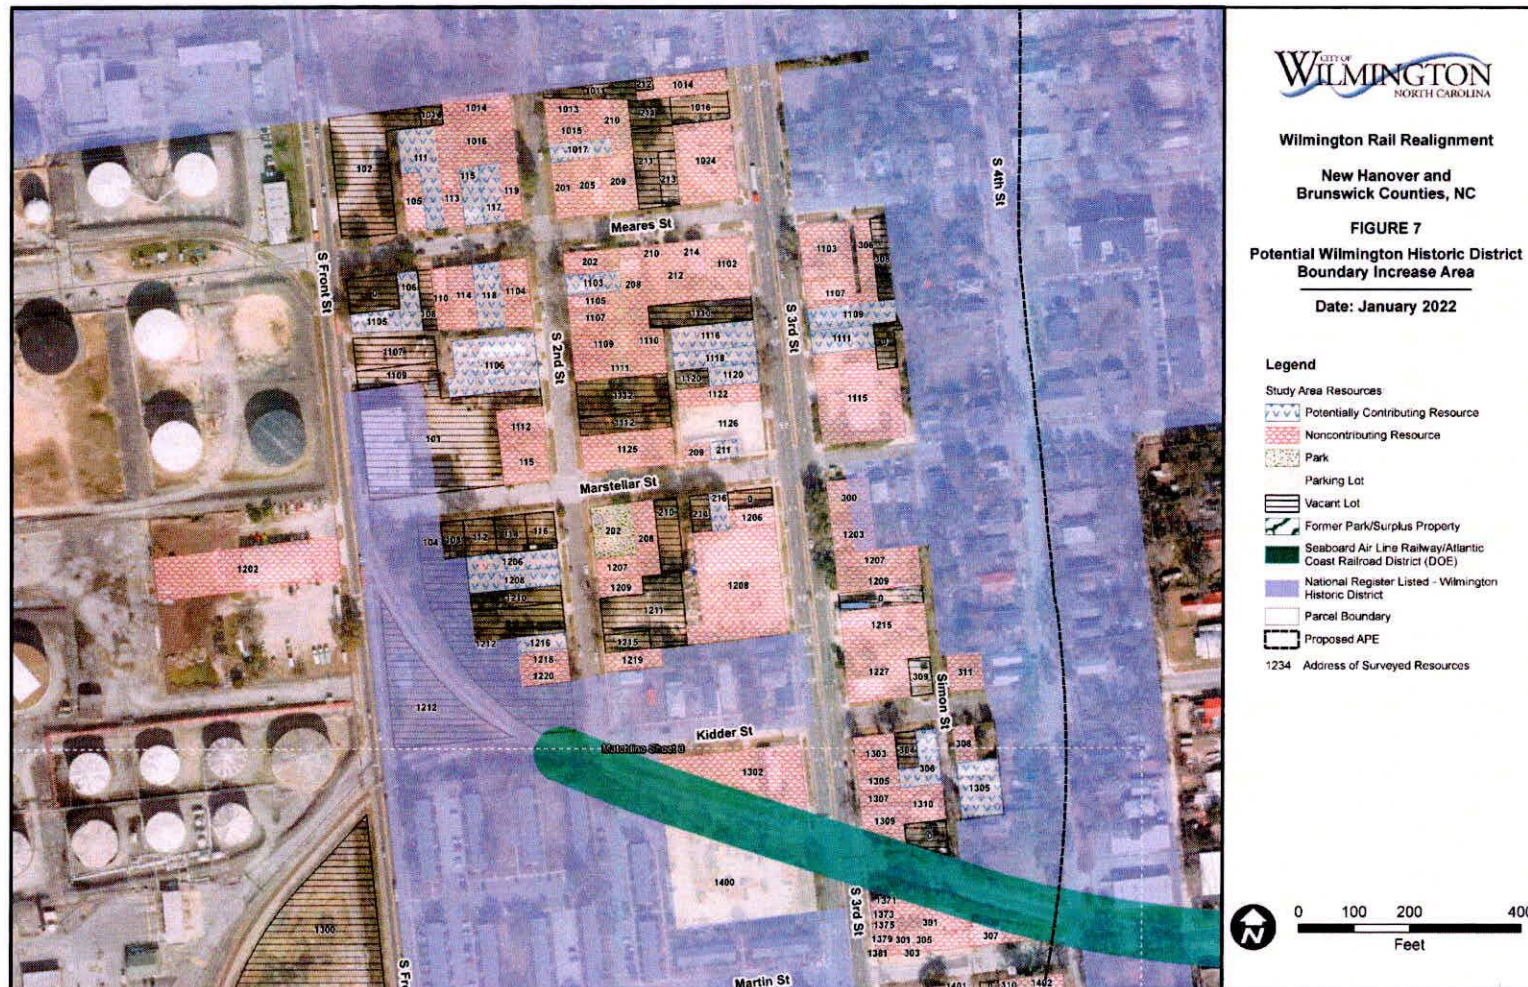
Figure 7: Sheet 1 of 3, Map of Potential Wilmington Historic District Boundary Increase Resources with their Recommended Potentially Contributing/Noncontributing Status

Within the southern APE area, 129 resources were surveyed. These are comprised of individual or small groups of standing resources, vacant lots, parking lots, and parks. The surveyed resources are mapped on Figures 7, 8, and 9, which identify them by parcel boundary, address, and a recommendation of whether a standing resource or group of standing resources would be potentially contributing (shaded in green) or noncontributing (shaded in red) if the historic district were to be expanded. Vacant lots, parks, and parking lots are discretely color-coded. The southern portion of the Wilmington HD is shaded purple; the boundaries of the southern portion of the APE are outlined in blue.

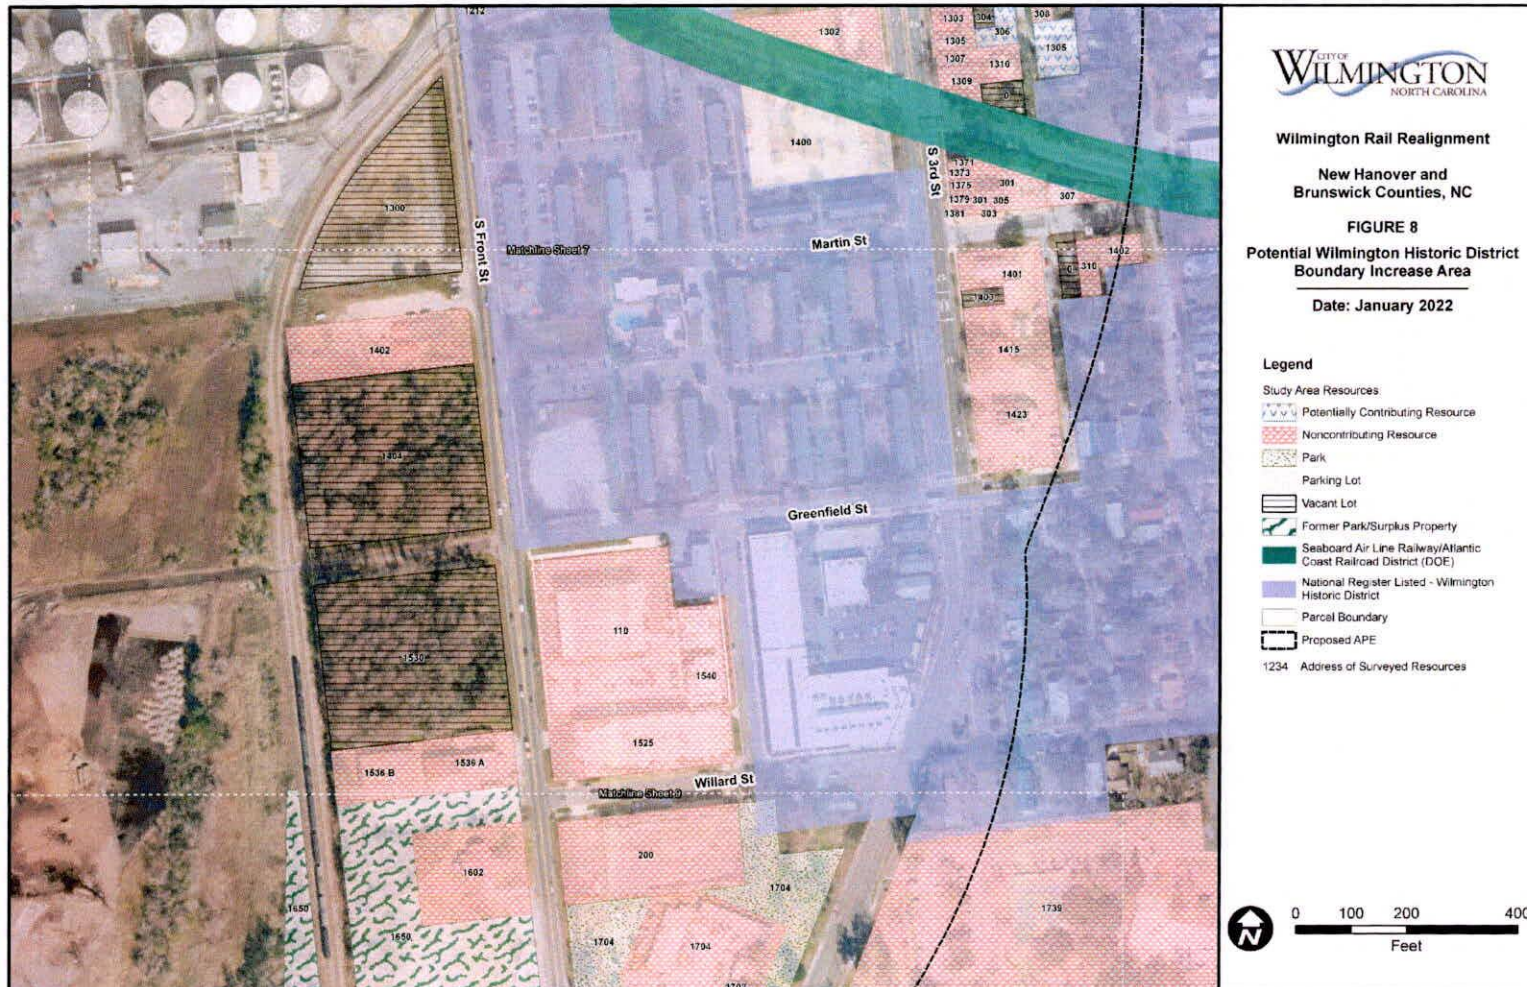
Figure 8: Sheet 2 of 3, Map of Potential Wilmington Historic District Boundary Increase Resources with their Recommended Potentially Contributing/Noncontributing Status

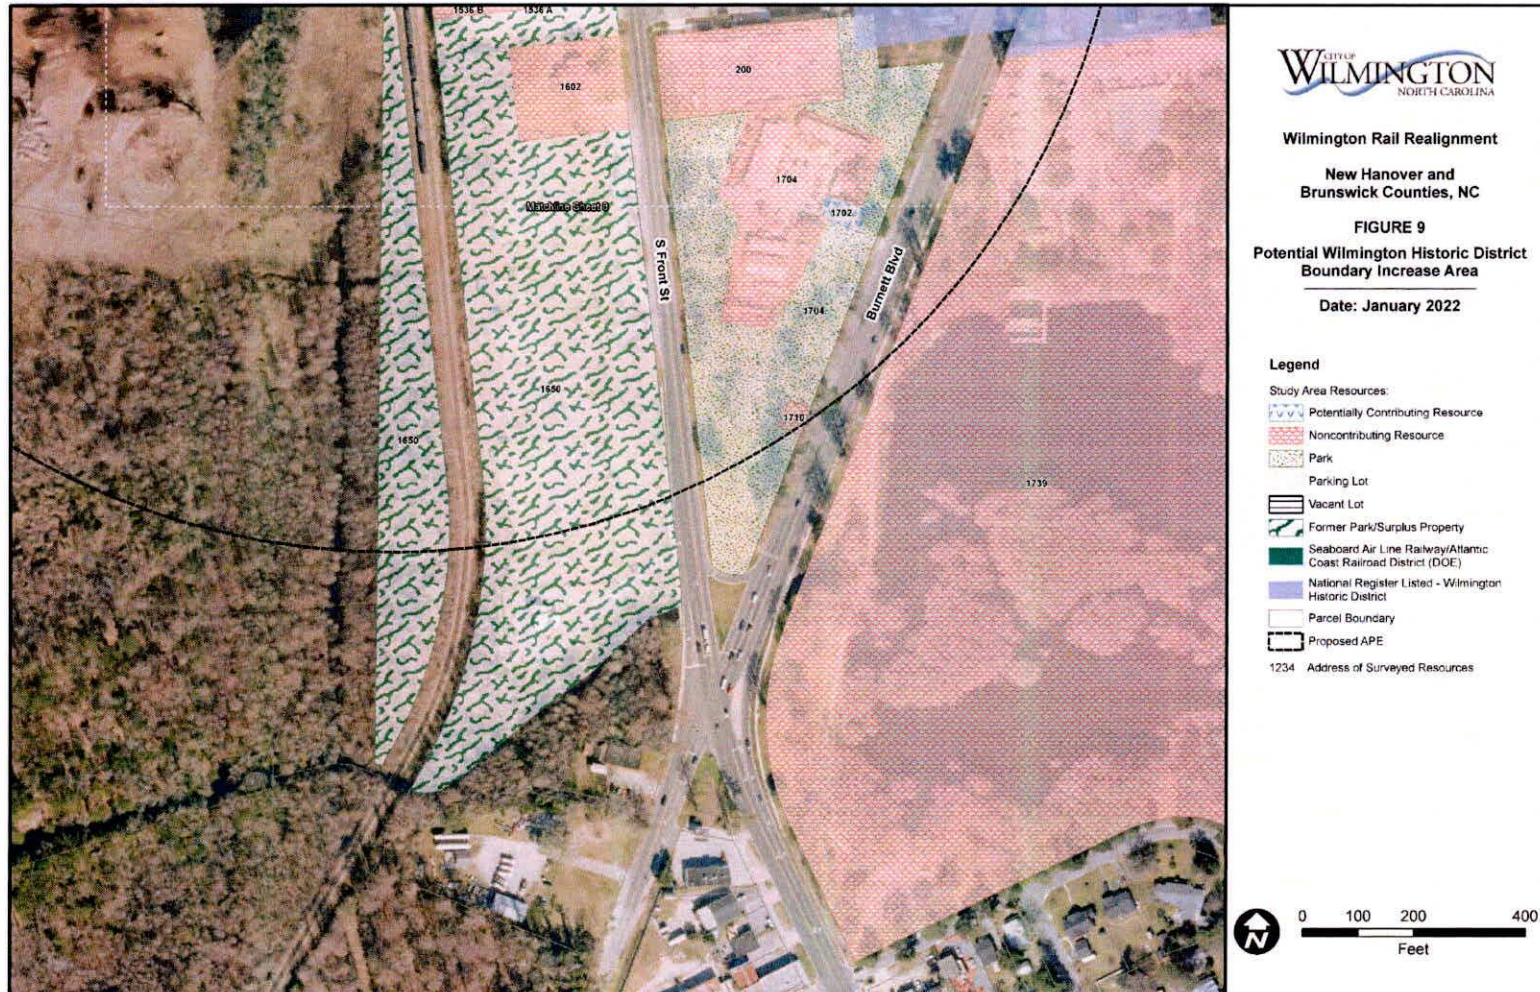
Figure 9: Sheet 3 of 3, Map of Potential Wilmington Historic District Boundary Increase Resources with their Recommended Potentially Contributing/Noncontributing Status

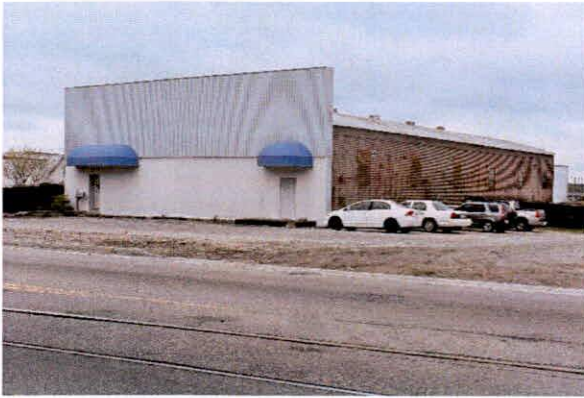
Exhibit 19: 1202 S Front St, facing southwest

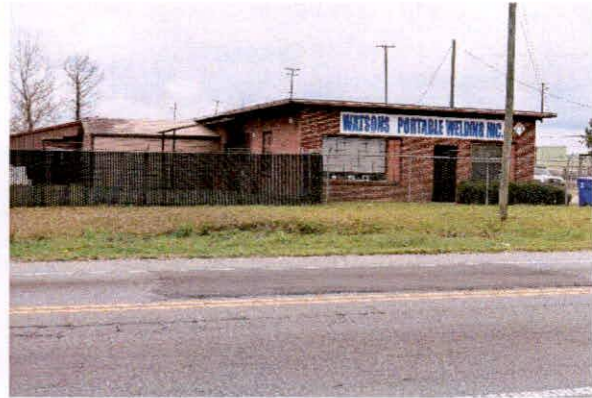
Exhibit 20: 1402 S Front St, facing northwest

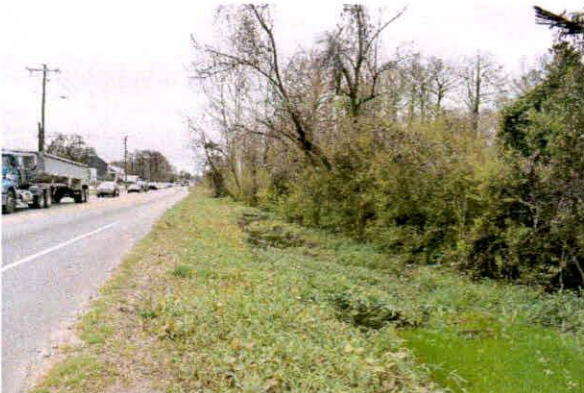
Exhibit 21: vacant lot at northwest corner of junction of S Front St and Greenfield St (1404 S Front St), facing south

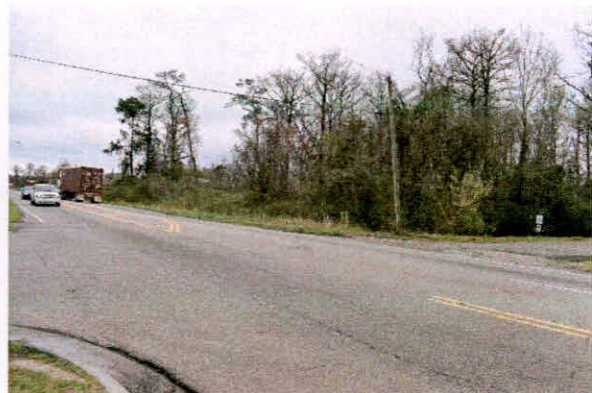
Exhibit 22: vacant lot at southwest corner of junction of S Front St and Greenfield St (1530 S Front St), facing southwest

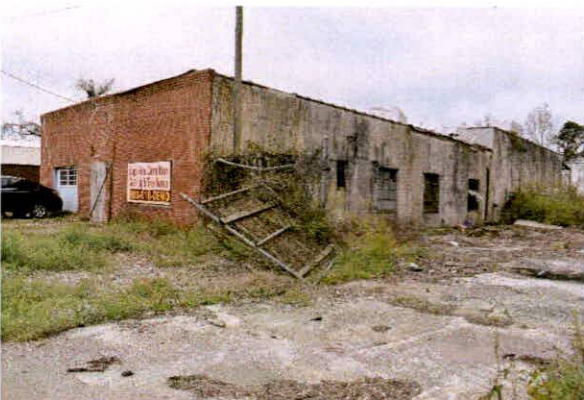
Exhibit 23: 1536A S Front St, facing southwest

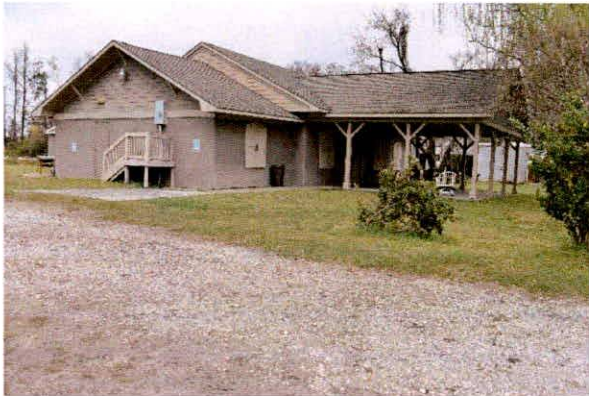
1536B S Front St (Fig #7/Exh #24)	Former auto repair shop (1957 tax date)	1-story, concrete block-and-brick veneer industrial building	NC – age, outside HD's period of significance; has further lost integrity
1602 S Front St (Fig #8/Exh #25)	Former Optimist Club (1963 tax date)	1-story, frame-and-stucco, gable-end clubhouse	NC – age, outside HD's period of significance
1650 S Front St (Fig #9/Exh #26)	Former Optimist Park (ca. 1960s)	Unmaintained former city park declared surplus property in 2020	NC – age, outside HD's period of significance; has further lost integrity
South Front Street (E side)			
NE corner of S Front & Meares St/102 Wright St (Fig #7/Exh #27)	Vacant house lots	Vacant lots that held six houses on 1955 Sanborn	V
SE corner of S Front & Meares St (Fig #7/Exh #28)	Vacant house lot	Vacant house lot	V
1105 S Front St (Fig #7/Exh #29)	House (1910 tax date)	1-story, frame, asbestos-sided house with seam-metal gable-front roof	PC – intact sash, surrounds, front door, corner post, boxed eaves, and form

Exhibit 25: 1602 S Front St, facing northwest

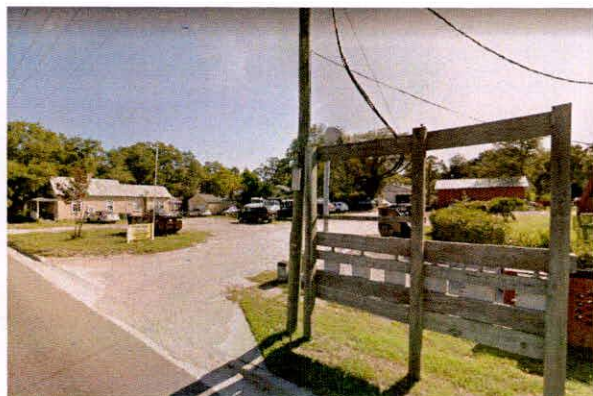
1107 S Front St (Fig #7/Exh #30)	Vacant house lot	Vacant lot that held one house on 1955 Sanborn	V
1109 S Front St (Fig #7/Exh #30)	Vacant house lot	Vacant lot that held one house on 1955 Sanborn	V
NE corner of S Front & Kidder St/ 1212 S Front St (Fig #7/Exh #31)	Vacant lot (vacant on 1955 Sanborn)	Vacant industrial lot	V
1525 S Front St (Fig #8/Exh #32)	Self-storage building (1967 tax date)	Repurposed, long, rectangular, brick-veneered, masonry building	NC – age, outside HD's period of significance; has further lost integrity
South 2nd Street (W side)			
1014 S 2nd St (Fig #7/Exh #33)	House (1910 tax date)	1-story, gable-front, frame house	NC – altered sash, surrounds, porch, vinyl siding

Exhibit 30: two vacant former house lots between 1105 S Front St and 101 Marstellar St, facing northeast (source: Google Maps)

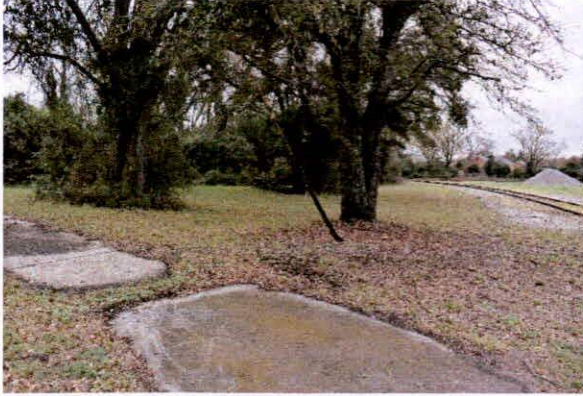
Exhibit 31: vacant lot at northeast corner of junction of S Front St and Kidder St, facing southeast

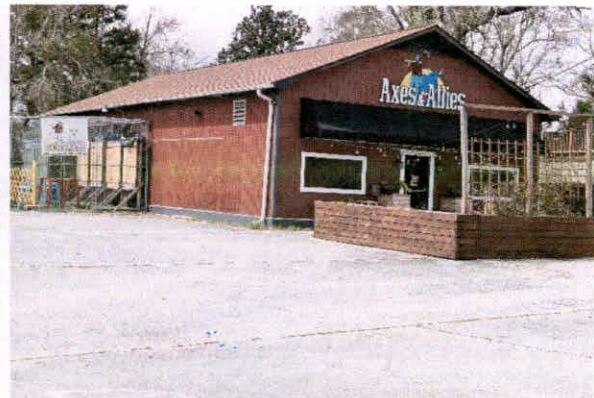
Exhibit 64: 1122 S 3rd St (NH2606) and corner parking lot, facing northwest

ADDRESS (FIGURE NUMBER/EXHIBIT NUMBER)	TYPE AND/OR NAME (DATE)	DESCRIPTION	RECOMMENDED STATUS [PC=POTENTIALLY CONTRIBUTING; NC=NON-CONTRIBUTING; V=VACANT LOT]
1126 S 3rd St (Fig #7/Exh #64)	Parking lot	Site of neon sign shop and office on 1955 Sanborn map	Paved lot
120_ S 3rd St (Fig #7/Exh #65)	Vacant lot	Open lot on 1955 Sanborn map	V
1206 S 3rd St (Fig #7/Exh #65)	Commercial building (1952 tax date)	1-story, concrete-block, flat-roofed building with front brick parapet	NC – age; also altered bays, store fronts, sash and doors
1208 S 3rd St (Fig #7/Exh #66)	Former A&P market (1952 tax date)	1-story, brick and steel, parapet-front thrift store with paved parking lot	NC – age; also altered and filled-in bays and entries
1302 S 3rd St (Fig #7/Exh #67, 68)	Former McKee Ice and Coal Company (1945 tax date)	L-shaped, 1-story, concrete-block warehouse	NC – bays altered and former north wing that gave building an H-shaped footprint removed

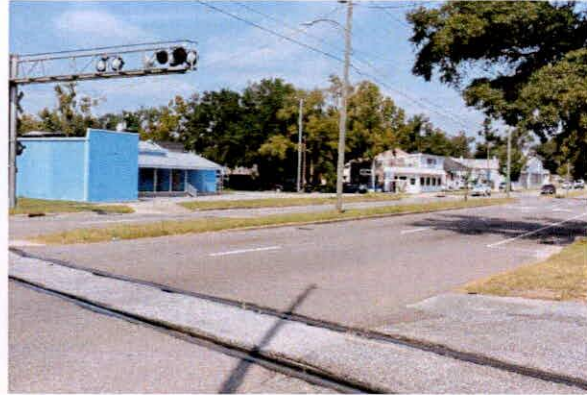
**Exhibit 68: NRHP-listed Seaboard Air Line Railway/
Atlantic Coast Railroad District (NH3674) crossing
1300 block of S 3rd St, facing northwest**

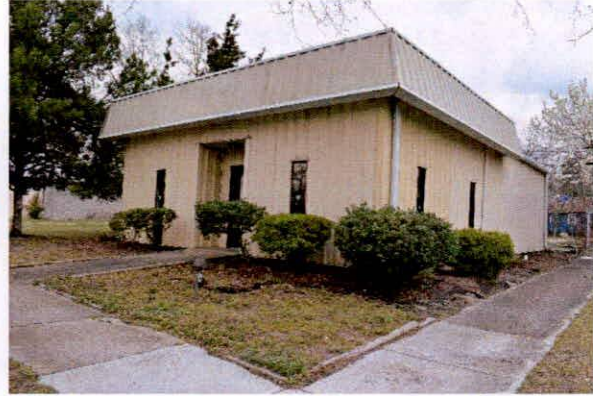
Exhibit 79: 1227 S 3rd St (NH2607), facing northeast

ADDRESS (FIGURE NUMBER/EXHIBIT NUMBER)	TYPE AND/OR NAME (DATE)	DESCRIPTION	RECOMMENDED STATUS [PC=POTENTIALLY CONTRIBUTING; NC=NON-CONTRIBUTING; V=VACANT LOT]
1227 S 3rd St (Fig #7/Exh #79)	Heating and air conditioning office (1982 tax date)	1-story building with walls and mansard-like roof sided with metal	NC - age, outside HD's period of significance
1303 S 3rd St (Fig #7/Exh #80)	House (1920 tax date, but on 1915 Sanborn map and outside coverage of earlier maps)	2-story, frame, gable-front, aluminum- and asbestos-sided house with altered sash, added rear stair leading to upper apartment	PC - retains wraparound Colonial Revival/Victorian porch, wood surrounds (upper front sash with spandrels), projecting side bay, diamond ventilator, rear ell
1305 S 3rd St (Fig #7/Exh #81)	House (2006 tax date, perhaps earlier but thoroughly renovated then)	1-story, gable-front, frame, vinyl-sided house	NC - age, outside HD's period of significance

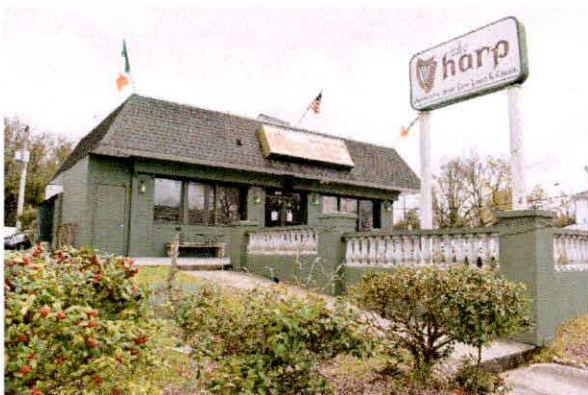
Exhibit 88: 1423 S 3rd St (NH2609), facing southeast

1423 S 3rd St (Fig #8/Exh #88)	Restaurant (1973) (The Harp)	1-story, concrete-block restaurant with mansard-like roof and plate-glass windows at front block	NC - age, outside HD's period of significance
Burnett Boulevard (W and E sides)			
1702 Burnett Blvd (Fig #9/Exh #89)	Former house now offices of City Parks Maintenance Division (1923 tax date)	1-story, gable-end, frame, vinyl-sided bungalow	PC - retains paired 2/2 windows, corner porch with wooden posts on brick piers, front dormer, and vinyl-clad triangular knee braces
1704 Burnett Blvd - Maintenance (Fig #9/Exh #90, 91)	City Parks Maintenance buildings (largely ca.1951-1955, per Sanborn maps, and later)	Eight functional, 1-story, concrete-block, steel, sheet metal, brick, plexiglass, and frame storage buildings, equipment sheds, cold frames and greenhouses	NC - age, outside HD's period of significance
