North Carolina Department of Natural and Cultural Resources
State Historic Preservation Office

August 4, 2022

RE: Wilmington Rail Realignment, Final Intensive-Level Historic Architecture Survey Report,
Brunswick and New Hanover Counties, ER 19-2629

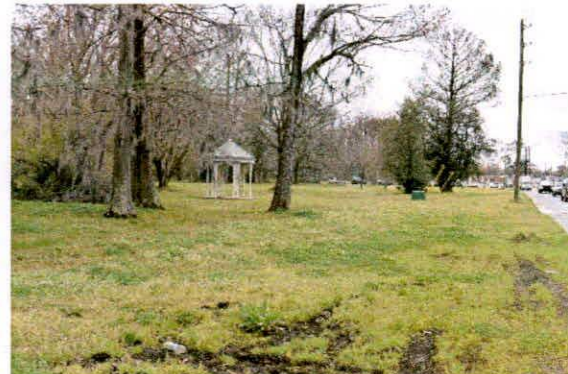
ADDRESS (FIGURE NUMBER/EXHIBIT NUMBER)	TYPE AND/OR NAME (DATE)	DESCRIPTION	RECOMMENDED STATUS [PC=POTENTIALLY CONTRIBUTING; NC=NON-CONTRIBUTING; V=VACANT LOT]
1704 Burnett Blvd – Park (Fig #9/Exh #92)	Park land	Undeveloped park land containing City Parks maintenance, offices, and forestry offices	Park land
1710 Burnett Blvd (Fig #9/Exh #93)	City Urban Forestry Division offices (ca. 1950s)	1-story, functional, gable-end, concrete-block building	NC - age, outside HD's period of significance
1739 Burnett Blvd (Fig #9/Exh #94)	Greenfield Lake Park (ca. 1925-1965)	195-acre city park with lake, gardens, fountains, cultural, and recreational resources	NC – not within HD's areas of significance (local landmark but found not individually NR-eligible)
Simon Street (W and E sides)			
1310 Simon St (Fig #7/Exh #95)	House (1910 tax date, but not on 1951 or 1955 Sanborns, so likely moved here)	1-story, frame, gable-end house with weatherboards, 2/2 sash, wooden surrounds	NC – altered by multiple additions including shed-roofed wing at north side and two-story addition at rear; altered front porch

**Exhibit 92: 1704 Burnett Blvd, facing south
(undeveloped city park property containing
maintenance facility north of juncture of Burnett
Blvd and S Front St)**

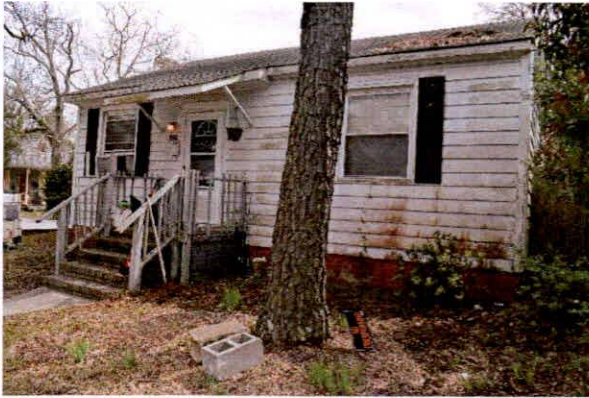
Exhibit 112: 120 Meares St (NH2581), facing southeast

120 Meares St (Fig #7/Exh #112)	House (1945 tax date)	1-story, gable-end, frame house	NC – aluminum-siding, replaced sash, altered porch
202 Meares St (Fig #7/Exh #113)	House (1950 tax date)	1-story, frame, gable-end house	NC – replaced windows, Masonite siding, porch, room extended off of east side
208 Meares St (Fig #7/Exh #114)	House (1901 tax date)	1-story, frame, gable-end house with intact porch posts and cornice returns	NC – altered aluminum siding and surrounds, porch balustrade, snap-in 1/1 sash
210 Meares St (Fig #7/Exh #115)	House (2000 tax date)	1-story, frame, vinyl-sided, gable-front house	NC – modern Habitat for Humanity house
212 Meares St (Fig #7/Exh #116)	House (1901 tax date)	1-story, front-gabled, aluminum-sided house	NC – altered porch, sash, surrounds, porch
214 Meares St (Fig #7/Exh #117)	House (1901 tax date)	1-story, frame, gable-front house with full-façade porch with triangular knee braces in gable	NC – replaced sash, surrounds, vinyl siding, porch members

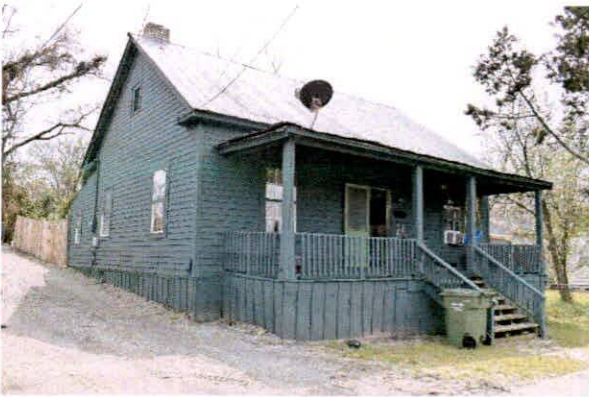
Exhibit 114: 208 Meares St (NH2582), facing southwest

sided with Masonite rather than weatherboards, its porch is not original, and its 6/6 windows are modern (Exhibit 142, at left). In similar fashion, the house at 208 Meares (ca.1901) retains early cornice returns and porch posts, but has snap-in muntins to create the illusion of early 6/6 sash, a modern porch balustrade, and aluminum siding (Exhibit 142, at right). As their most prominent features are modern, they are recommended as noncontributing.

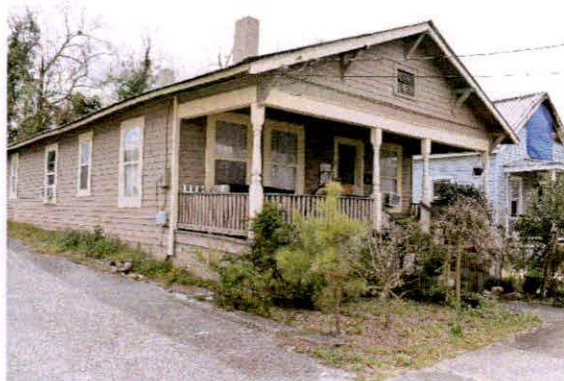
Exhibit 117: 214 Meares St (NH2582), facing southwest

Two additional representatives of houses recommended as noncontributing due to the prominence of their later features are those at 115 Marstellar St (ca.1910) and 214 Meares St (ca.1901). The Marstellar St house has an intact transom at its entry and what may be an original pointed-arch window with tracery in its front gable. However, its sash and porch posts have been replaced and its siding is artificial (Exhibit 143, at left). The Meares St house retains an engaged full-façade porch and triangular knee-braces, but has modern porch posts, vinyl siding, windows, and surrounds (Exhibit 143, at right).

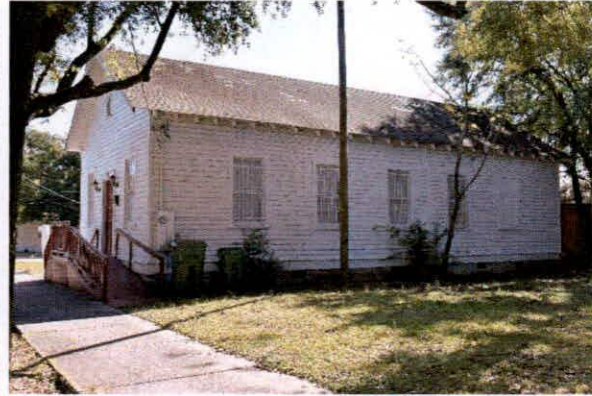
Exhibit 125: 216 Marsteller St (NH3680) and adjacent vacant house lot, facing southeast (former Holy Church of Jesus Christ)

The above resources are all residences. Although 29 of the 98 individual/groups of standing resources are non-residential, only one is believed to fall within the historic district's period of significance and to retain sufficient integrity to merit a contributing recommendation—the Holy Church of Jesus Christ which was individually assessed above.

The former Holy Church of Jesus Christ is recommended eligible for NRHP listing under Criterion C as a rare surviving example in the Wilmington area of the basic, traditional, rectangular form and frame construction of Protestant meetinghouses in the late nineteenth and early twentieth centuries. The Church retains all seven elements of NRHP integrity in support of its significance under Criterion C. Further, the Church also meets the requirements of Criteria Consideration (Exception A) as a religious resource that derives its primary significance from its architectural importance.

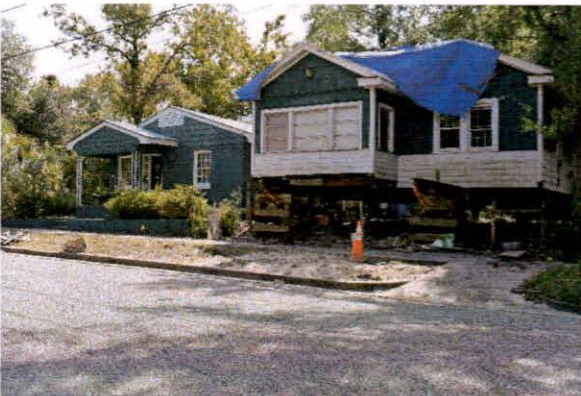
Exhibit 128: House moved in late 2021 onto empty lot at 306 Kidder St (NH 2597), facing southeast

ADDRESS (FIGURE NUMBER/EXHIBIT NUMBER)	TYPE AND/OR NAME (DATE)	DESCRIPTION	RECOMMENDED STATUS [PC=POTENTIALLY CONTRIBUTING; NC=NON-CONTRIBUTING; V=VACANT LOT]
Kidder Street (S side)			
304 Kidder St (Fig #7/Exh #128)	A house on 1955 Sanborn gone by early 2021, then a house moved to lot late 2021	1-story, frame, gable-front house up on blocks on lot in late 2021	NC – not on original site
306 Kidder St (Fig #7/Exh #129)	House (1945 tax date)	1-story, concrete-block, gable-front house	PC – intact stuccoed concrete-block house with two-bay front porch, original 6/6 sash
308 Kidder St (Fig #7/Exh #130)	House (1930 tax date)	1-story, gable-end, frame house	NC – altered sash, aluminum siding, porch
Martin Street (N and S sides)			
301-305 Martin St (Fig #8/Exh #131)	Townhouses (2019 tax date)	Three 2-story, frame and metal, gable-front townhouses	NC - age, outside HD's period of significance
307 Martin St (Fig #8/Exh #132)	Professional office (1948 tax date)	1-story, concrete-block, former warehouse or shop with bowstring truss roof	NC – front elevation and bays altered; shipping containers affixed to rear elevation

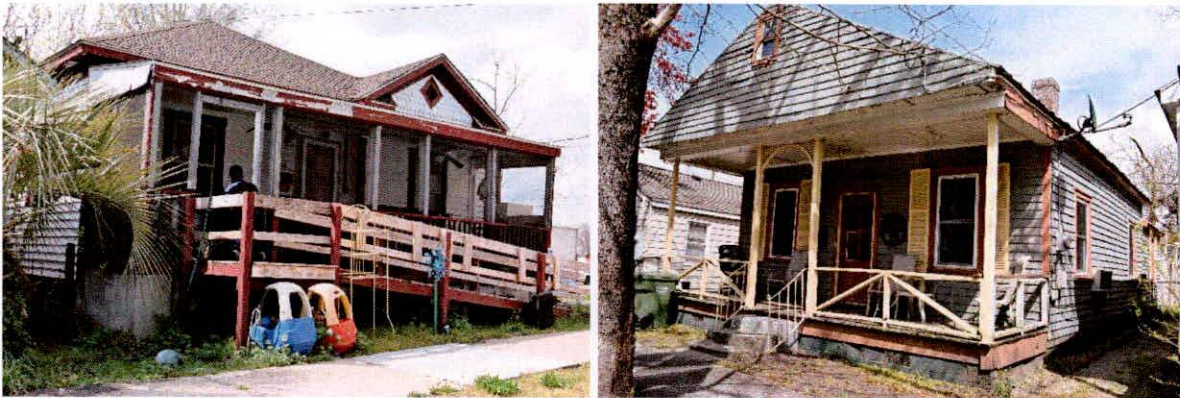
Exhibit 136: 1206 S 2nd St, south side and east front elevations, left; 1103 S 2nd St, west front and south side elevations, right

In spite of alterations to its porch and some sash, the house at 1206 S 2nd St (ca.1910) would contribute to the historic district, as it retains early weatherboards, surrounds, cornerboards, and friezeboards (Exhibit 136, at left). The house at 1103 S 2nd St (ca.1915) has modern sash and an altered engaged porch, but also early weatherboards, surrounds and a front gable window (Exhibit 136, at right).

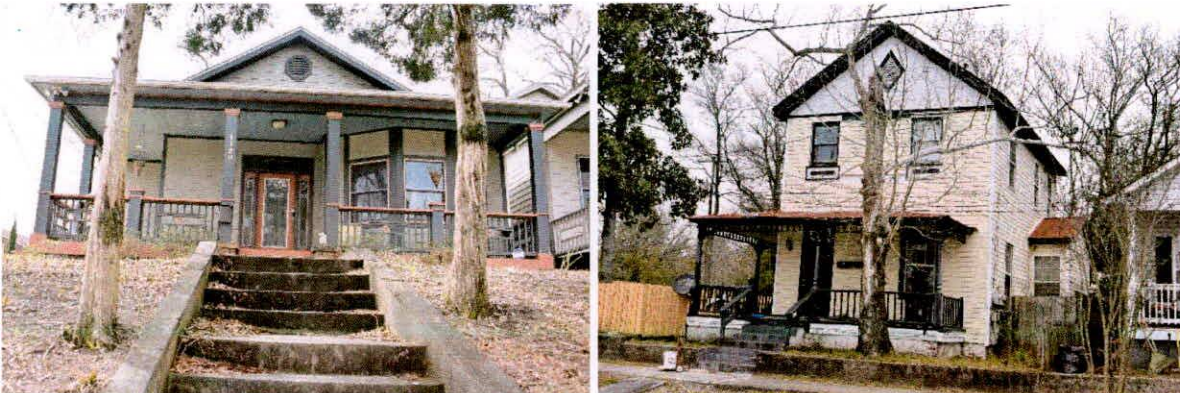
Exhibit 137: 1120 S 3rd St, east front elevation, left; 1303 S 3rd St, west front and south side elevations, right

The ca.1912 frame house at 1120 S 3rd St contributes despite its modern sash, balustrade, and HardiPlank siding due to its early wraparound porch, cornerboards and surrounds, bay window and entryway (Exhibit 137, at left). The contributing two-story house at 1303 S 3rd St (pre-1915) retains an early wraparound porch, surrounds, spandrels, and projecting side bay and rear ell alongside of aluminum and asbestos siding and altered sash (Exhibit 137, at right).

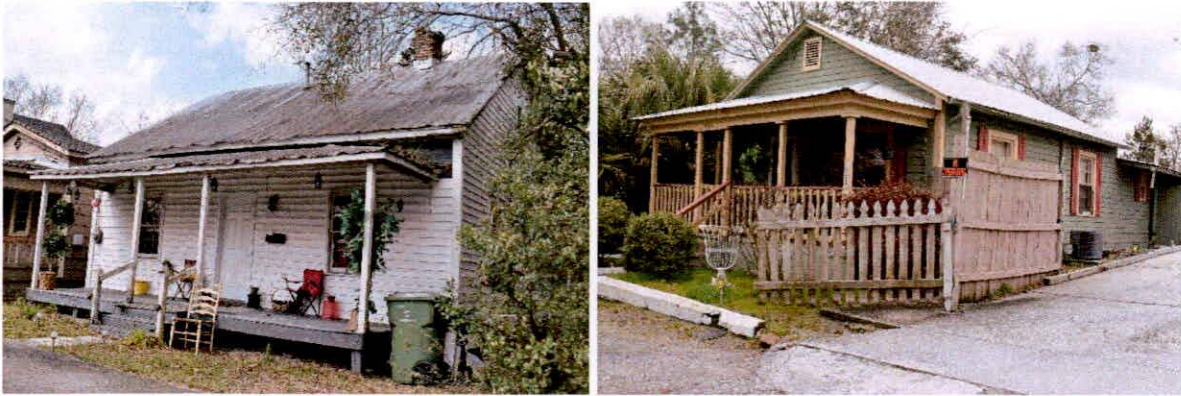
Exhibit 138: 115 Meares St, south front and east side elevations, at left; 1305 Simon St, west front and south side elevations, at right

The pre-1915 gable-end dwelling at 115 Meares St is recommended as contributing despite having vinyl siding due to its retention of early weatherboards visible beneath the vinyl, porch posts and double-hung sash in original surrounds (Exhibit 138, at left). The gable-front house at 1305 Simon St (pre-1915) has weatherboards, wooden surrounds and cornerboards, and a gable ventilator in place. It is recommended as contributing even though its sash and porch are altered (Exhibit 138, at right).

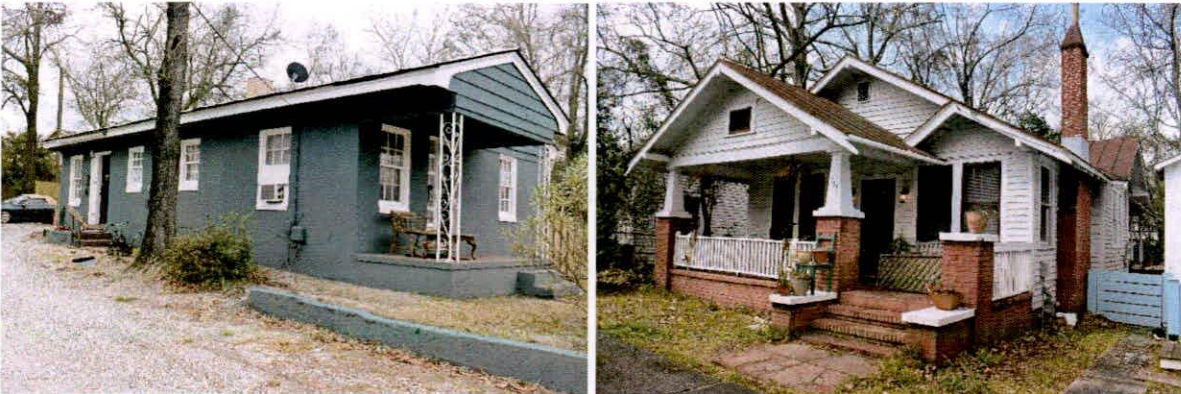
Exhibit 139: 306 Kidder St, east side and north front elevations, at left; 117 Meares St, south front and east side elevations, at right

The two most intact, and therefore most clearly contributing resources, are the gable-front concrete-block house at 306 Kidder St (ca.1945) (Exhibit 139, at left) and the multi-gabled bungalow at 117 Meares St (ca. 1937), which retains its siding, sash, and Craftsman-style porch and woodwork (Exhibit 139, at right). These are the exception within the southern APE area, however.

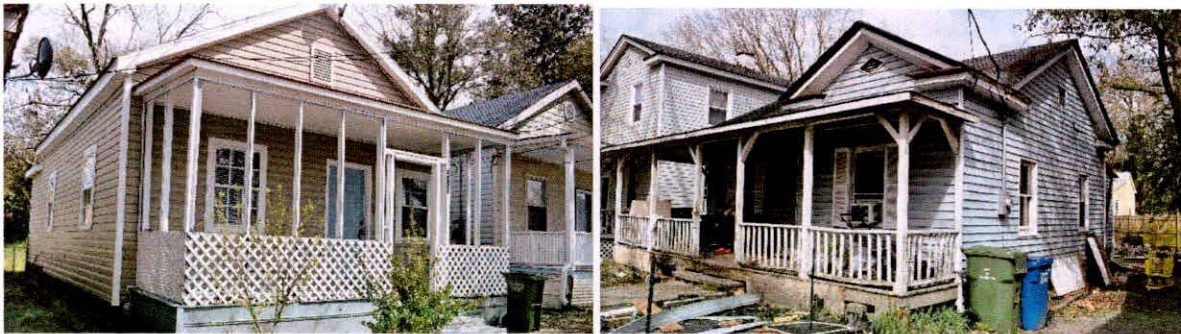
Exhibit 140: 1105 and portion of 1107 S 2nd St, north side and west front elevations, left; portion of 1015 and 1017 S 2nd St, south side and west front elevations, right

The noncontributing ca.1915 houses at 1105 and 1107 S 2nd St retain their gable-front frame forms, but have modern vinyl siding, windows, surrounds, and much-altered porches (Exhibit 140, at left). The two-story house at 1015 S 2nd St (ca.1917) and its one-story neighbor to the south at 1017 S 2nd (ca.1912) are altered in similar fashion (Exhibit 140, at right).

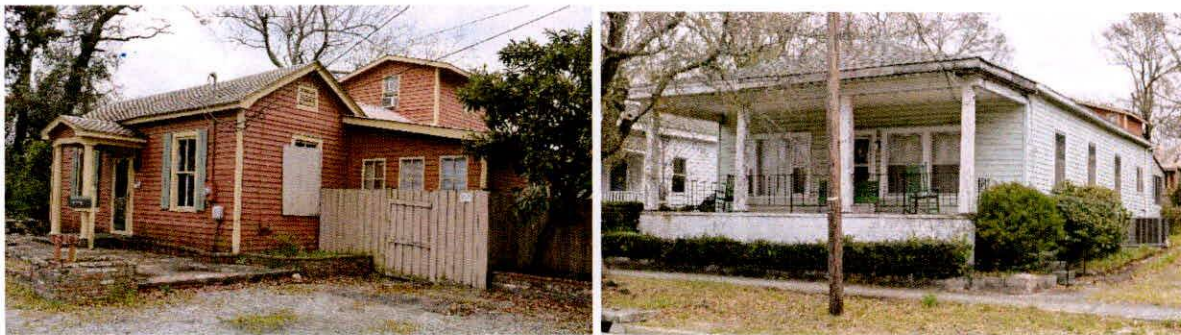
Exhibit 141: 1310 Simon St, east front and north side elevations, left; 1309 S 3rd St, west front and south side elevations, right

The houses at 1310 Simon St (Exhibit 141, left) and 1309 S 3rd St (Exhibit 141, right) retain more early features than those above. The Simon St house (ca.1910 or moved post-1955) has some 2/2 sash, weatherboards, and wooden surrounds; a full-façade porch with heavy posts is an early prominent feature at the 3rd St house (ca.1920). But 1310 Simon has multiple later extensions, including a two-story rear addition, and a modern portico, while 1309 S 3rd has vinyl siding, altered sash, and two later doubled window bays at its façade. Both are therefore believed to have lost their integrity and would not contribute to an expanded historic district.

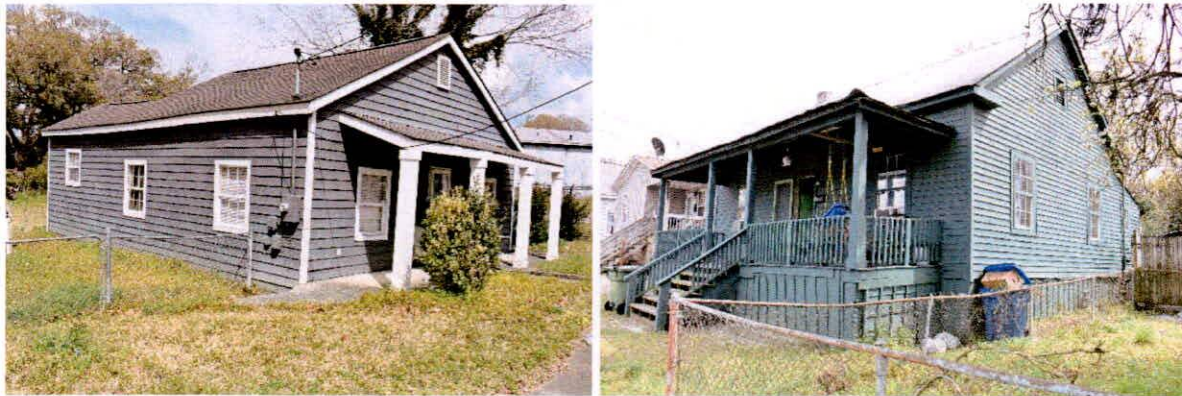
Exhibit 142: 209 Meares St, east side and south front elevations, left; 208 Meares St, north front and west side elevations, right

The intact appearance of houses opposite each other on Meares St is less evident when they are viewed up close. Frame cornerboards continue to edge 209 Meares (pre-1915), but it is

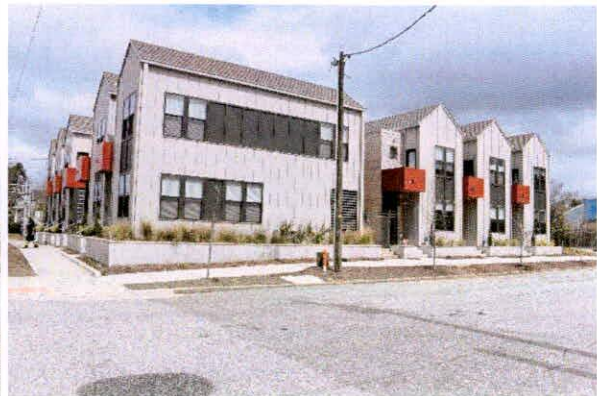
Exhibit 144: 1540 S 2nd St, south side and east front elevations, at left; 1371-1381 S 3rd St (left) and 301-305 Martin St (right), at right

Thirty-four of the noncontributing standing resources were built after 1945, the end of the historic district's period of significance. Some are new and clearly would not contribute to an expanded district. These include South Front, a mixed-use commercial development at 1540 S 2nd St (2018) (Exhibit 144, at left), and the condominium development at 1371-1381 S 3rd St/301-305 Martin St, built in 2019 (Exhibit 144, at right). Others were built within the past 25 years, such as New Kelly's Chapel AME Church at 1125 S 2nd St (1999) (Exhibit 145, at left) and four Habitat for Humanity houses, including one at 1207 S 2nd St (2002) (Exhibit 145, at right).

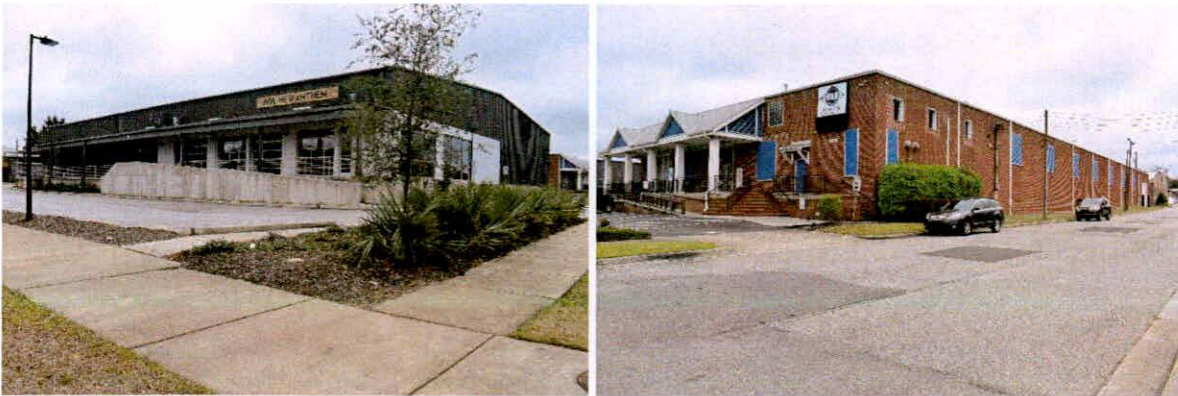
Exhibit 151: 110 Greenfield St at corner of S Front St, left; 1525 S Front St at corner of Willard St, right

Nonresidential buildings erected within the past 50 on prominent corner sites with the southern APE area include the New Anthem Brewery (1986), 110 Greenfield St at S Front St (Exhibit 151, at left); the adjacent self-storage building, 1525 S Front St at Willard St, erected in 1967 by Block Shirt/Southland Manufacturing Co (Exhibit 151, at right); the mixed-use strip building (1997), 1115 S 3rd St at Marsteller St (Exhibit 152, at left); and the 1973 restaurant building at 1423 S 3rd at the corner of Greenfield St (Exhibit 152, at right).
