Re: Develop Yeargen Park, East Garner Road, Garner, Wake County, ER 19-3021

# HISTORIC STRUCTURES SURVEY REPORT

**L.C. YEARGAN FARM (WA0352)**  
Town of Garner, St. Mary's Township,  
Wake County, North Carolina

**Technical Report # 2021-118NC**

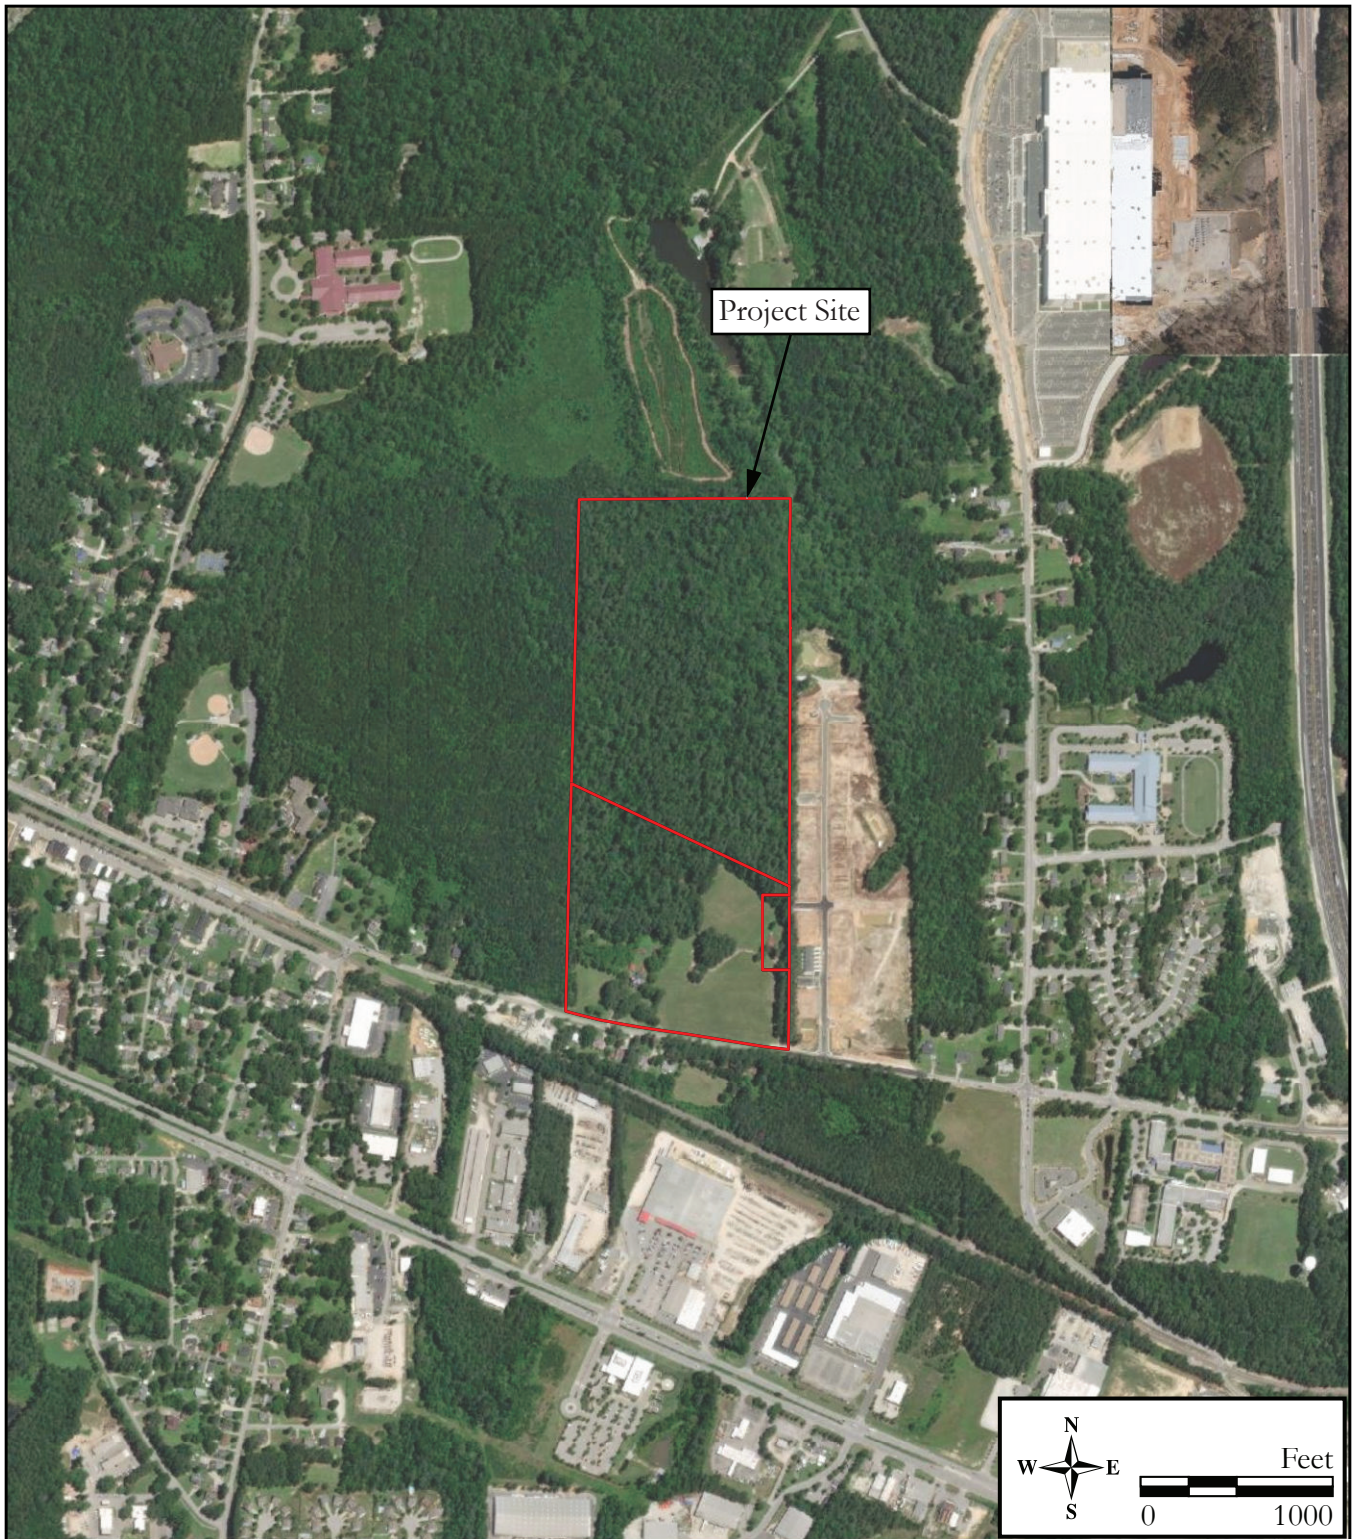
Figure 2.2: Aerial map showing the location of the L.C. Yeargan Farm (World Imagery, ESRI 2020).

The project area is located east of downtown Garner in St. Mary's Township, Wake County, North Carolina (Figures 2.1-2.2). Three parcels owned by the Town of Garner are situated on the north side of East Garner Road. The project area is roughly bounded by wooded land and a small body of water to the north, modern townhomes to the east, East Garner Road to the south, and heavily wooded parcels to the west.

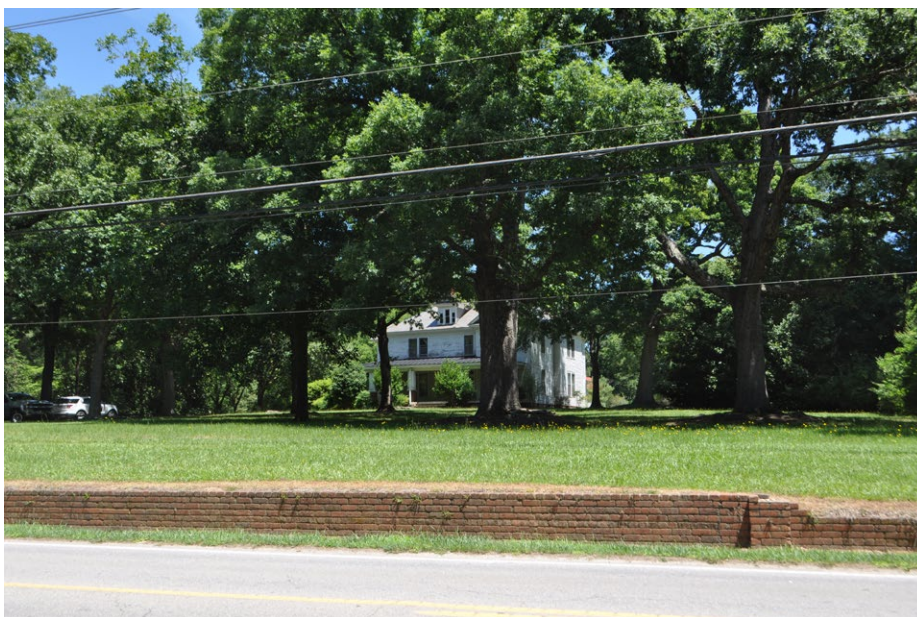
Plate 4.1: L.C. Yeargan Farm.

The L. C. Yeargan Farm is comprised of three parcels totaling approximately 72 acres on the north side of East Garner Road in Garner, St. Mary's Township, Wake County, North Carolina (Figure 4.1; Plates 4.1-4.3). The L.C. Yeargan House, its associated outbuildings, and the Martha Dupree House are all located in the southernmost portion of the farm (Figure 4.2). Open fields survive along the Garner Road frontage, but the majority of the property north of the buildings had converted to woodlands by the 1970s (USDA 1971).

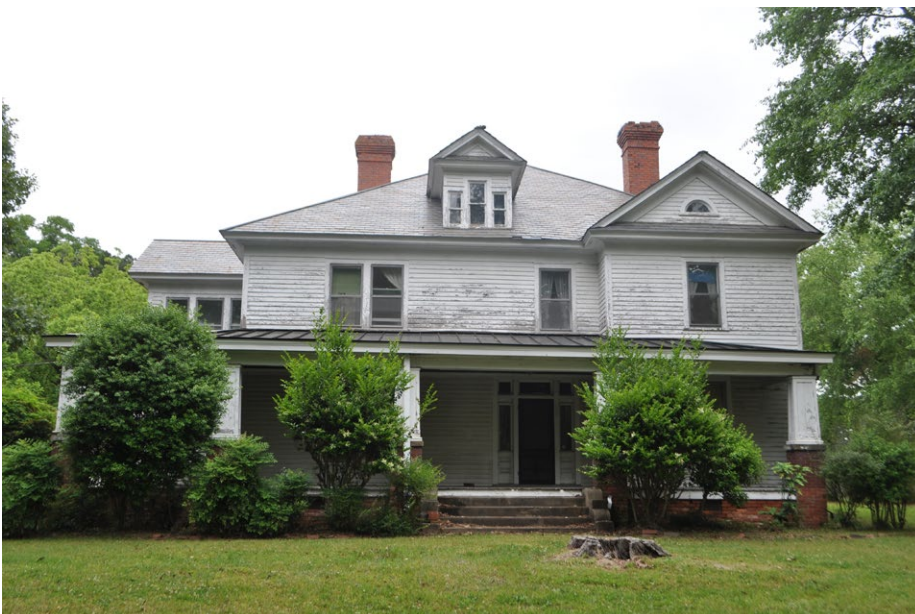
Plate 4.4: L.C. Yeargan  
House.

The 1919 house at the center of the L.C. Yeargan Farm is a substantial, frame, two-story, double-pile Colonial Revival-style residence which rests on a continuous brick foundation and is topped by a high, hipped, slate roof. A pedimented dormer with a tripartite window pierces the front roof slope, and two interior brick chimney stacks with corbelled caps rise from the east and west slopes of the roof. There is a projecting front-gable wing at the east end of the south-facing façade with a semi-circular window in its pediment. A two-story pedimented sunroom wing projects from the west side elevation, and opposite it a two-story pedimented bay projects slightly from the east side elevation. A one-story, gable-roofed kitchen ell projects from the rear (north) elevation. The house is clad with original weatherboard siding. Windows throughout are original, wood, one-over-one double-hung sashes with

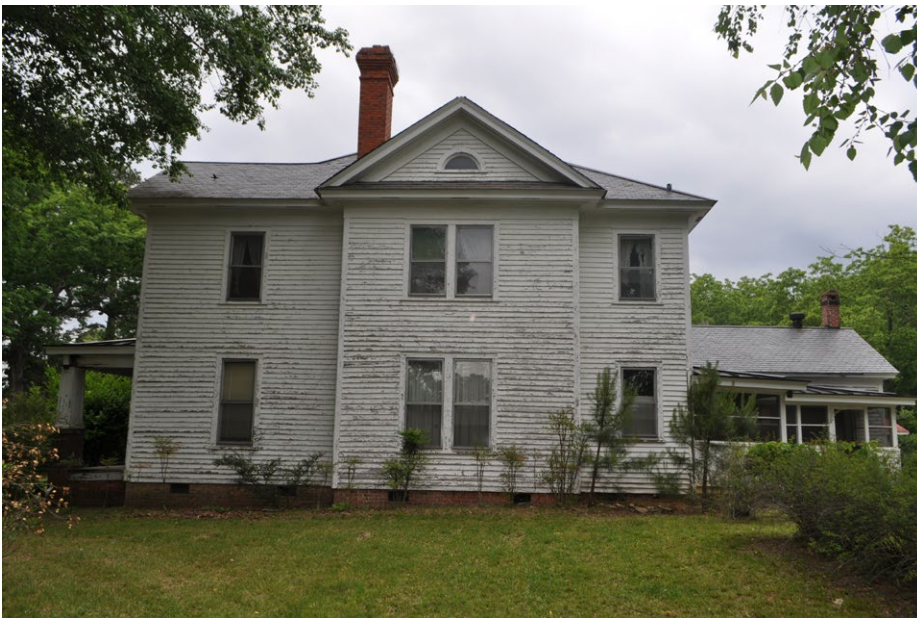
Plate 4.6: L.C. Yeargan House.

The west side elevation is dominated by the projecting sunroom wing. This wing is lit on three sides by triple window units at both levels. On either side of the wing are double window units on both the first and second stories. The front porch wraps around from the façade to meet the sunroom wing.

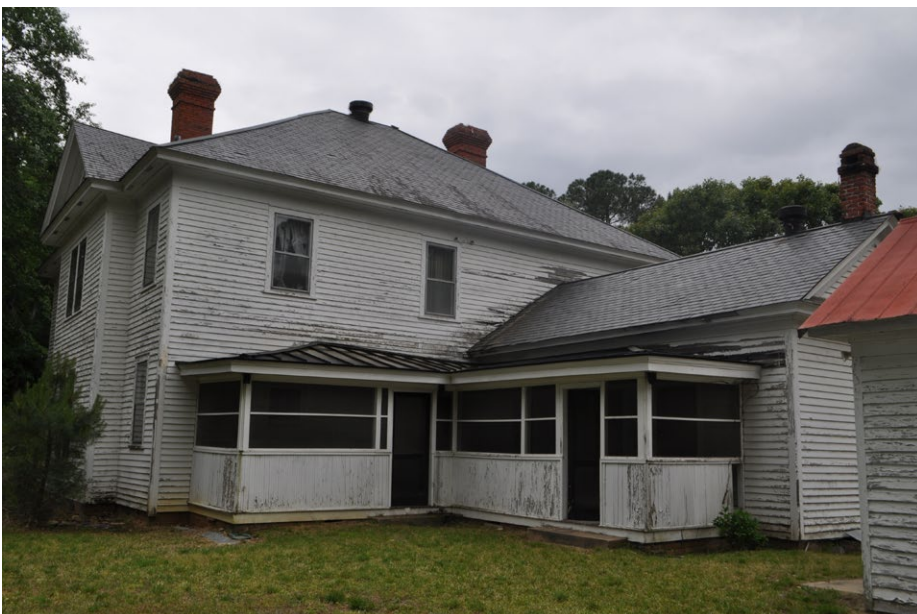
Plate 4.7: L.C. Yeargan House.

The rear (north) elevation contains the one-story kitchen ell, which appears to be original to the house. Its gabled roof is sheathed with slate, and a brick chimney flue with a corbelled cap rises from its peak. Three single window units on the second story of the house are arranged around the intersection of the ell's gabled roof with the house's rear wall. The ell is lit by three windows on its west side elevation. A hip-roofed, L-shaped porch extends along the east wall of the ell and the rear wall of the house. The porch is supported by chamfered posts, and like the front porch, retains its original tongue-and-groove floor and ceiling. The porch is enclosed with screens in the upper half and flush wood sheathing below. Its enclosure may be a later alteration. The porch roof is recent metal. There is a secondary entry into the rear stair hall of the house from the back porch. The original half-glazed door and decorative screen door match those found at the front entry, though they do not have the same elaborate surround. There is also an original half-glazed door providing direct access to the kitchen from the porch.

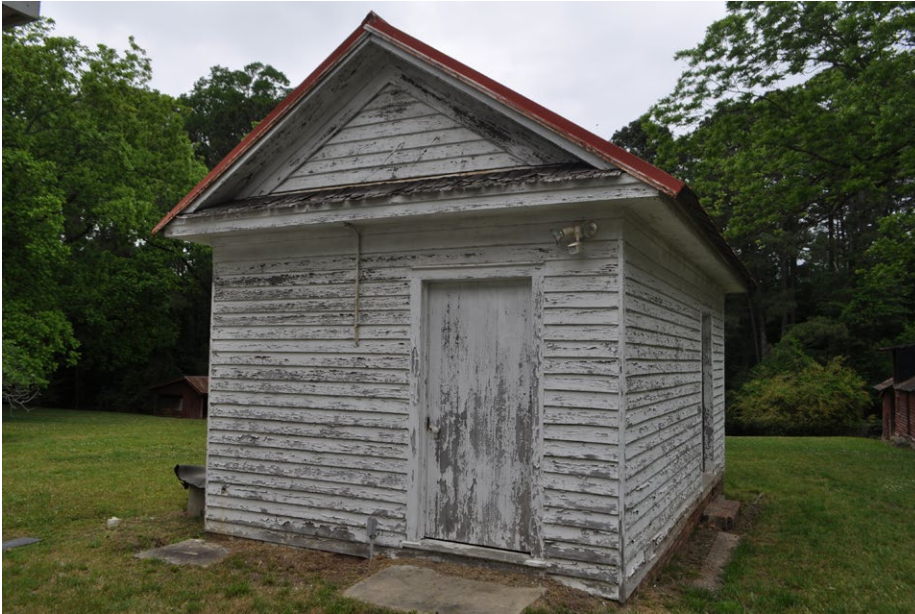
Plate 4.42: Outbuilding #1.

Located almost directly behind the Yeargan House to the north is Outbuilding #1. This small, frame, rectangular building has an overhanging front-gable roof that has been clad recently with metal roofing. A wood-shingled overhang on the both the front (south) and rear (north) elevations creates pedimented gable ends. The building has original weatherboard siding and rests on a brick foundation. It is accessed by a wood batten door at its south end facing the house. There is a second batten door on the east side elevation. The building has no windows. On the interior, the building is divided into two spaces. The original use of Outbuilding #1 is unknown at this time.

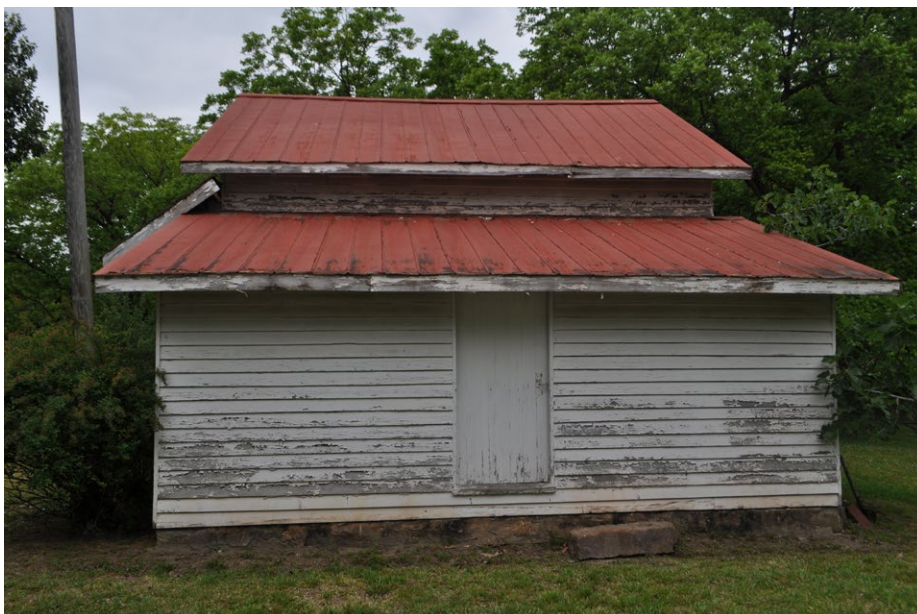
Plate 4.47: Garage.

The garage is situated off the northwest rear corner of the house. It is a one-and-one-half-story, weatherboarded, front-gable building with an enclosed shed on the east side. It has a parged stone foundation. There is a fixed four-pane window in the gable end. A wood-shingled pent roof shelters the automobile entry, which is accessed through a pair of original sliding batten doors. The overhanging roof has exposed rafter tails on the side elevations. There is one batten pedestrian door into the side shed. On the interior of the shed, a ladder provides access to the upper half-story of the garage. The interior of the garage itself was not accessible. The garage is likely contemporaneous with the house.

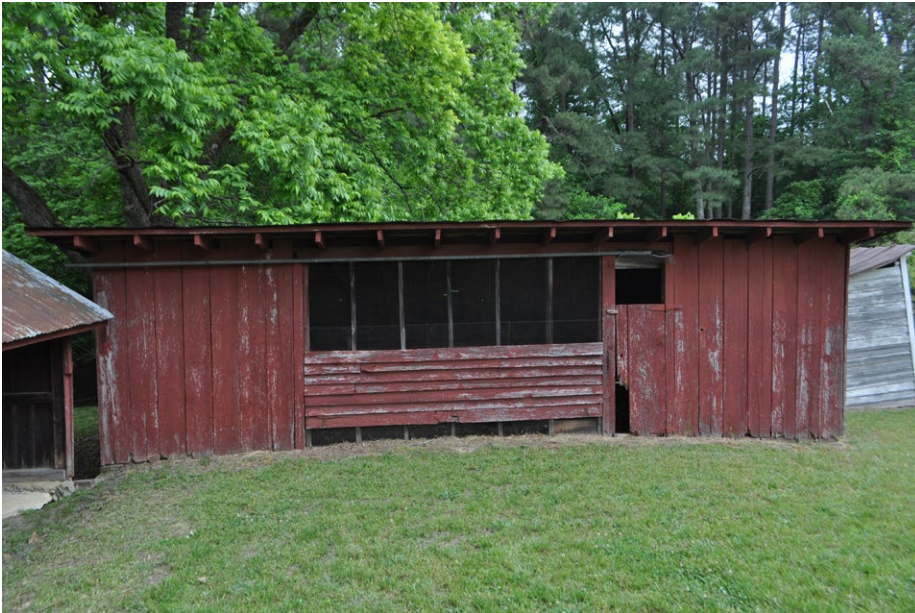
Plate 4.52: Chicken Coop #2.

Chicken Coop #2 is set perpendicular to Chicken Coop #1, facing south, and is almost twice as big. It is a fully-enclosed, shed-roofed building resting on a red brick foundation. The siding is a combination of red-painted weatherboards and vertical planks. The overhanging roof slopes from front to back and has exposed rafter tails on the south and north elevations. A three-quarters height batten door provides access to the interior. West of the entry is a screened section.

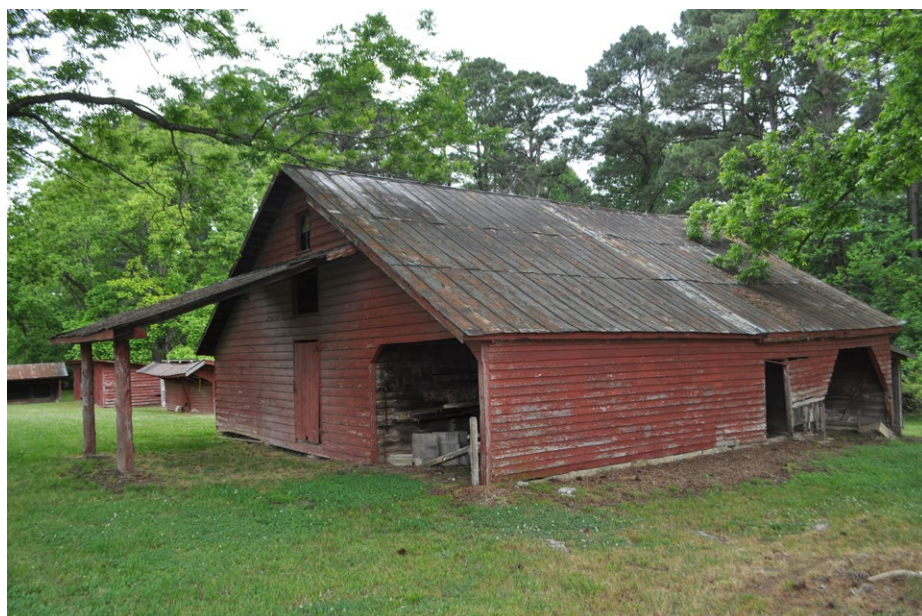
Plate 4.60: Barn #1.

East of the chicken houses is a frame, one-and-one-half-story barn with a broad, front-gable roof. The main body of the barn is clad with red-painted weatherboards and is roofed with metal. The front (south) elevation has a central batten pedestrian entry door with an opening to the hayloft above it and a fixed four-light window near the peak of the roof. The entry door and opening to the hayloft are sheltered by a tall, drive-through shed supported by cedar posts. At the east end of the front elevation is an open equipment storage bay. At the back of the barn is a wide, open passage lined with feed troughs. Attached to the rear (north) elevation is another shed which is clad with sheet metal and open on the east side.

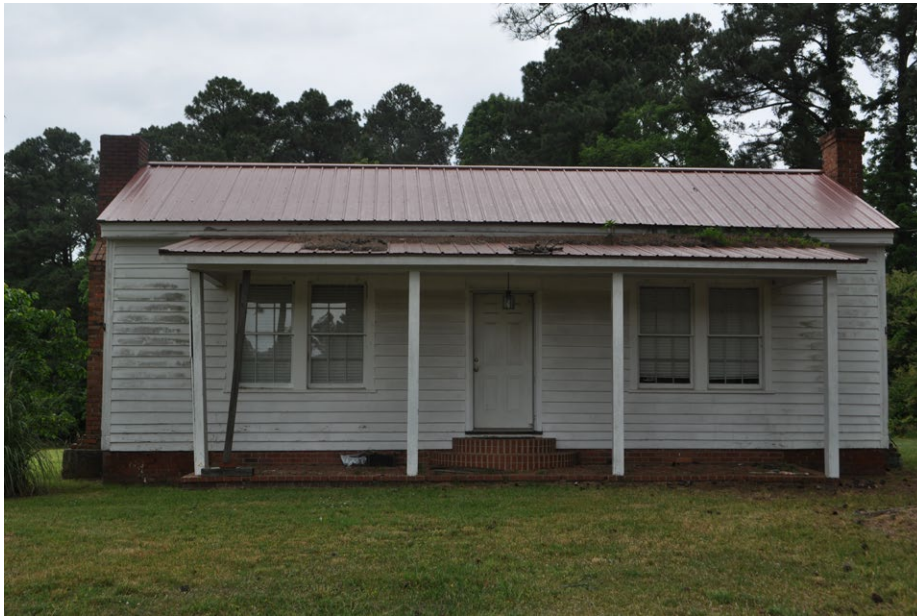
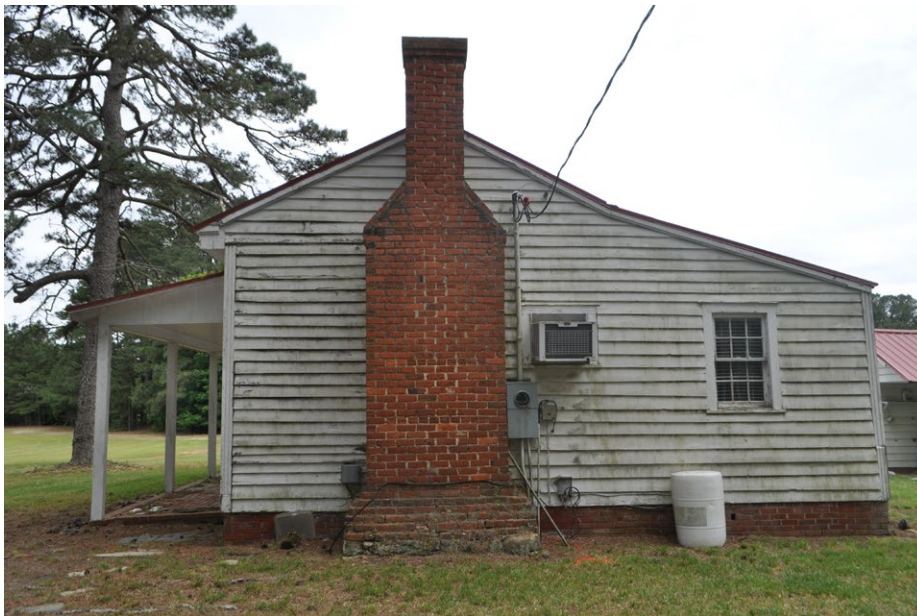
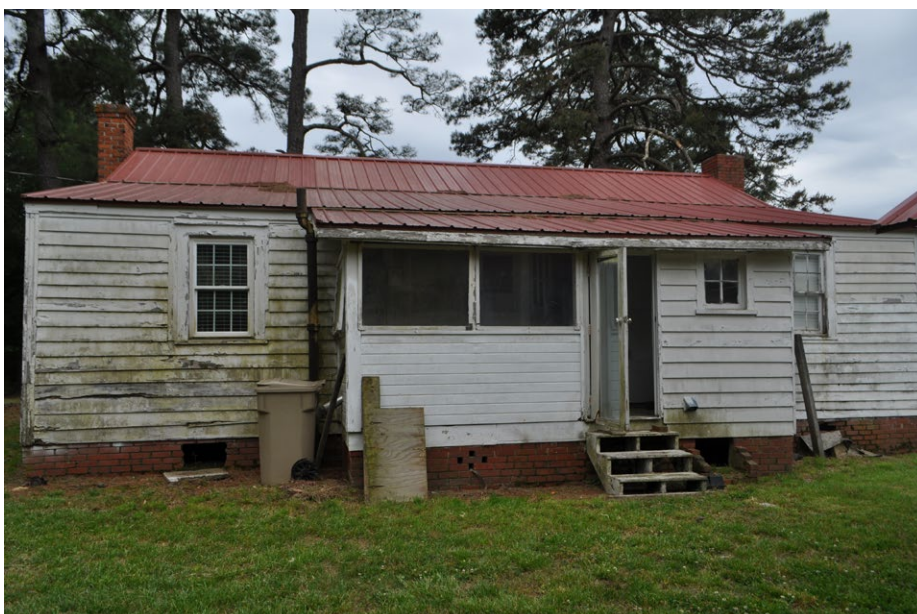
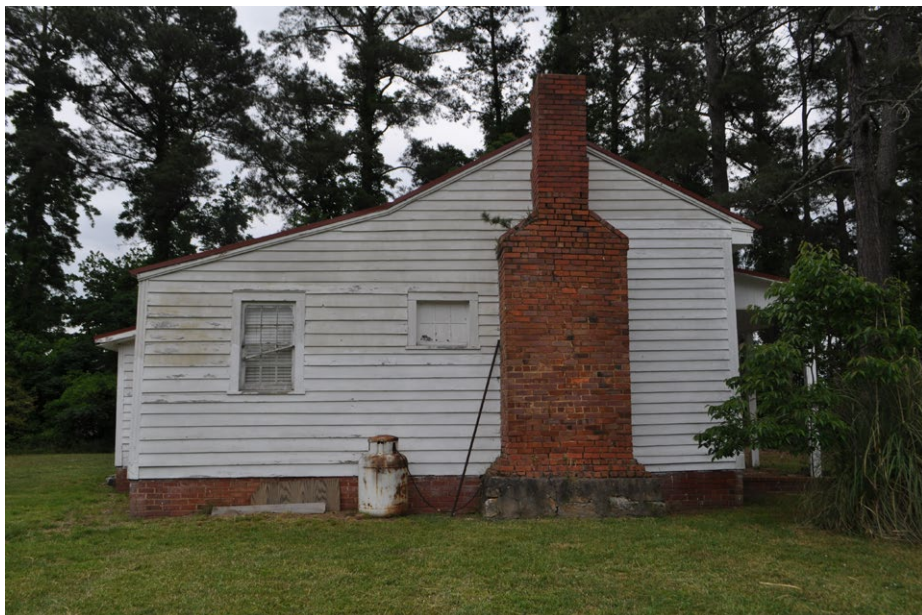
The Martha Dupree House was moved from its original location, but the move occurred within the farm's period of significance. Renovations undertaken after the dwelling was moved around 1920 and in the mid-twentieth century include the new porch with plain support posts and a brick floor, as well as the replacement front door. Despite these alterations, the Sarah Dupree House retains its circa 1850 form and stands as an example of an increasingly rare pre-Civil War-era dwelling.

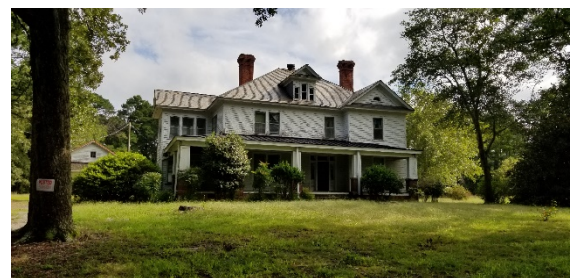
Figure 3: Larger House

The site varies in topographic and landcover character. Upon entering the gravel drive off Garner Road nearest downtown Garner, the stately historic house and old-growth trees (Figure 3) provide a welcoming entrance. Large oaks and magnolias line the driveway, creating frames of views upon fallow fields and a grove of 75+ year old pecan trees.

The house appears to be in a state of deterioration, exhibited by rotting wood and peeling paint. A garage, several sheds, a chicken coop and barns flank the house to the rear. A dirt road passes between the house and the barns, leading to an open field where another barn is situated by a stand of trees in the distance.
