Re: Construct Old Milburnie Road residential subdivision, 1521 Old Milburnie Road, Raleigh, Wake County, ER 22-1032

# HISTORIC STRUCTURES SURVEY REPORT

**JOSEPH COLLIER FARM (WA1679)**  
Raleigh, Wake County, North Carolina

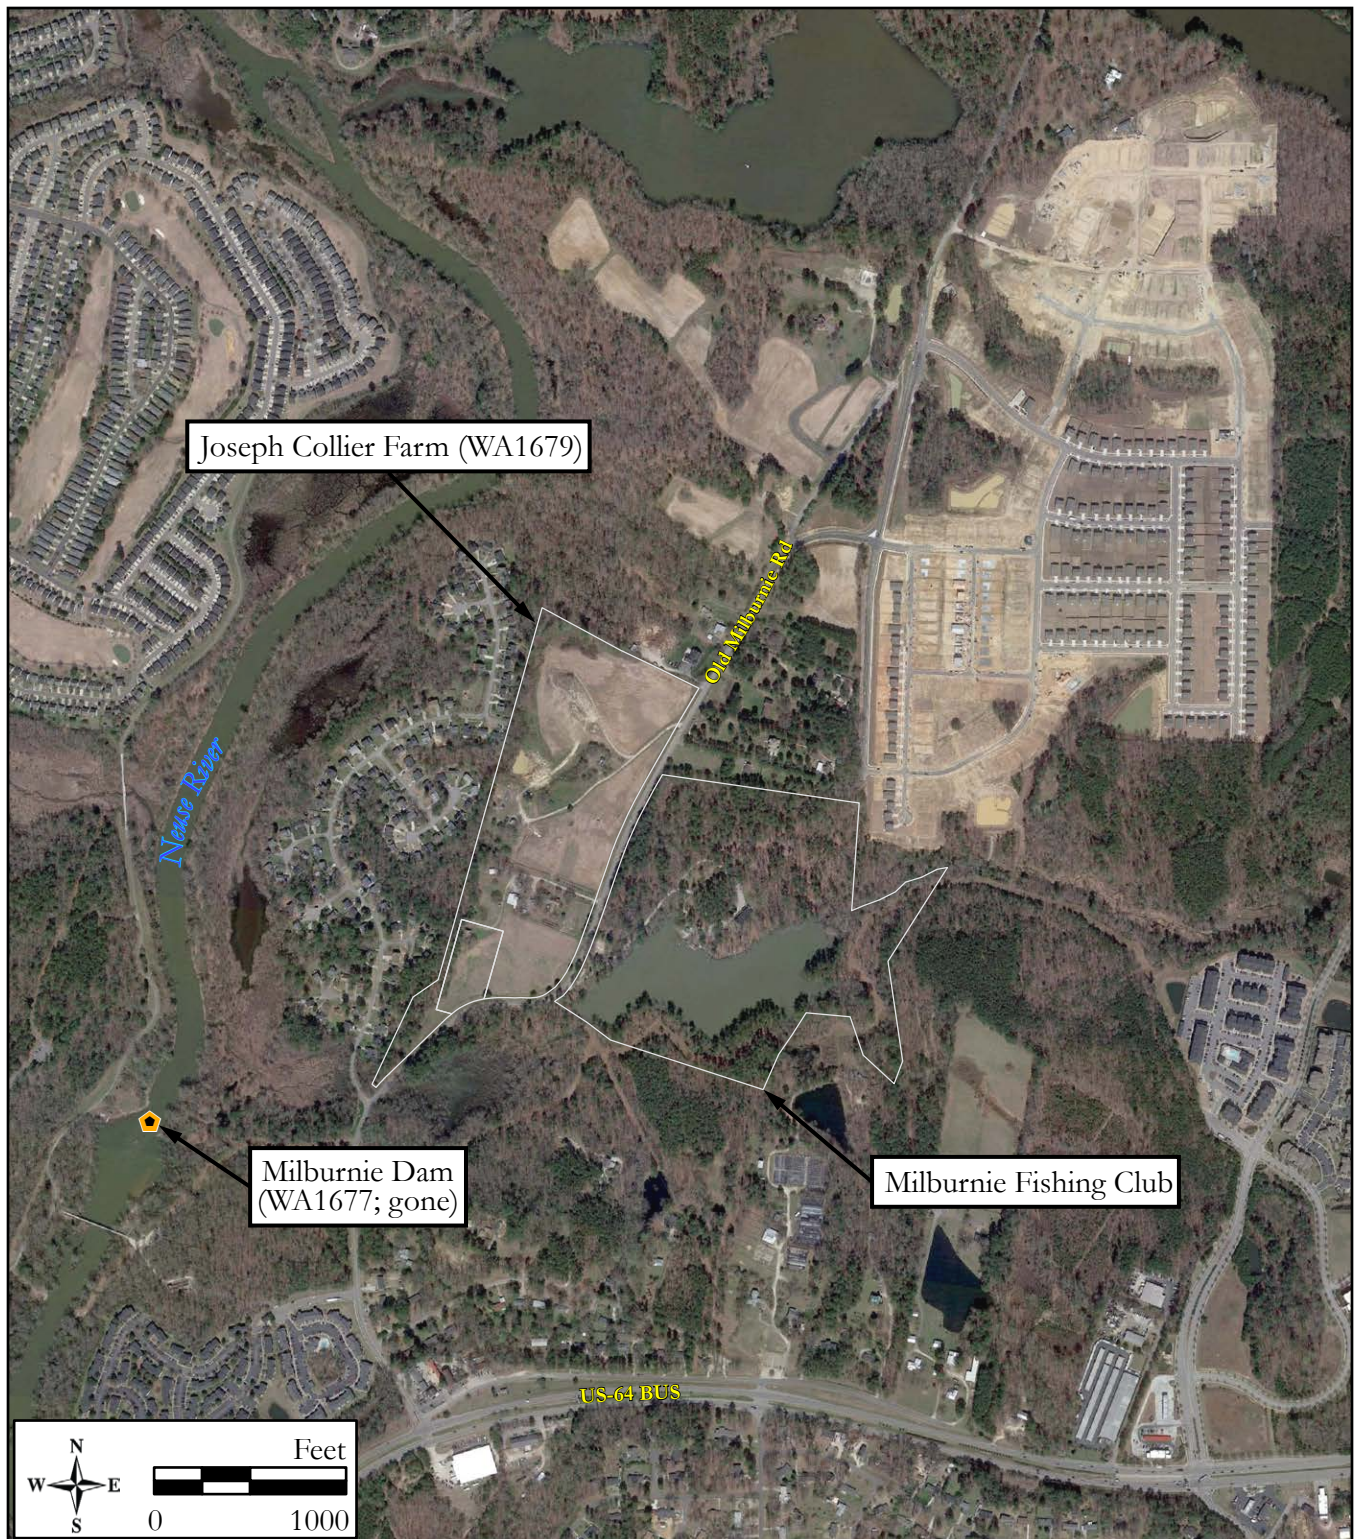
Figure 4.1: Setting, Joseph Collier Farm  
(World Imagery, ESRI 2021).

The Joseph Collier Farm (Figure 4.1-4.2) is situated on the west side of Old Milburnie Road approximately six miles northeast of downtown Raleigh. It sits on high land on the east side of the Neuse River, one-half mile northeast of the site of the former Milburnie Dam (WA1677), which served gristmills at that location during the eighteenth through early twentieth centuries. Between the farm and the river is the circa-1990 Beachwood residential subdivision. Across Old Milburnie Road from the farm is the Milburnie Fishing Club, a private social and recreational club established in 1913. There has been scattered single-family development of parcels along Old Milburnie Road since the mid-twentieth century, and currently, dense residential development is taking place to the northeast. The 34-acre Collier Farm is one of only a few large tracts of undeveloped land remaining in the area.

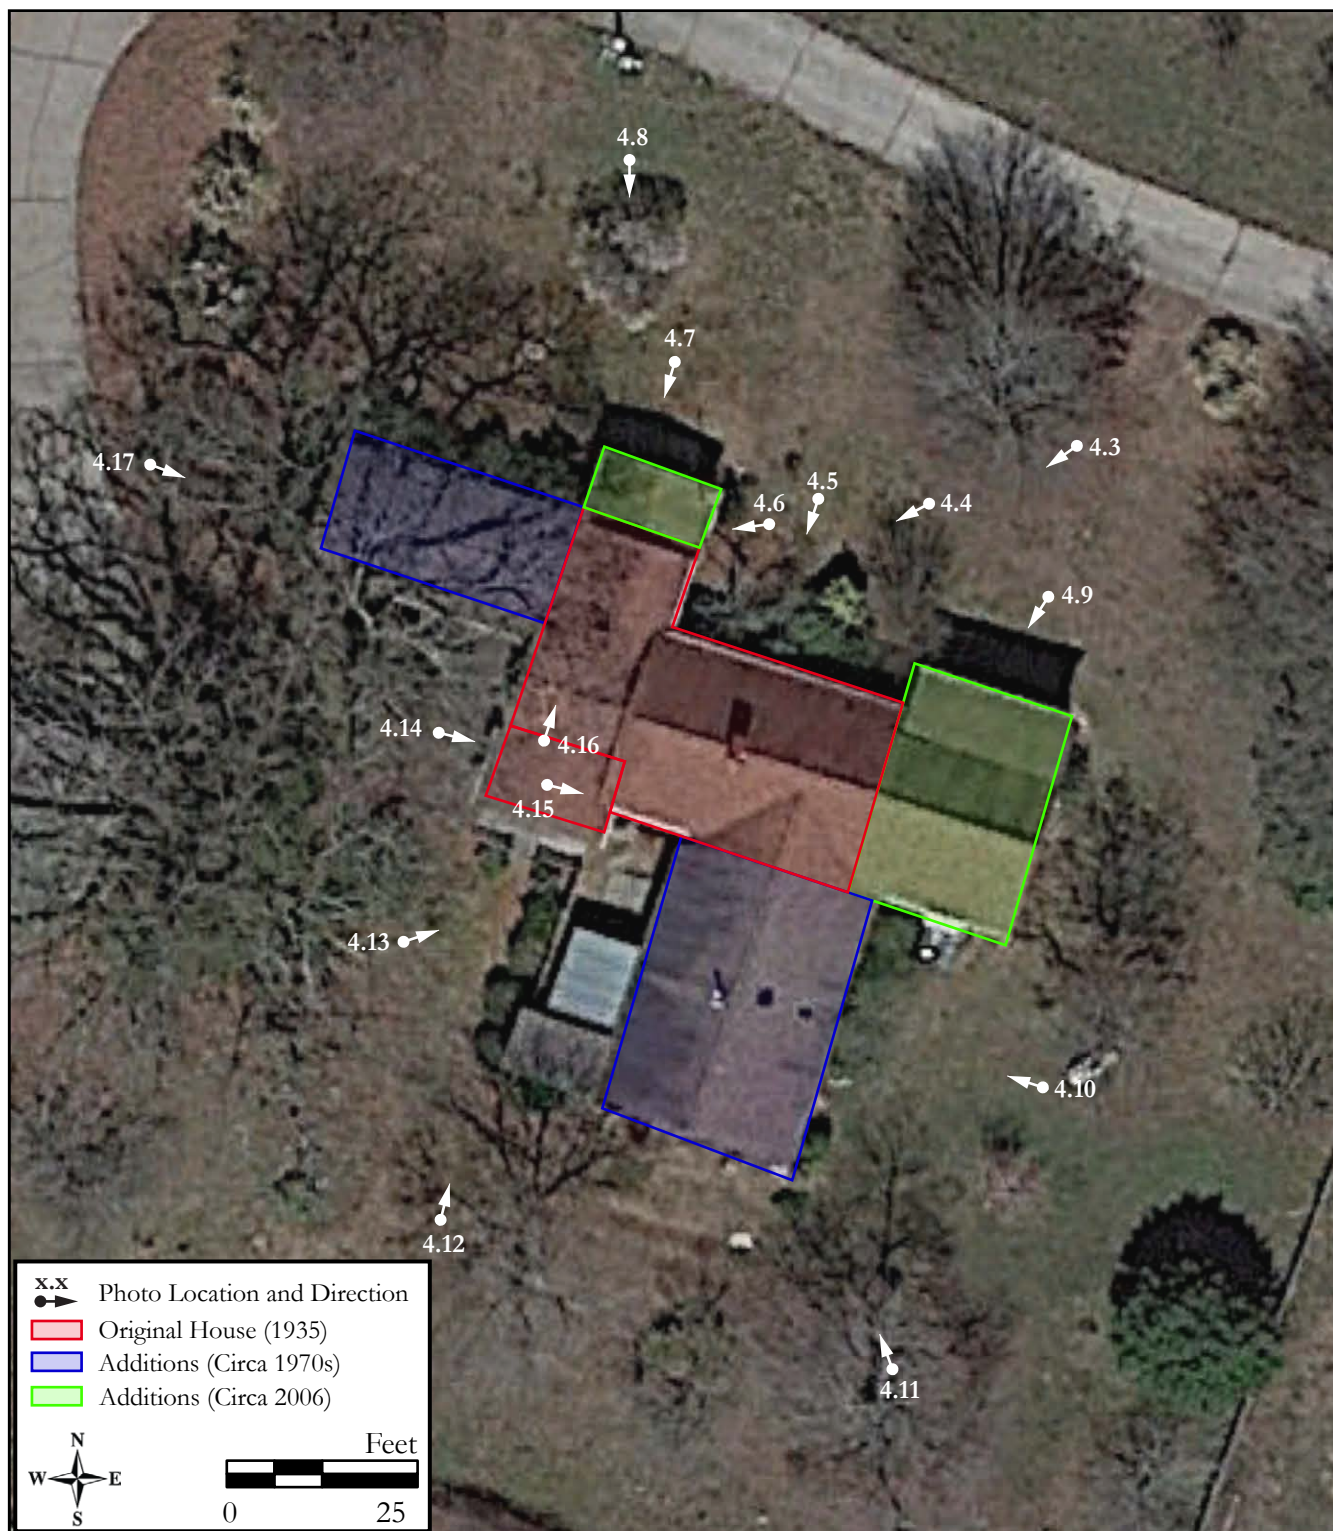
Figure 4.3: Joseph Collier house, photo locations (World Imagery, ESRI 2021).

The Joseph Collier house is a small, one-story, front-gable house clad with a distinctive multi-colored, irregular granite veneer with prominent, flattened mortar joints. It has a solid masonry foundation and is topped by an asphalt-shingled roof which is pierced by two stone chimneys. The original house consisted of a rectangular, front-gable block with a nested, gabled rear wing. A projecting gabled entry vestibule towards the rear of the north side elevation and a projecting porch off the rear of the south side elevation gave the house a subtle T-shape. The east-facing façade of the original house is obscured by a 2006 addition. Windows in the original house are paired and single wood, double-hung, six-over-six sashes with stone sills. The south side porch has original stone piers but its enclosure with glass is a later alteration. The porch has a stone floor and there are two 15-light doors opening into the house from it.

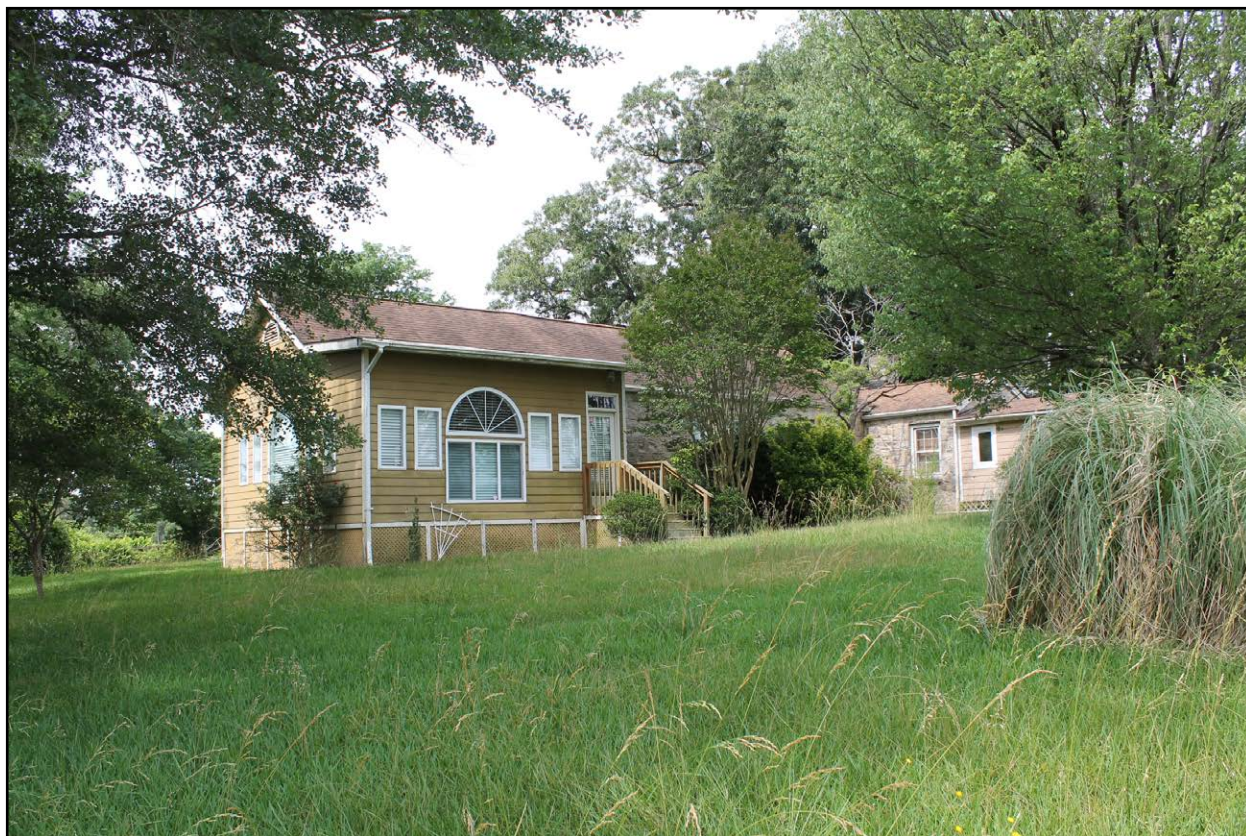
Figure 4.4: Joseph Collier house, view facing southwest.

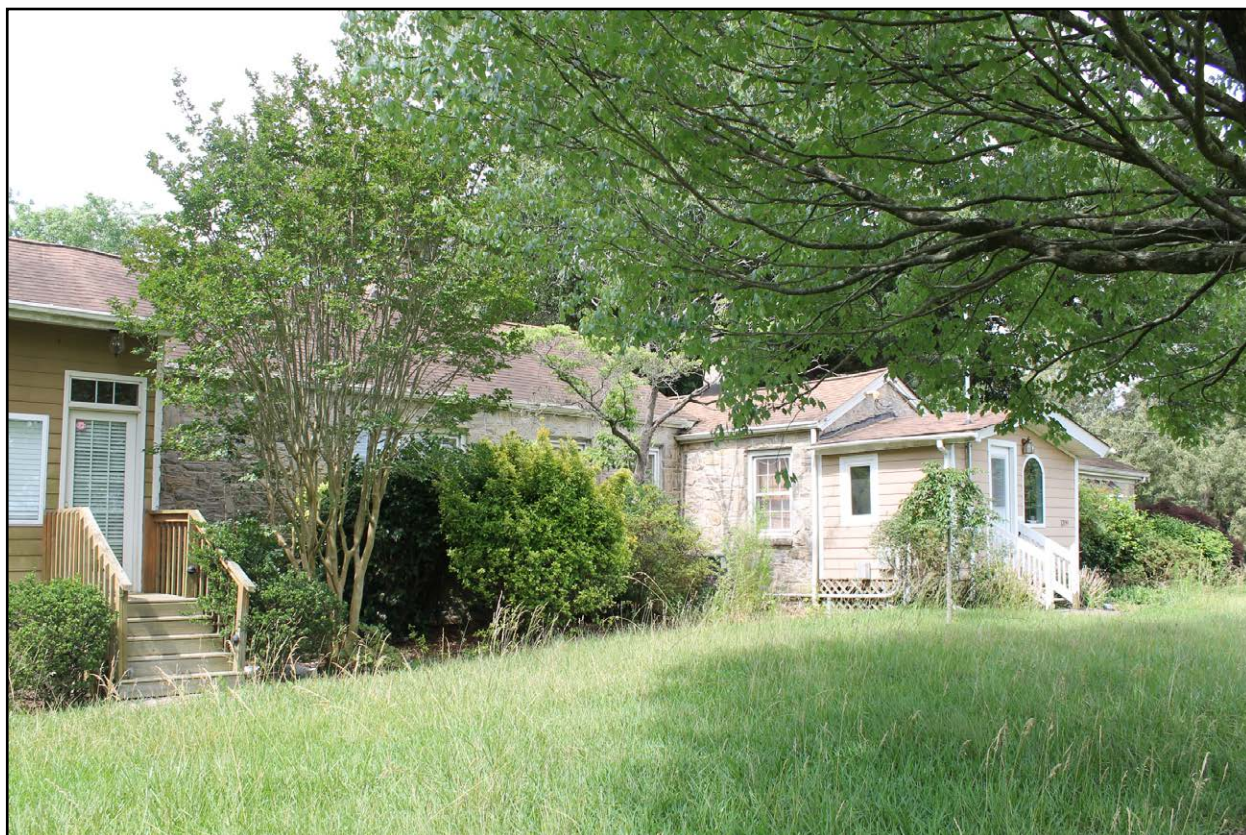
Figure 4.5: Joseph Collier house, view of north side elevation, facing southwest.

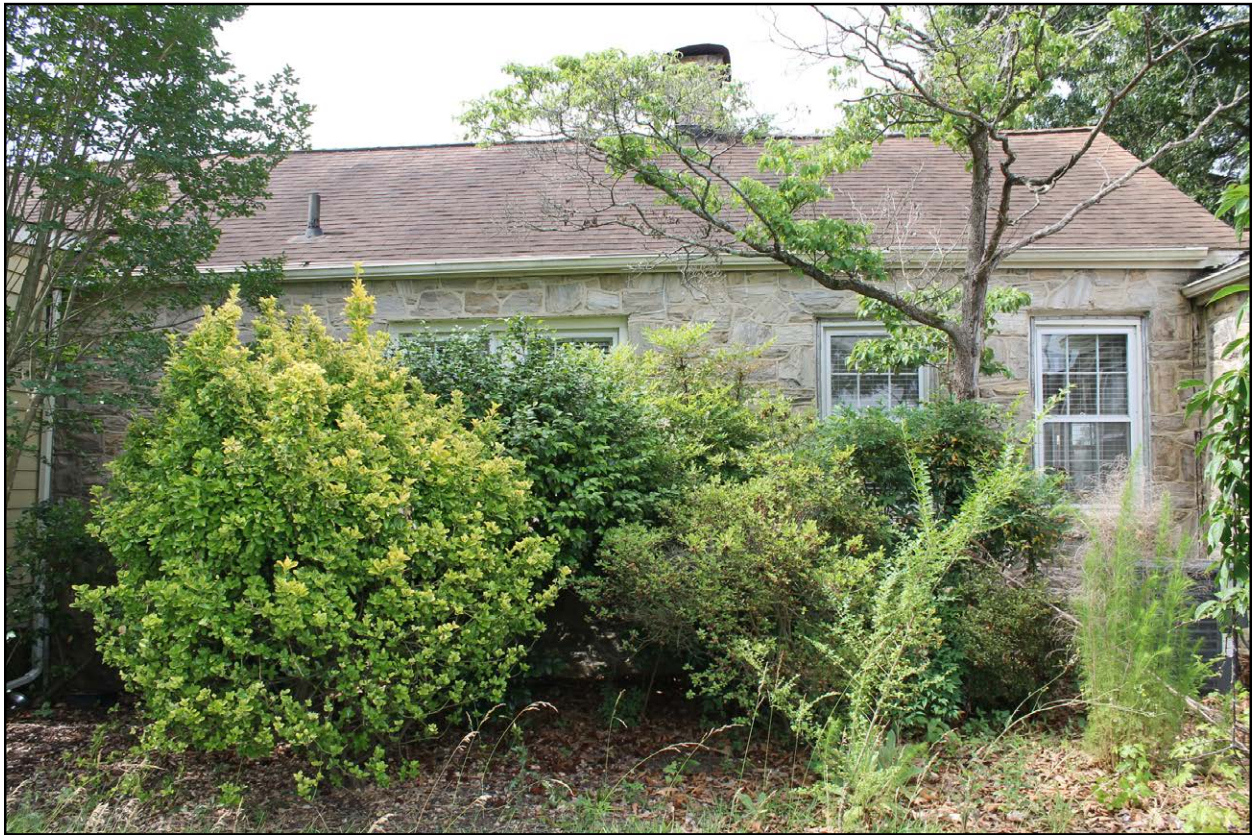
Figure 4.6: Joseph Collier house, view of portion of original north side elevation, facing south.

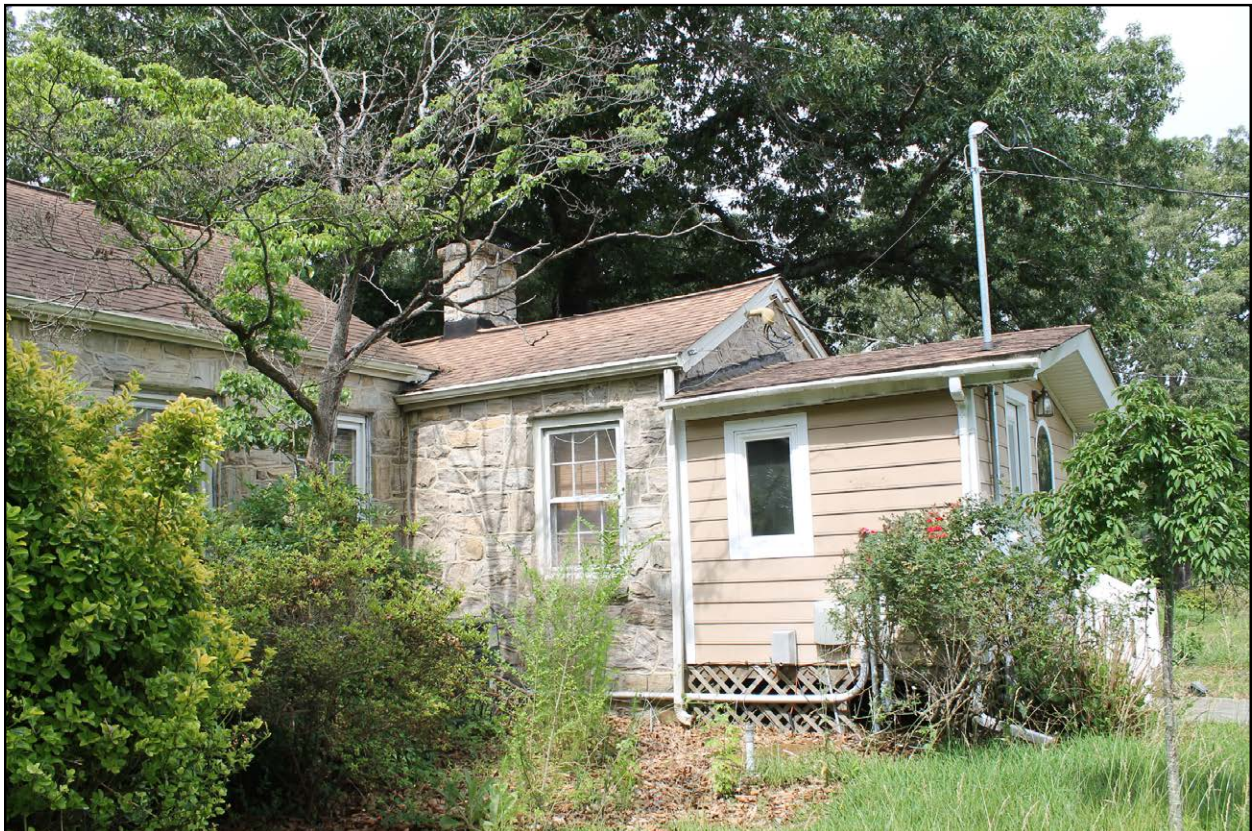
Figure 4.7: Joseph Collier house, view of original entry vestibule on north side elevation, facing southwest.

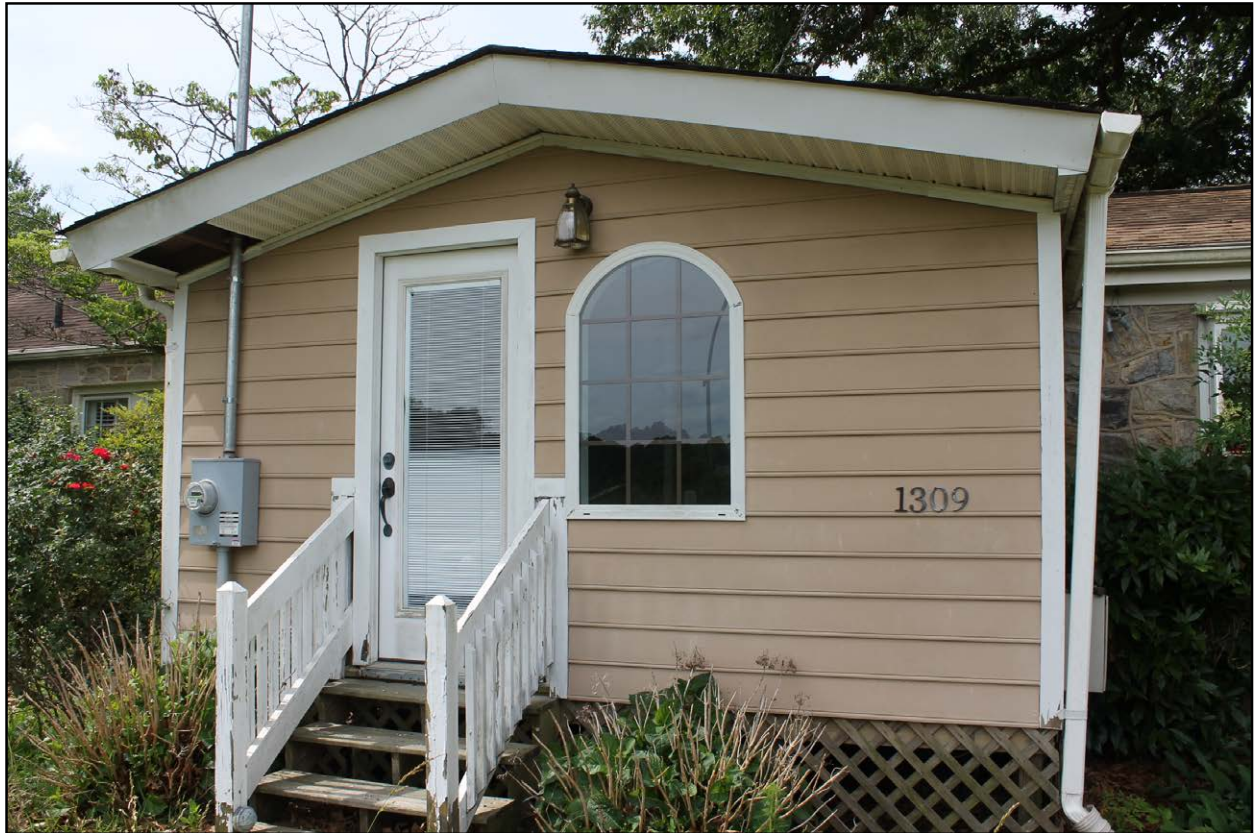
Figure 4.8: Joseph Collier house, view of 2006 addition to entry vestibule on north side elevation, facing south.

In 2006, a gabled and shed-roofed wing was added to the front of the house. The wing has vinyl siding and a lattice-covered pier foundation. It is lit on three sides by large central window units composed of a semi-circular pane over a strip of three vertical panes. Flanking the central window units are single-pane vertical windows. There is a glazed entry door accessed by wood steps on the north side of the wing. A second, gabled, vinyl-sided wing constructed at the same time projects from the north side entry vestibule and is finished similarly to the front wing.

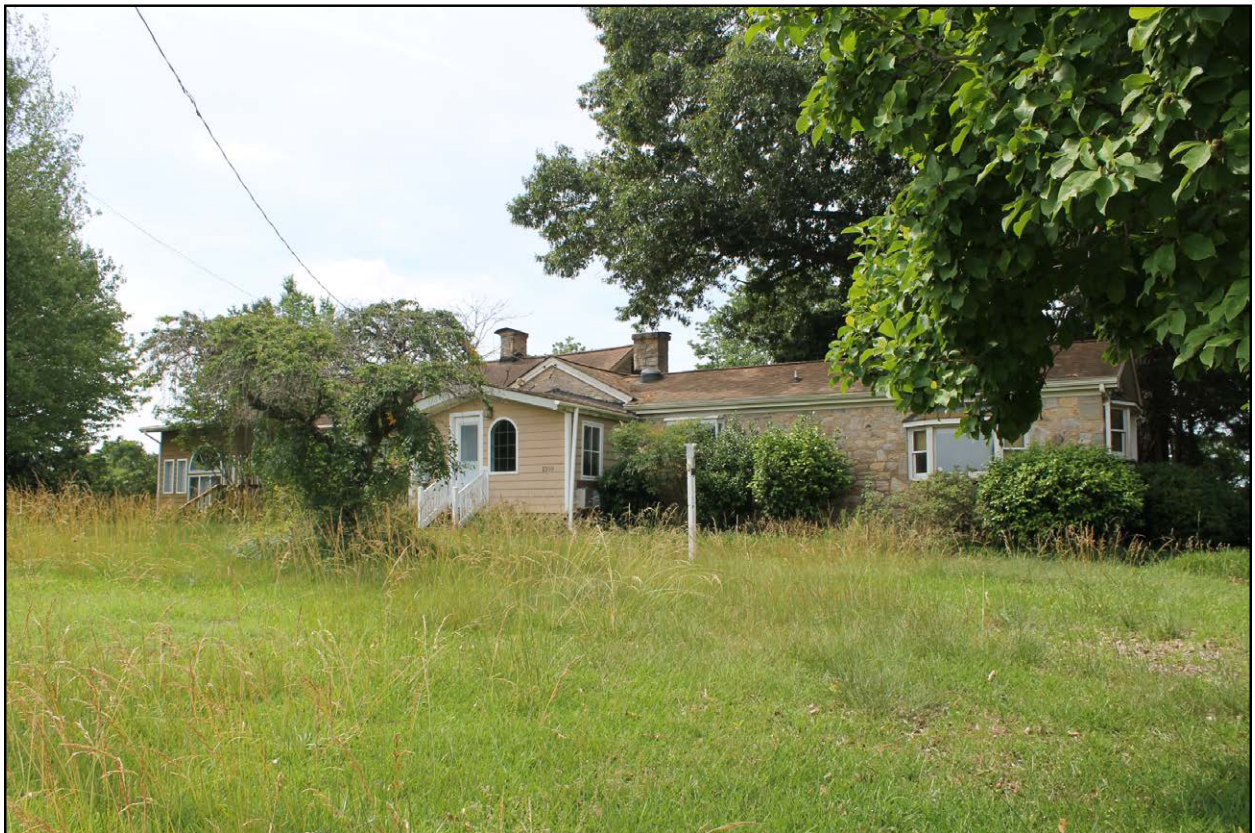
Figure 4.9: Joseph Collier house, view of north side elevation showing rear wing addition, facing south.

Rectangular gabled wings added between 1971 and 1985 project from the rear (west) and south elevations. These wings are clad in a stone veneer that is indistinguishable from that of the original house. The wings are lit by a combination of bay windows and fixed rectangular windows set high in the wall. There are glazed entries on the rear (south and west) elevations of the wings. An extensive wood deck built in 1985 wraps around the rear elevations.

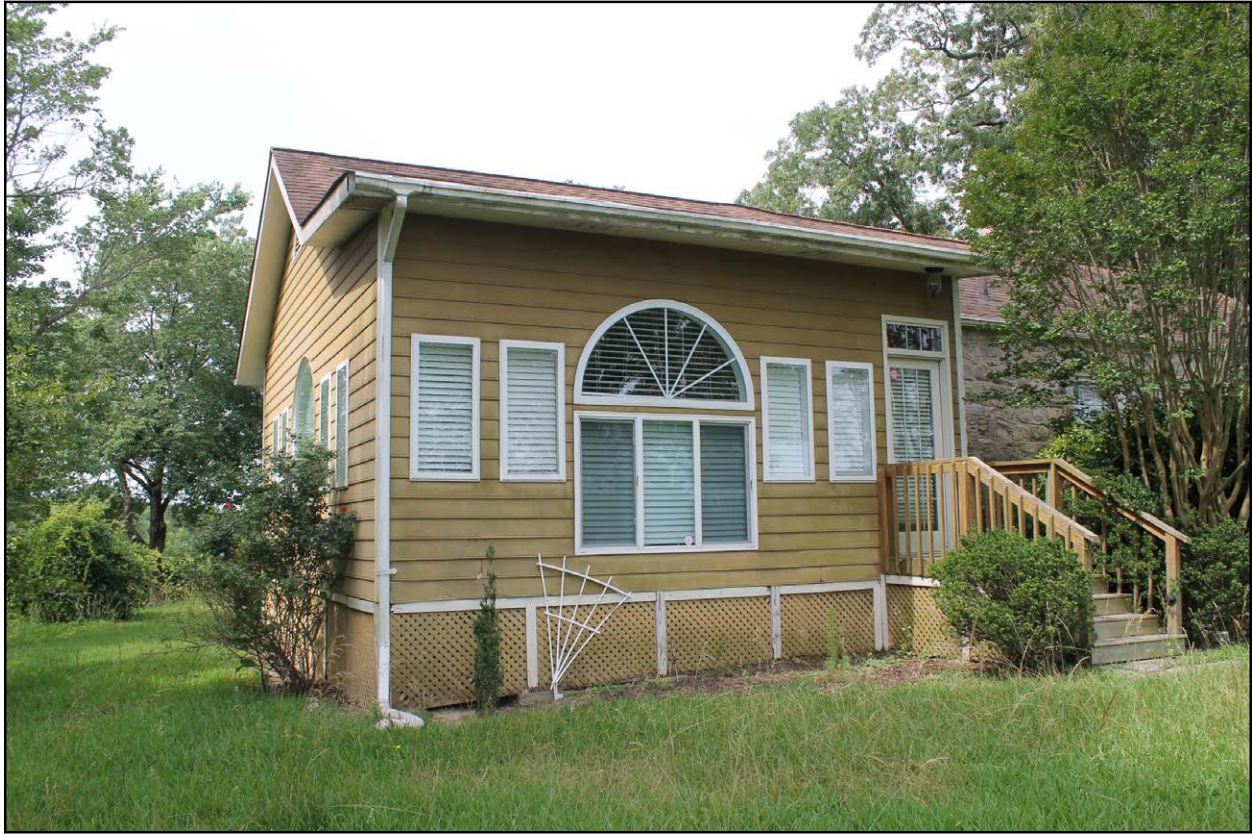
Figure 4.10: Joseph Collier house, view of 2006 façade addition, facing southwest.

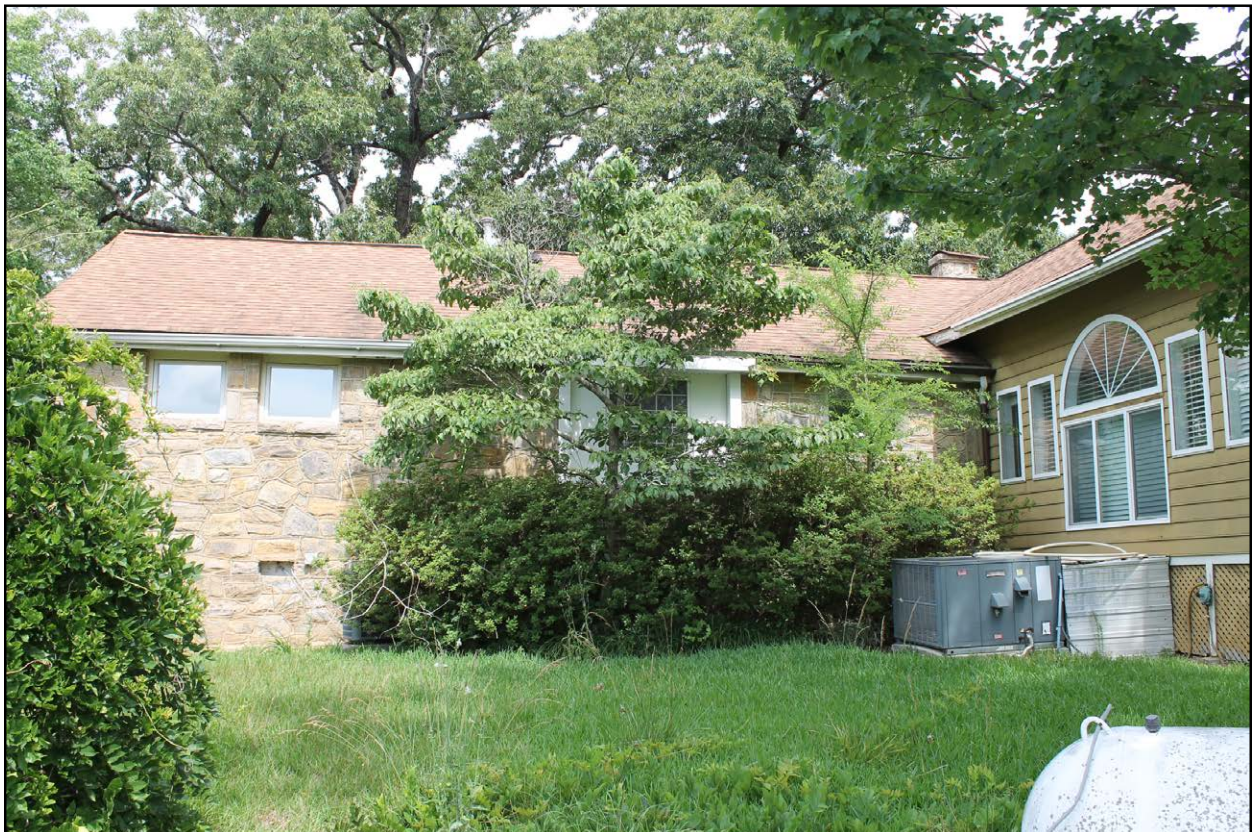
Figure 4.11: Joseph Collier house, view of south side wing, facing west.

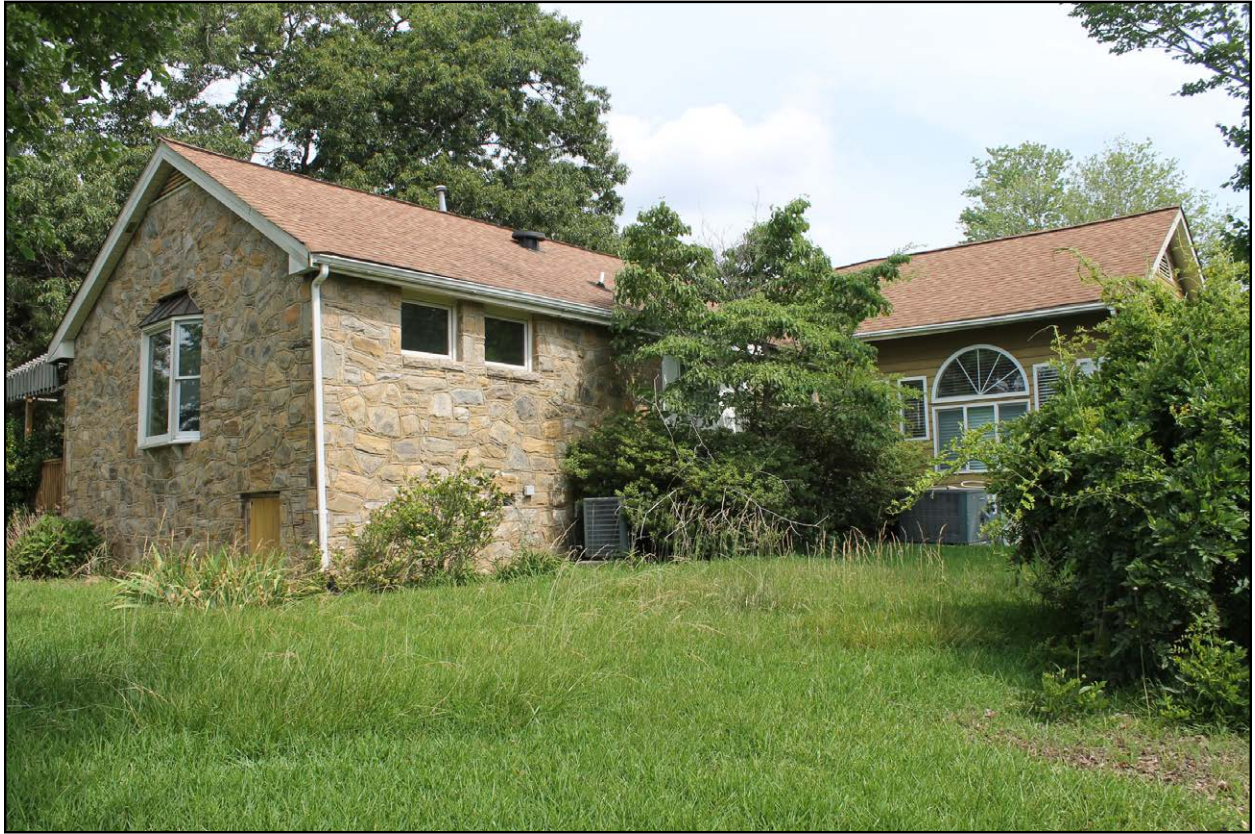
Figure 4.12: Joseph Collier house, view of south side wing and 2006 addition, facing northwest.

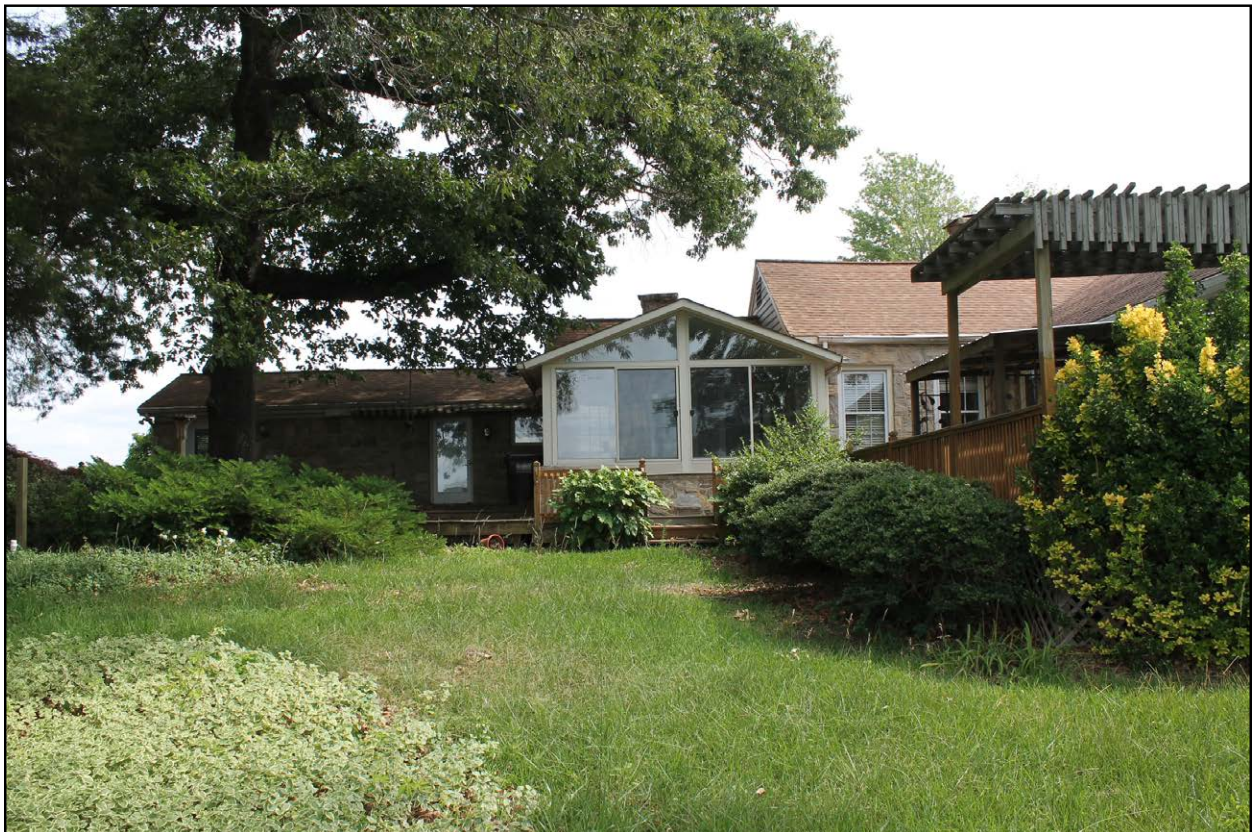
Figure 4.13: Joseph Collier house, view of south elevations of original house and rear wing, facing north.

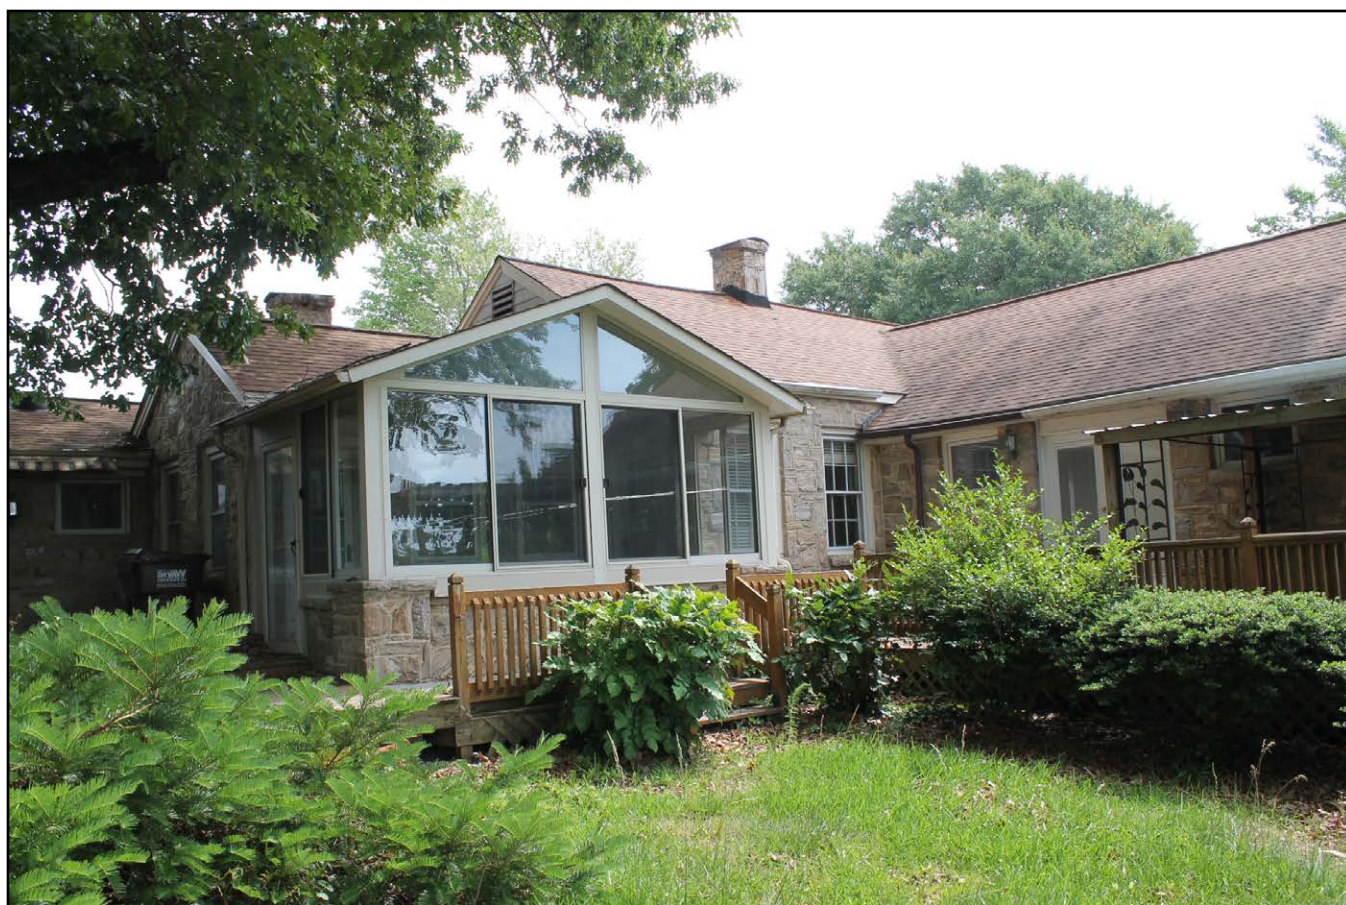
Figure 4.14: Joseph Collier house, view of original side porch with later glass enclosure, facing northeast.

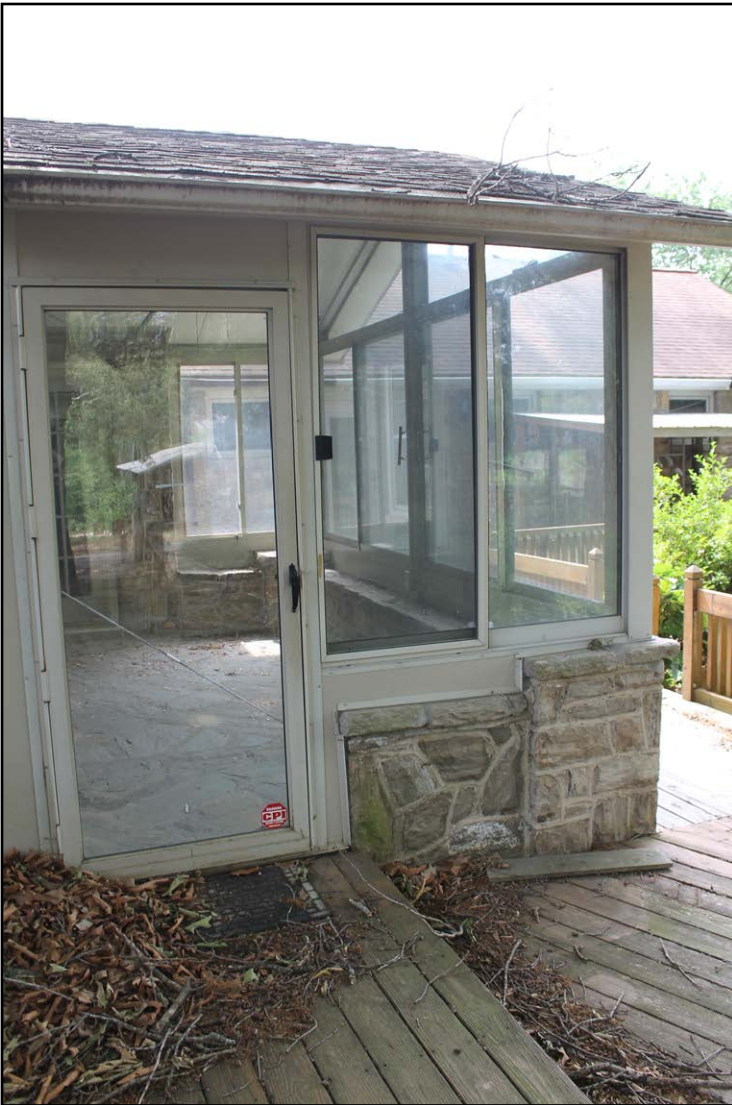
Figure 4.15: Joseph Collier house, view of original side porch piers, facing east.

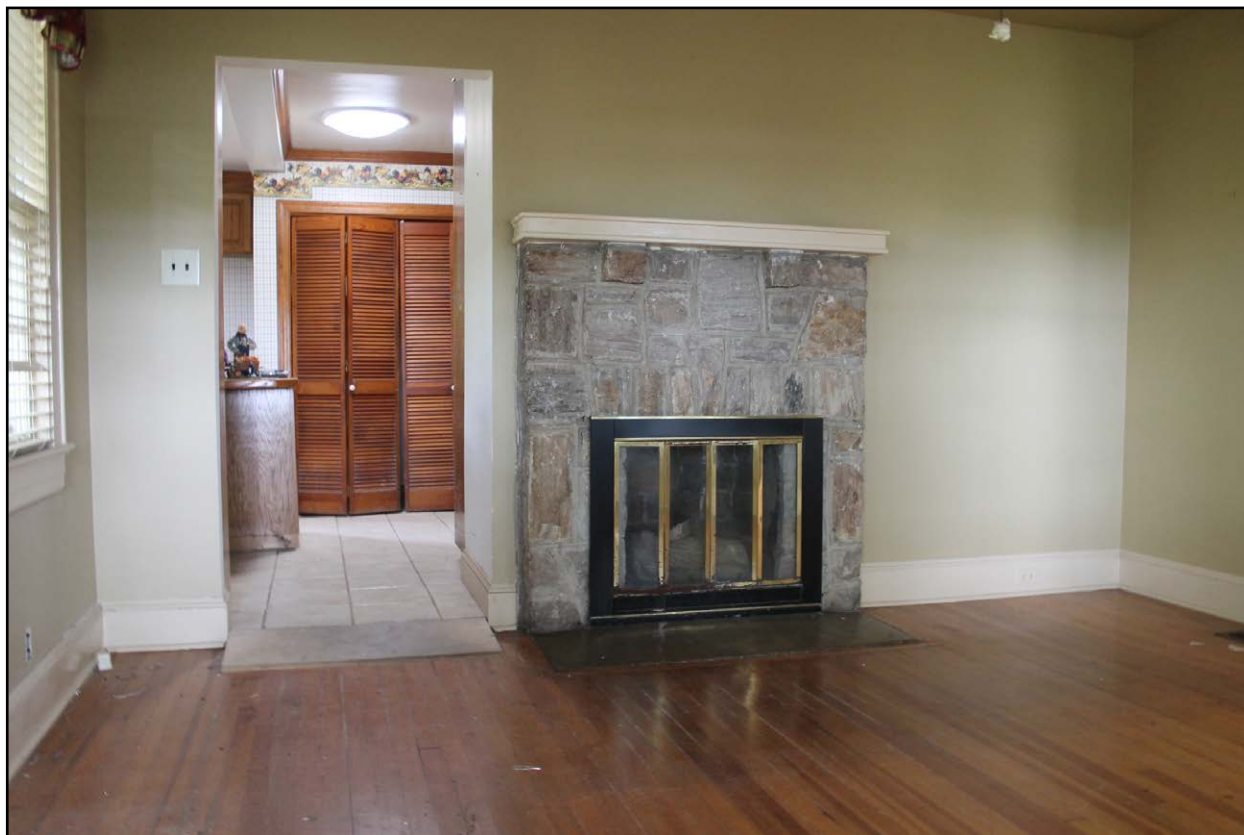
Figure 4.17: Joseph Collier house, view through broken window into rear of original house, facing north.

The interior of the house was not accessible but looking through windows it appears that the circa-1935 core of the house retains original oak flooring, wide baseboards, and two fireplace surrounds of irregular granite blocks

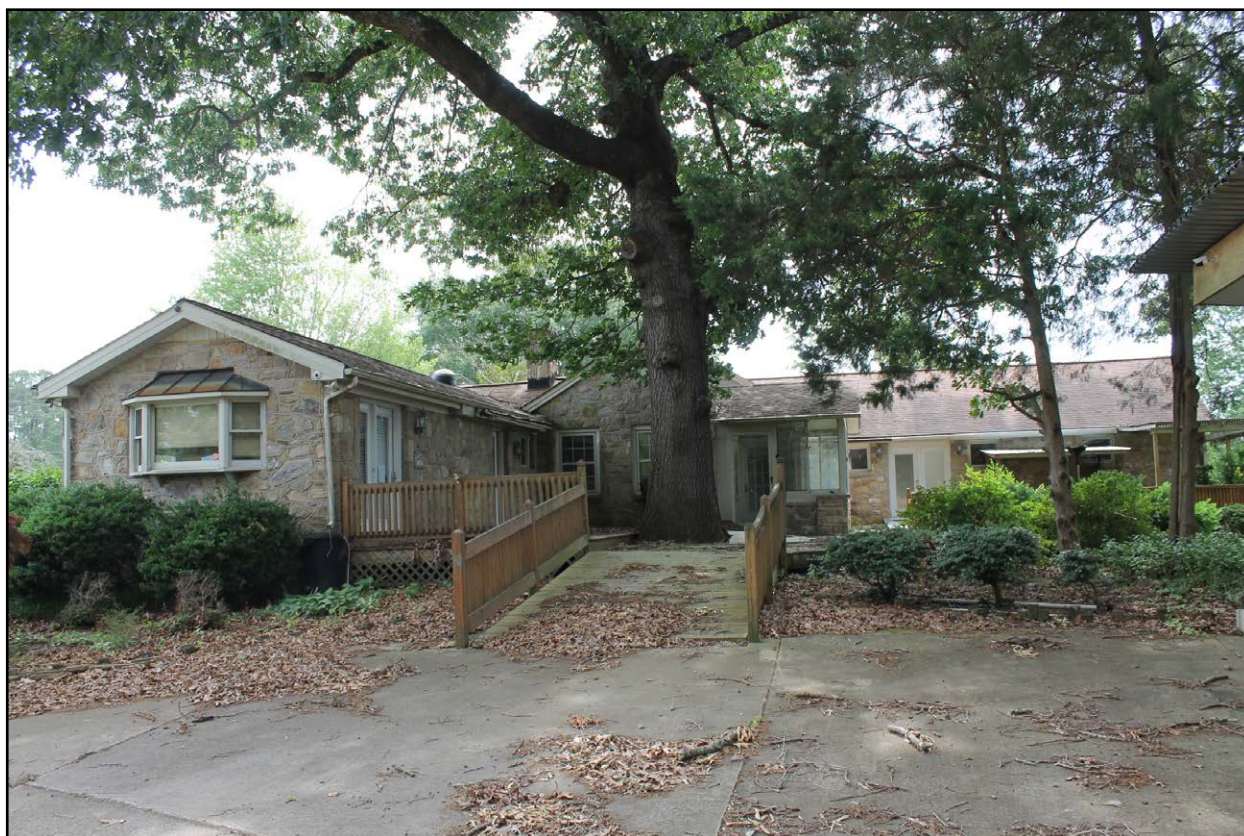
Figure 4.18: Joseph Collier house, view of rear elevation, facing east.

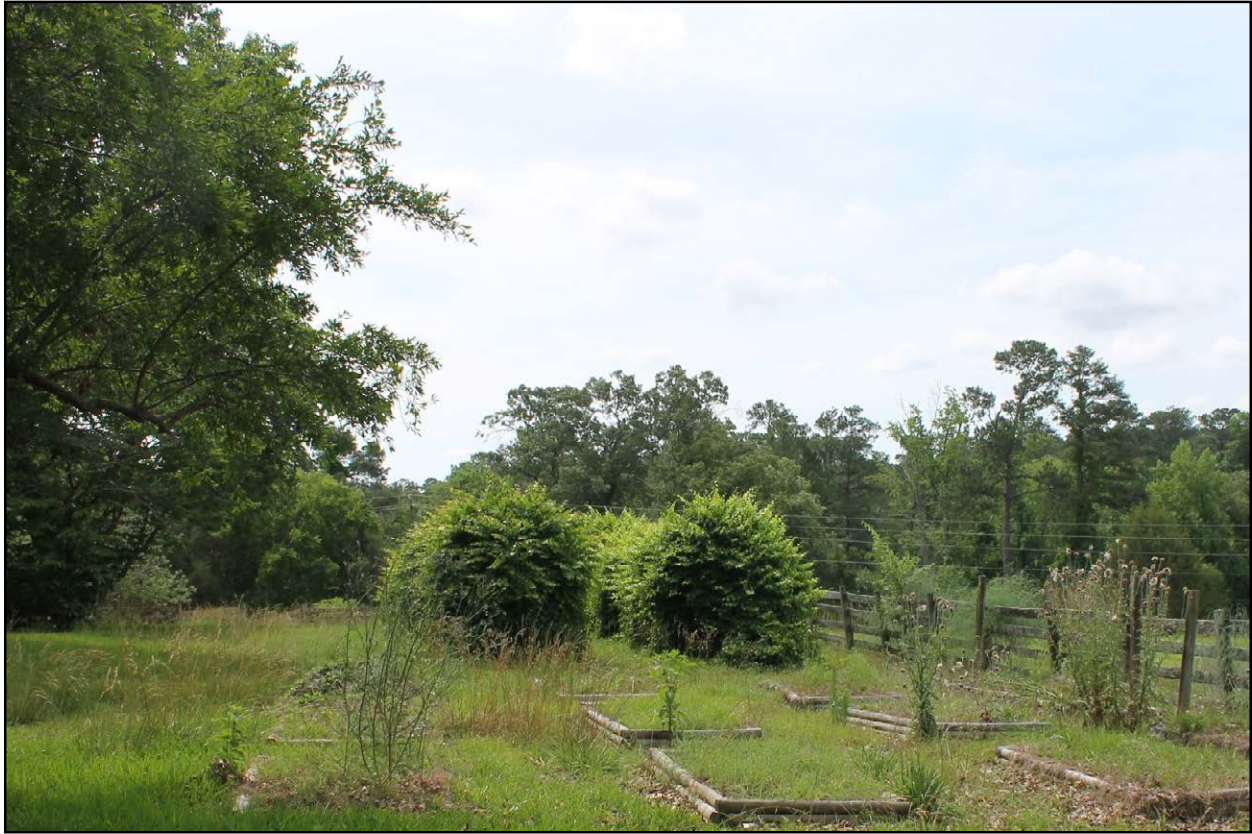
South of the house, at the edge of the fenced yard, is a double grape arbor supported by wood posts.

Figure 4.19: Grape Arbor, view facing east.

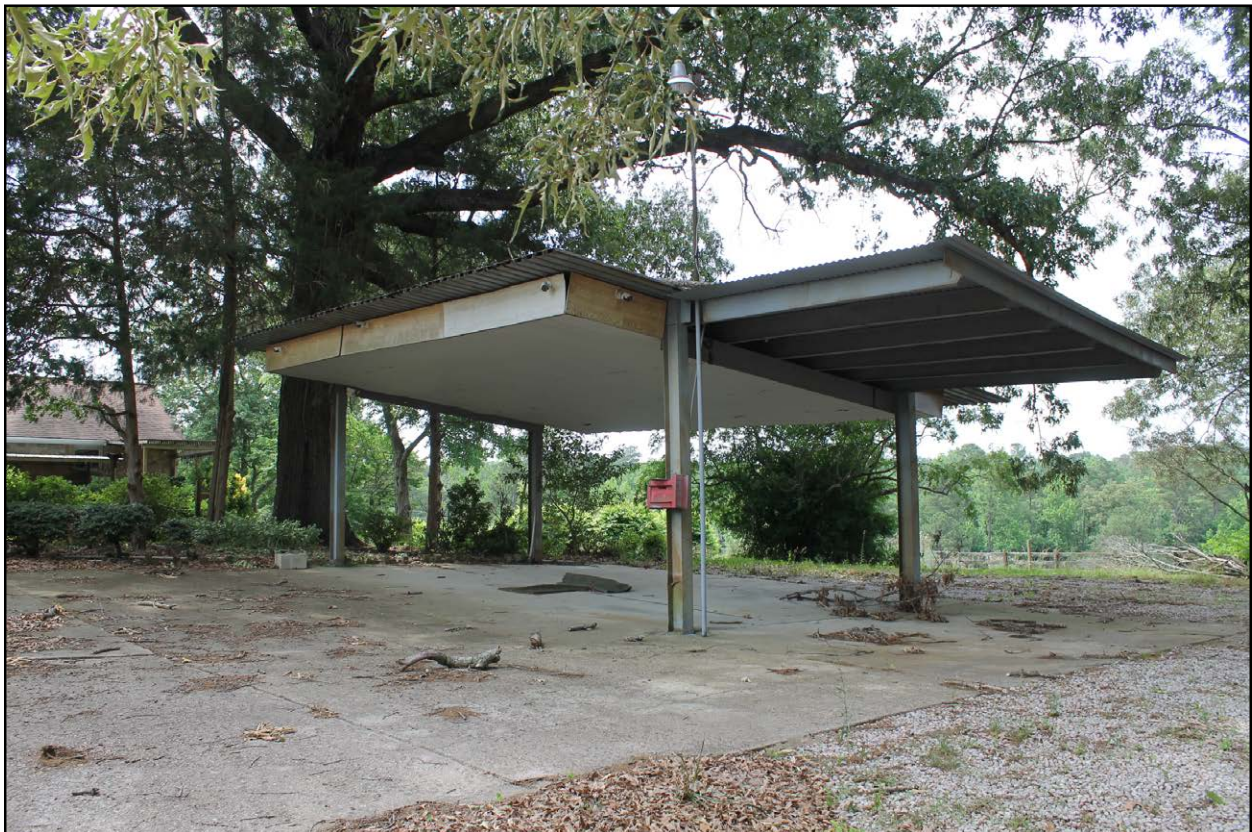
A large, flat-roofed, free-standing carport supported by steel beams is located behind the house to the west.

Figure 4.20: Carport, view facing southeast.
