Re: Construct Old Milburnie Road residential subdivision, 1521 Old Milburnie Road, Raleigh, Wake County, ER 22-1032

# HISTORIC STRUCTURES SURVEY REPORT

**JOSEPH COLLIER FARM (WA1679)**  
Raleigh, Wake County, North Carolina

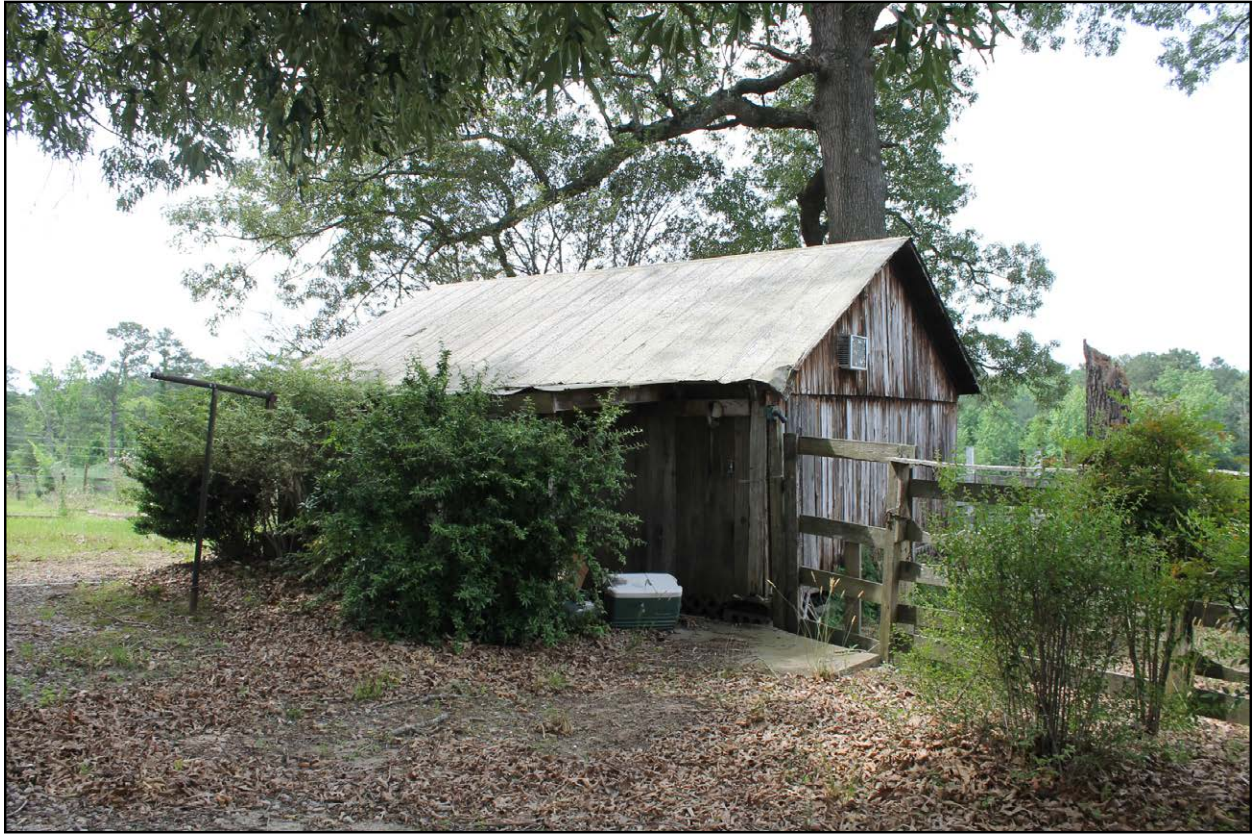
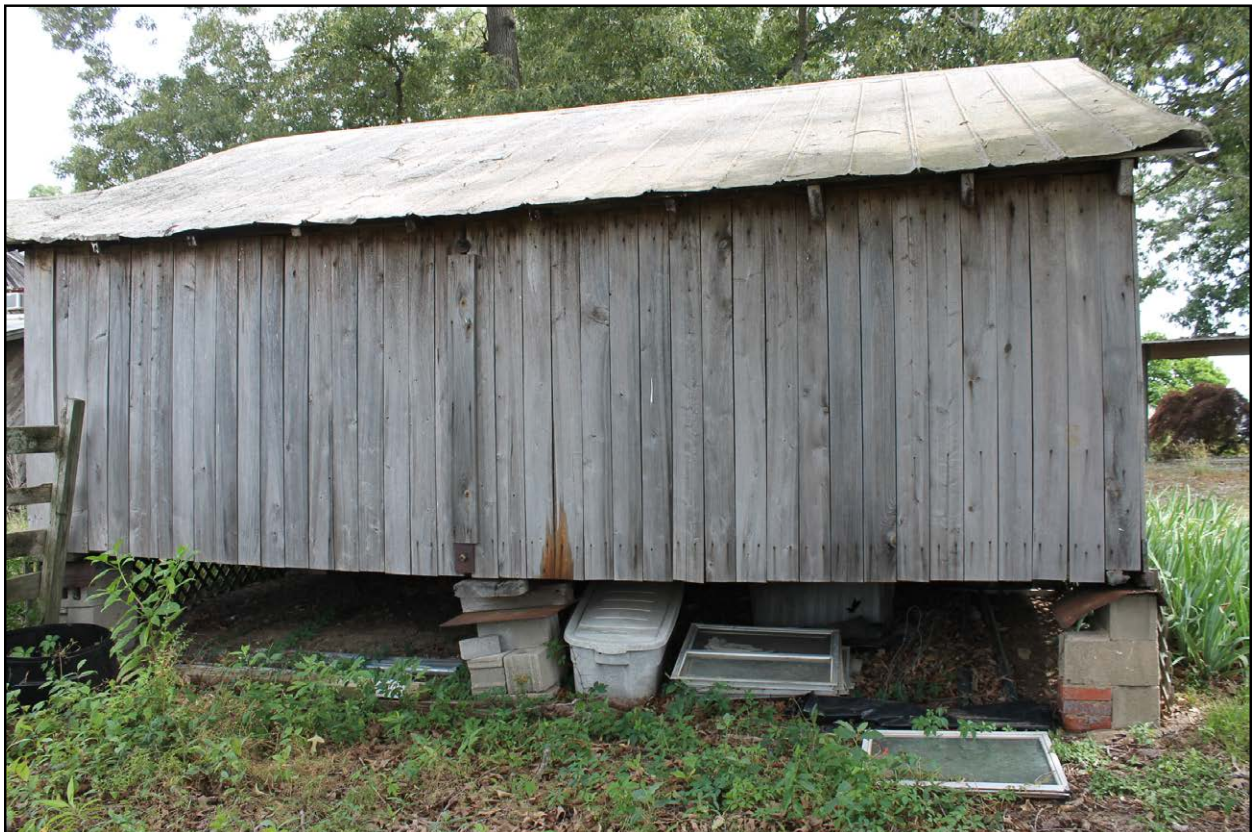
This gabled frame building was moved at an unknown date to its present location along the fence southwest of the house. It has vertical wood sheathing and rests on concrete block piers. It has a metal roof and exposed rafter tails on its north and south side elevations. There is a shed-roofed porch and batten pedestrian entry on the north elevation. It is currently used for storage, but its original use and location are unknown.

Figure 4.21: Storage building, view of north side elevation, facing southeast.

Figure 4.22: Storage building, view of south side elevation, facing north.

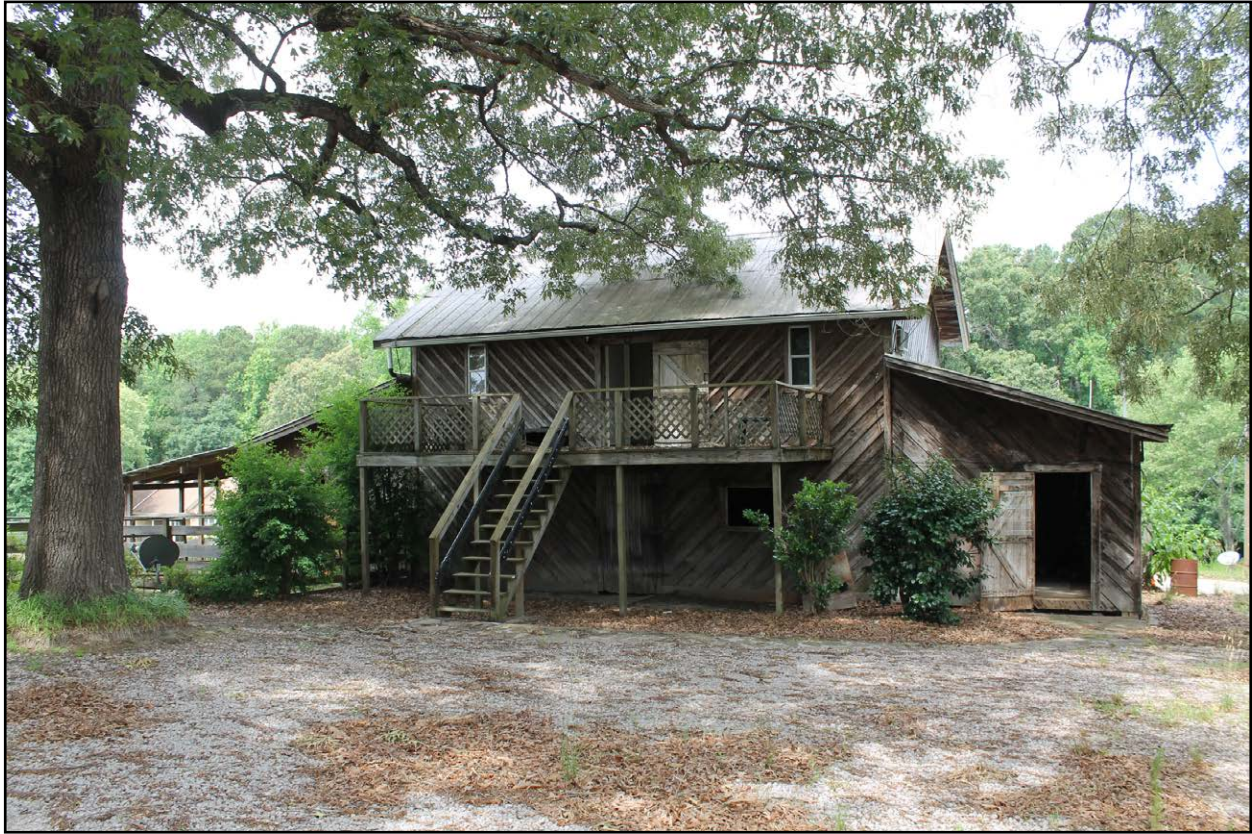
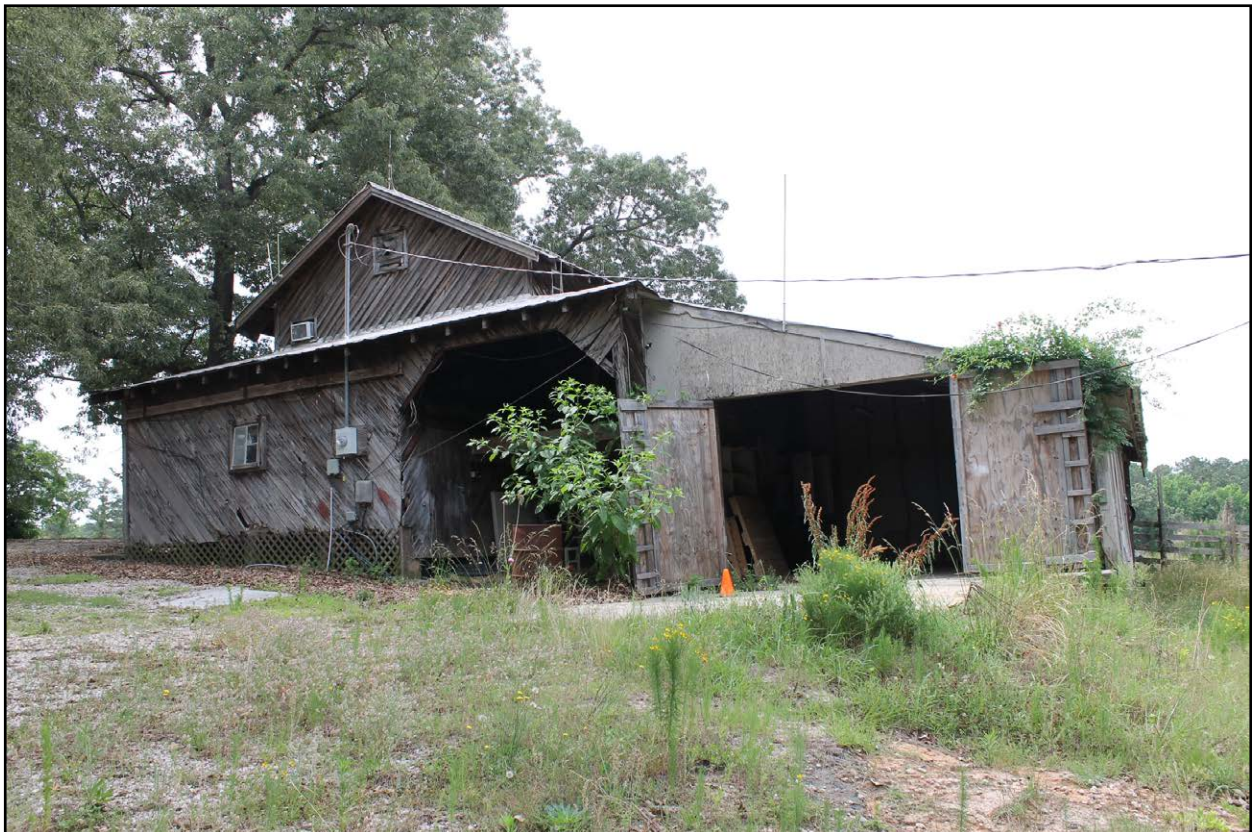
This barn with multiple side and rear sheds was converted to a dwelling at an unknown date in the twentieth century. The barn is clad with diagonal wood boards and has a metal roof and exposed rafter tails. There is a central, two-story, side-gabled section. A set of wood stairs and a second story deck attached to the east side elevation provide access to the interior. Window and door openings are not original and reflect its current domestic use. There are one-story enclosed sheds on each side (north and south) elevation. There is an open bay on the rear of the north side shed, plus an attached, partially enclosed, shed-roofed section on the rear of the building. The rear sheds appear to have retained some agricultural function.

Figure 4.23: Barn converted to dwelling, view of east elevation, facing west.

Figure 4.24: Barn converted to dwelling, view of north side elevation, facing southeast.

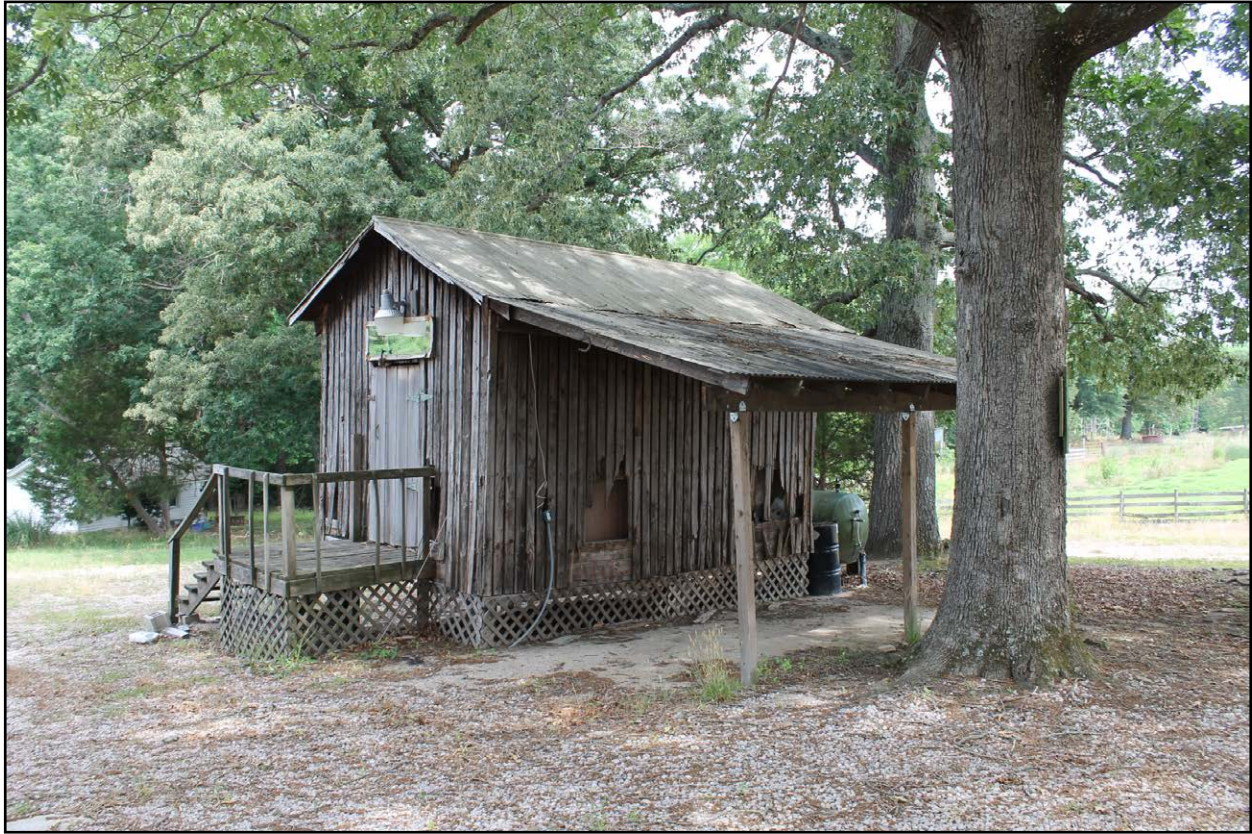
This small, frame building originally served as a corn crib but was converted to a chicken house at an unknown date. It has a gabled roofline, vertical wood sheathing, a metal roof, and a wood pier foundation. A batten door on the south elevation is accessed by a set of wood steps. There is an open shed on the east side elevation.

Figure 4.25: Corn crib converted to chicken house, view facing northwest.

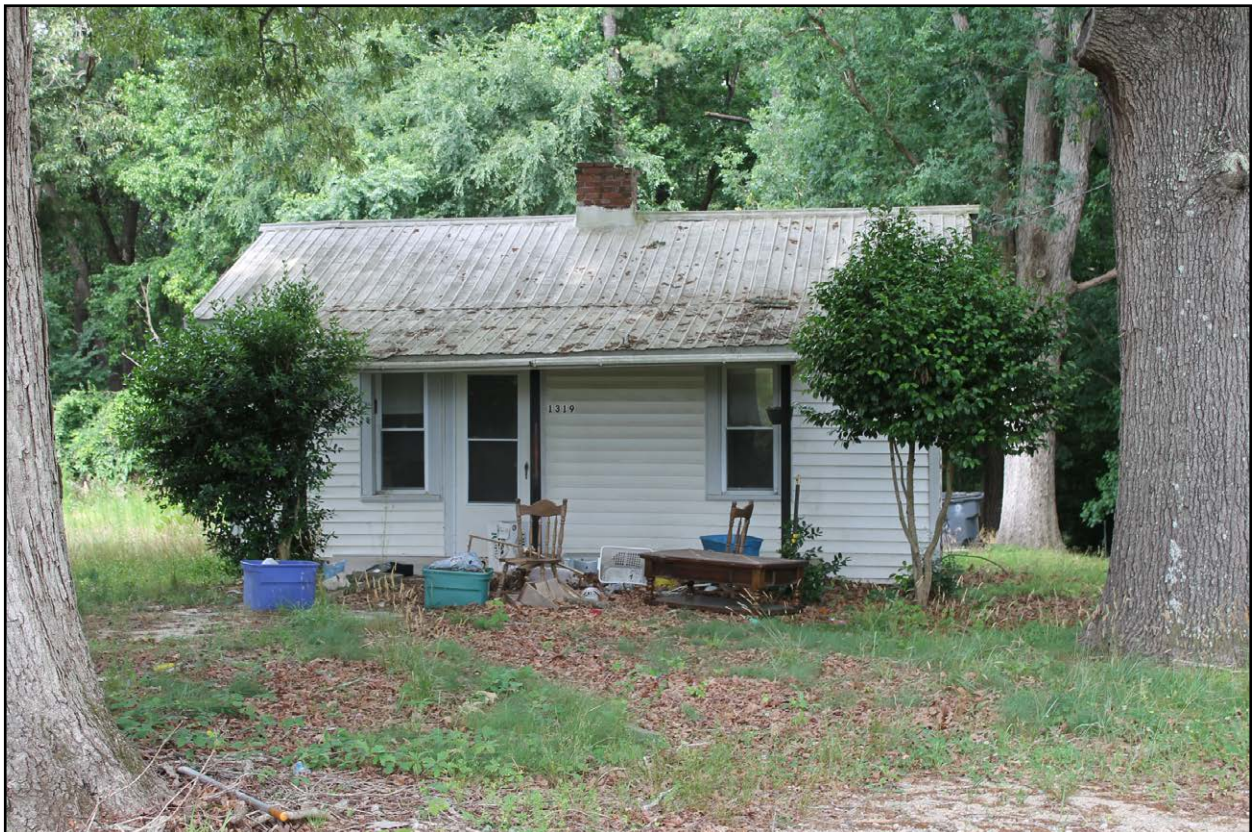
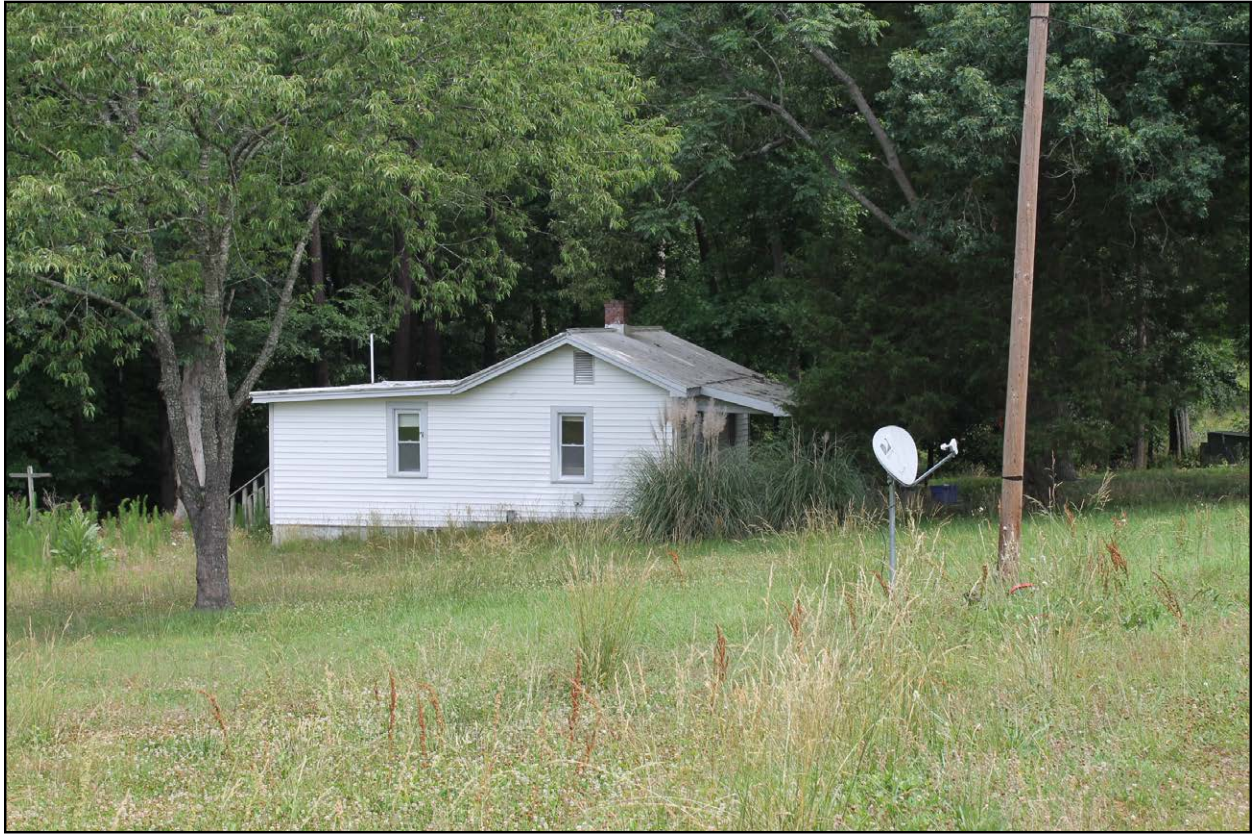
This tenant house is located against the tree line west of the main house. It is a one-story, side-gabled dwelling with a full-width rear shed. The house has a stone foundation, is clad with vinyl siding, and has a metal roof with a single interior brick chimney. The three-bay façade, which faces east, is sheltered by a shed-roofed porch on slender posts. It has an off-center entry and two replacement vinyl, one-over-one, double-hung windows.

Figure 4.26: Tenant House #1, view of façade (east elevation), facing west.

Figure 4.27: Tenant House #1, view of south side elevation, facing north.

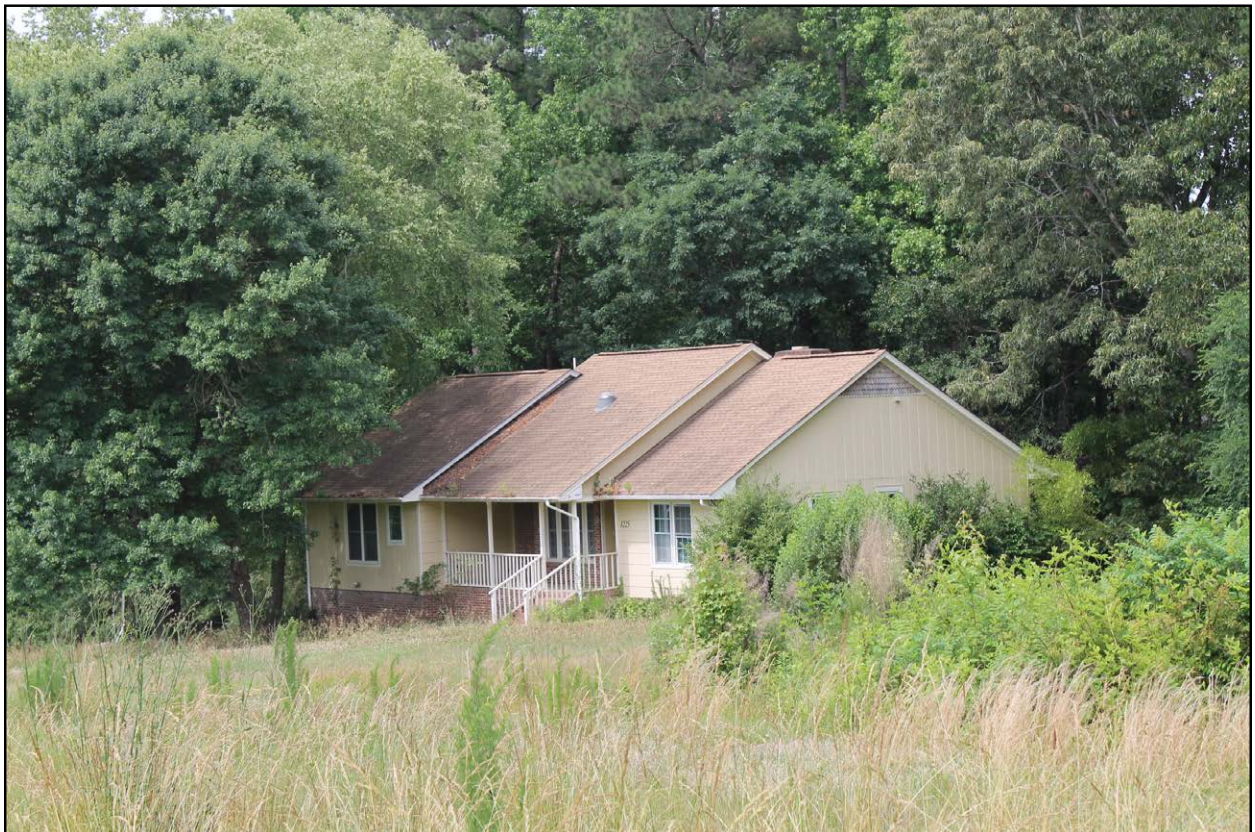
The one-story, side-gabled house with telescoping side wings is clad with a combination of composite wood siding and brick veneer. It is located at the edge of the pasture south of the Joseph Collier house. It sits on a parcel which was subdivided from the larger farm in 1991.

Figure 4.28: 1992 house, view facing southwest.

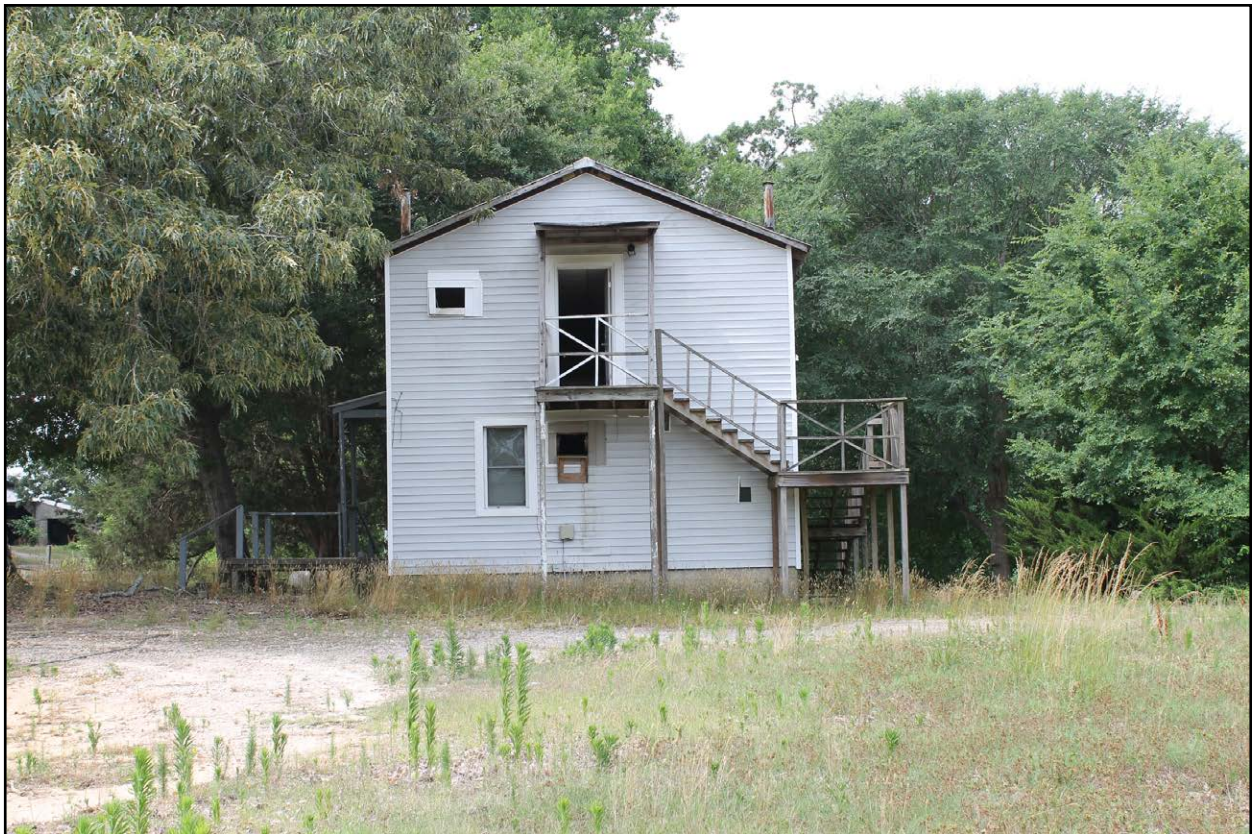
This former tobacco barn was converted into a dwelling at an unknown date prior to 1990. It is clad with vinyl siding and sits on a concrete block foundation. The non-historic window and door openings, porches, and an exterior stair reflect its domestic use.

Figure 4.29: Tobacco barn converted to dwelling, view of north side elevation, facing south.

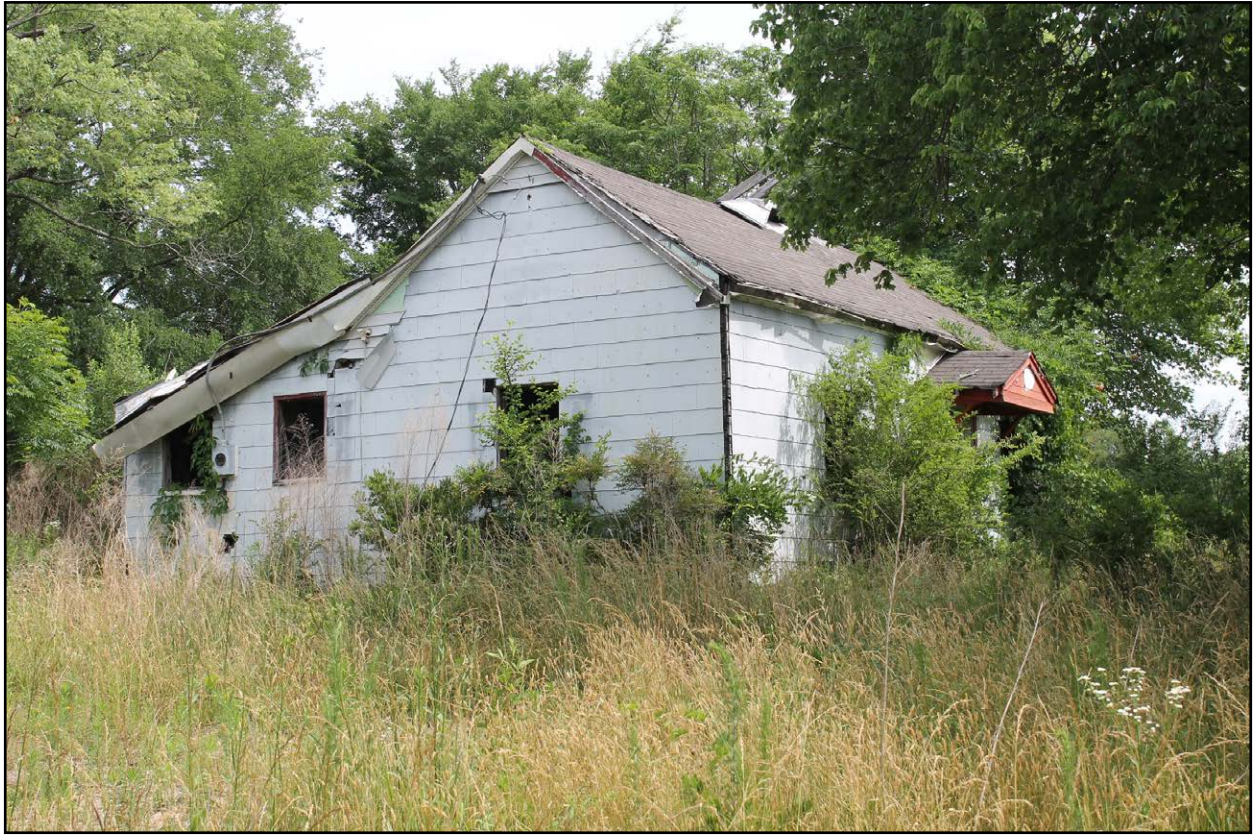
This ruinous tenant house is located in the center of the fields towards the northern end of the parcel. It is a side-gabled dwelling with a rear ell. It is clad with wavy-edge asbestos siding and has a small gabled hood with brackets over its front entry. The window sash and doors have been removed from the house and the rear ell is collapsing.

Figure 4.30: Tenant House #2, view facing northwest.

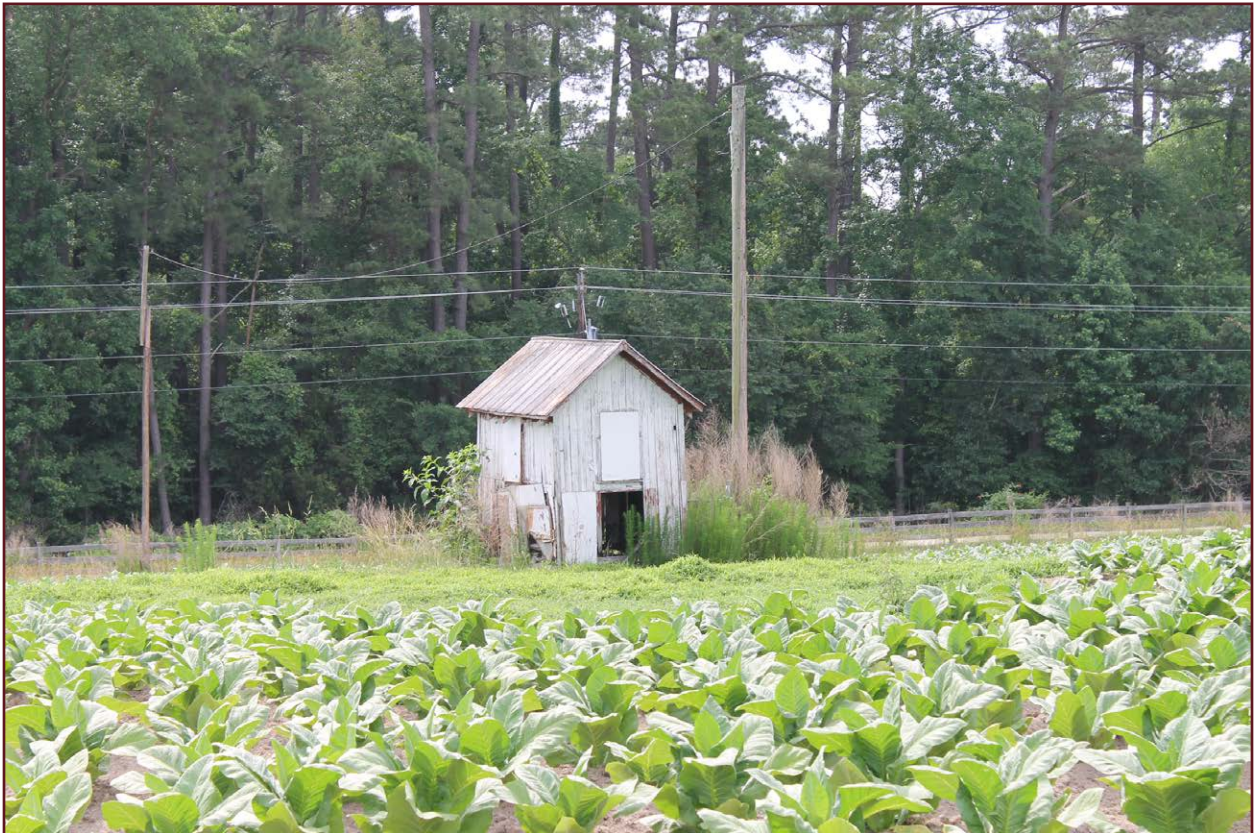
This small outbuilding sits in the center of the tobacco field. The front-gable building has vertical wood siding and a metal roof with exposed rafter ends. Rectangular openings centered on the gable end access the first level and loft level above. Its original use is unknown.

Figure 4.31: Outbuilding, view facing east.

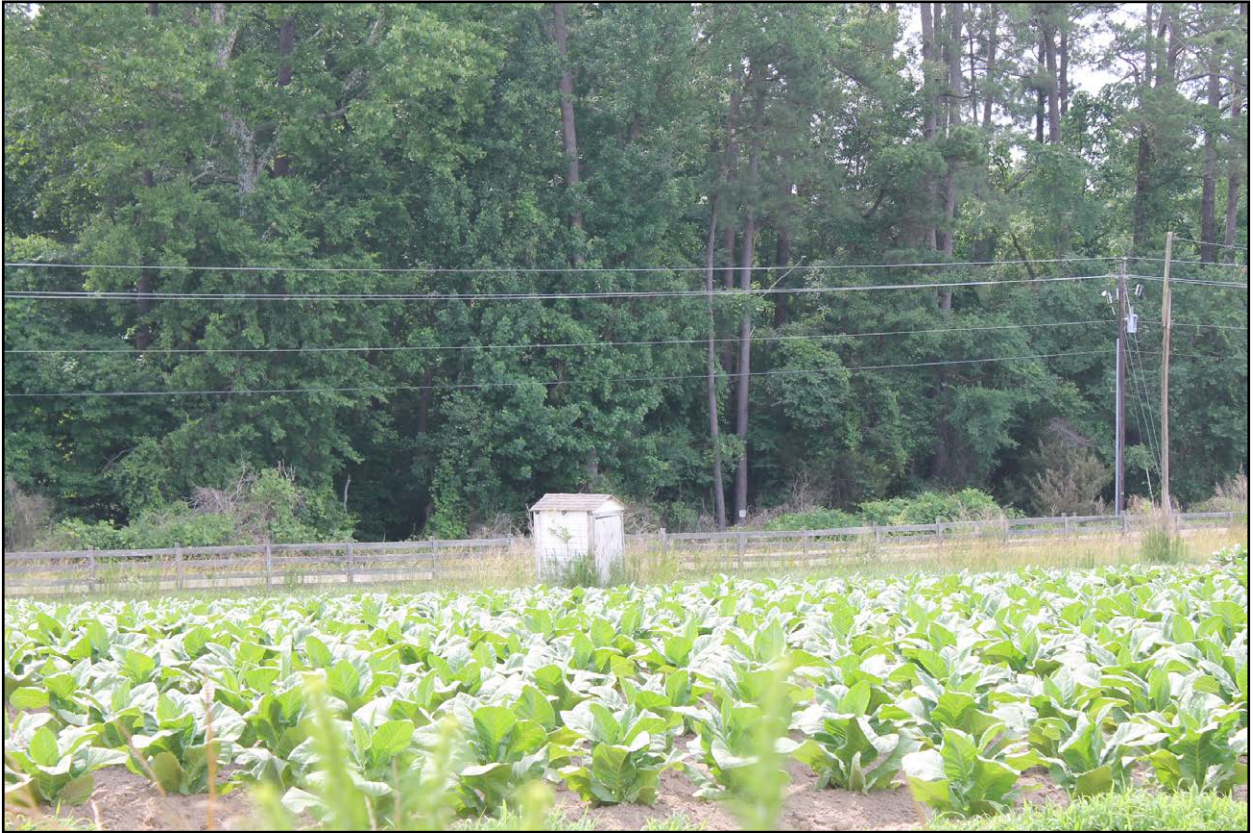
This small, shallow-gabled pumphouse is located at the edge of the tobacco field. It has horizontal wood siding, an asphalt shingle roof, and a single plywood door on its gable end.

Figure 4.32: Pump House, view facing east.

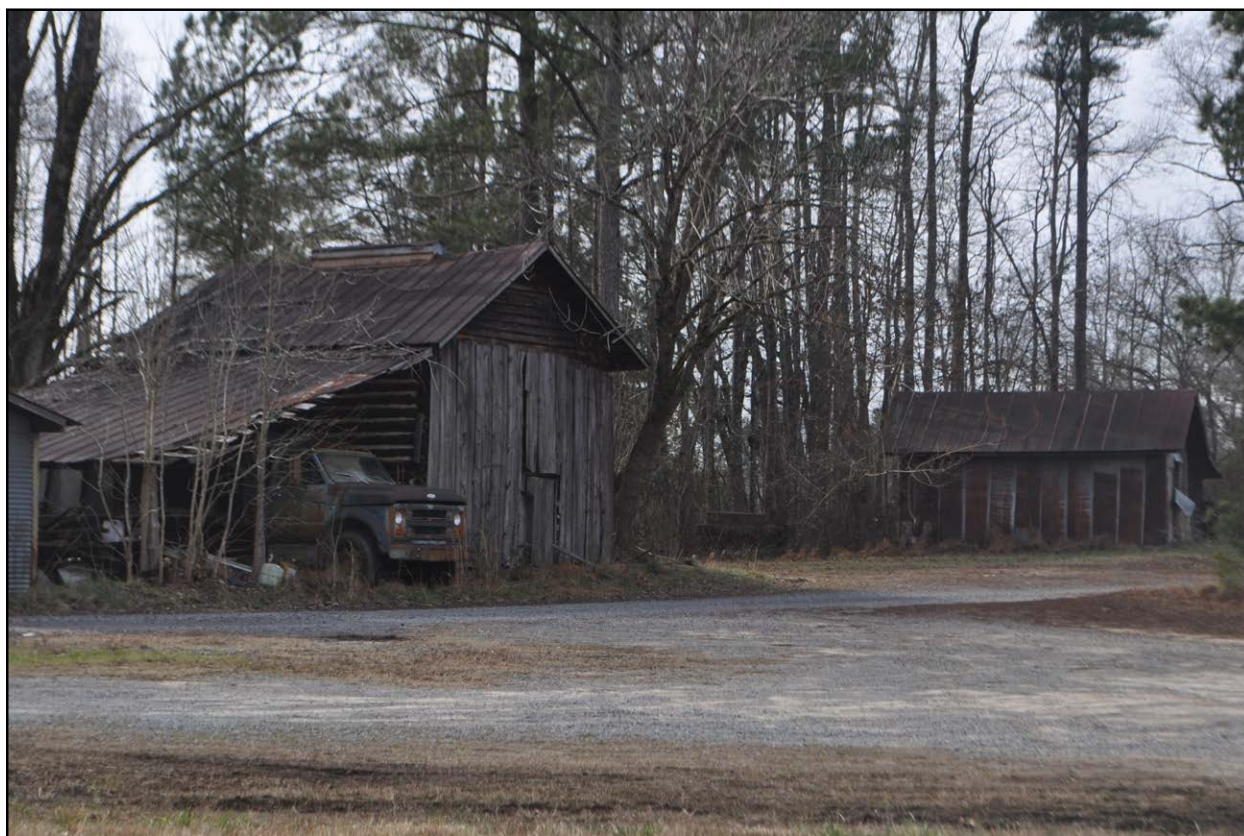
Figure 4.37: James Ragan Farm (WA1071), view of log, frame, and bulk tobacco barns.

Despite intense development throughout the county, there are surviving farm complexes dating to the 1920s and 1930s which retain both relatively intact main dwellings and a complement of domestic and agricultural outbuildings, along with components of the farmed landscape. The 1938 James Ragan Farm (WA1071) has a large, brick-veneered Craftsman bungalow as well as log, frame, and bulk tobacco barns depicting changing agricultural practices throughout the first half of the twentieth century (Figure 4.36-4.37). The house at the center of the Montezuma Pearce Farm (WA1799) in northeastern Wake County reflects a circa 1925 remodeling of an earlier house. Surrounding the house are a woodshed, smokehouse, potato house and garage, while three tobacco barns and a strip room are located along the tree line adjacent to cultivated tobacco fields (Figure 4.38). Similarly, the Snipes Farm (WA4785) house was remodeled in the 1930s and anchors an impressive complex of agricultural outbuildings related to tobacco production (Figure 4.39)
