**SUBJECT:** Historic Structures Survey Report for BP3-R008, replacement of Bridge No. 352 on  
SR 1004 over Outlaws Pond Spillway, Duplin County, ER 22-1532

**HISTORIC STRUCTURES SURVEY REPORT  
REPLACE BRIDGE NO. 352 ON SR 1004 (SUMMERLIN CROSSROAD ROAD) OVER  
OUTLAWS POND SPILLWAY, DUPLIN COUNTY, NORTH CAROLINA**

**TIP PROJECT BP3-R008  
WBS NO. BP3.R008.1.1.1  
PA TRACKING NO. 22-03-0001**

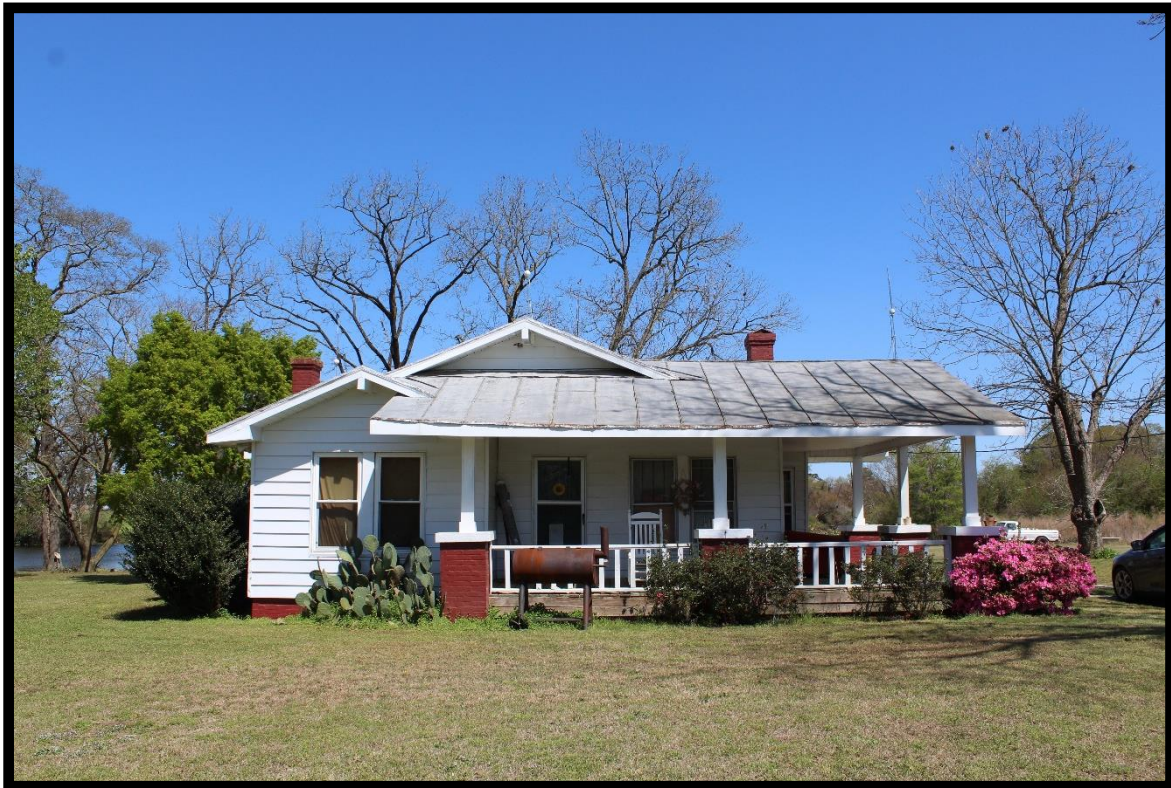
Figure 3: Outlaw House, Looking Northeast.

Resource Name:	Outlaw House and Store
NCDOT Survey Site Number:	001
HPO Survey Site Number:	DP1234
Location:	2452 Summerlin Crossroad Road, Mount Olive, NC 28365
Parcel ID:	340900478869
Dates(s) of Construction:	1926
Recommendation:	Eligible

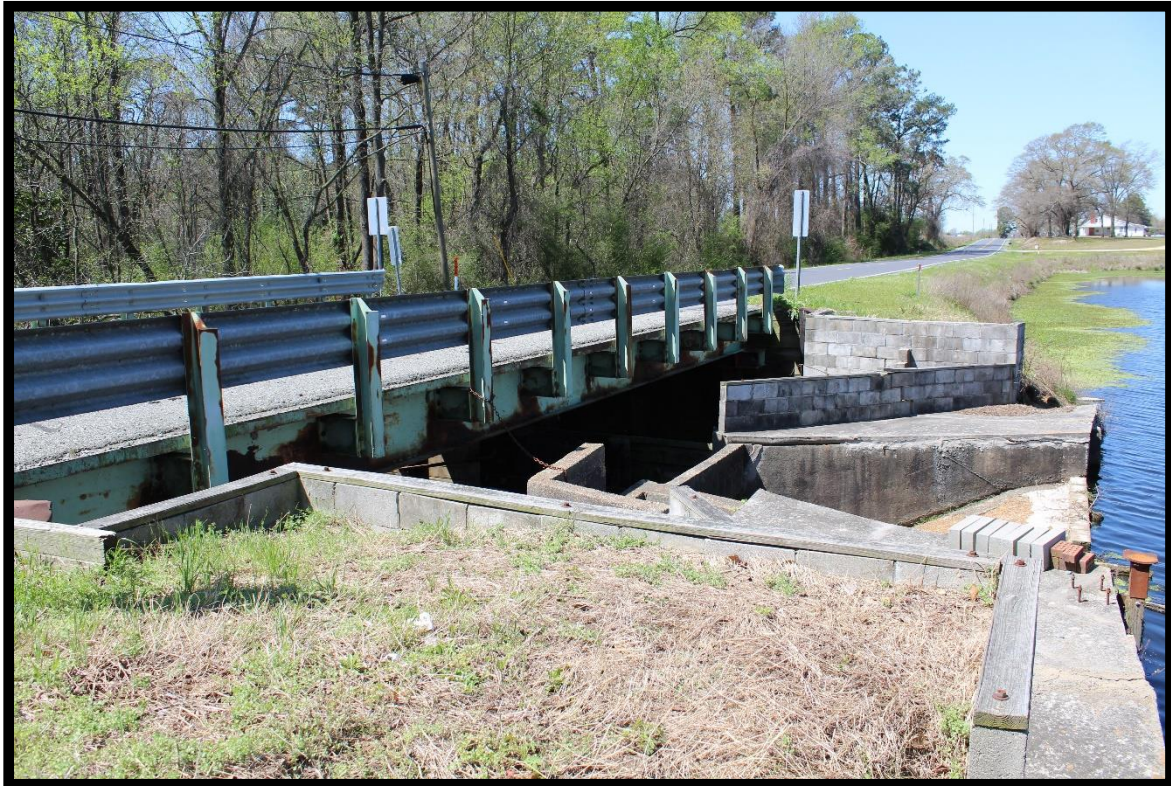
Figure 4: Bridge No. 352, Looking Northwest.

where Hooker's Marsh meets Outlaws Pond (Figure 5). Beneath the bridge, on the side with the pond, is a concrete dam designed to retain water in the pond. The area around the property is predominantly agricultural with plowed fields, pockets of woodlands, agricultural buildings paired with manmade ponds (possibly swine sheds and lagoons), and houses on large parcels.

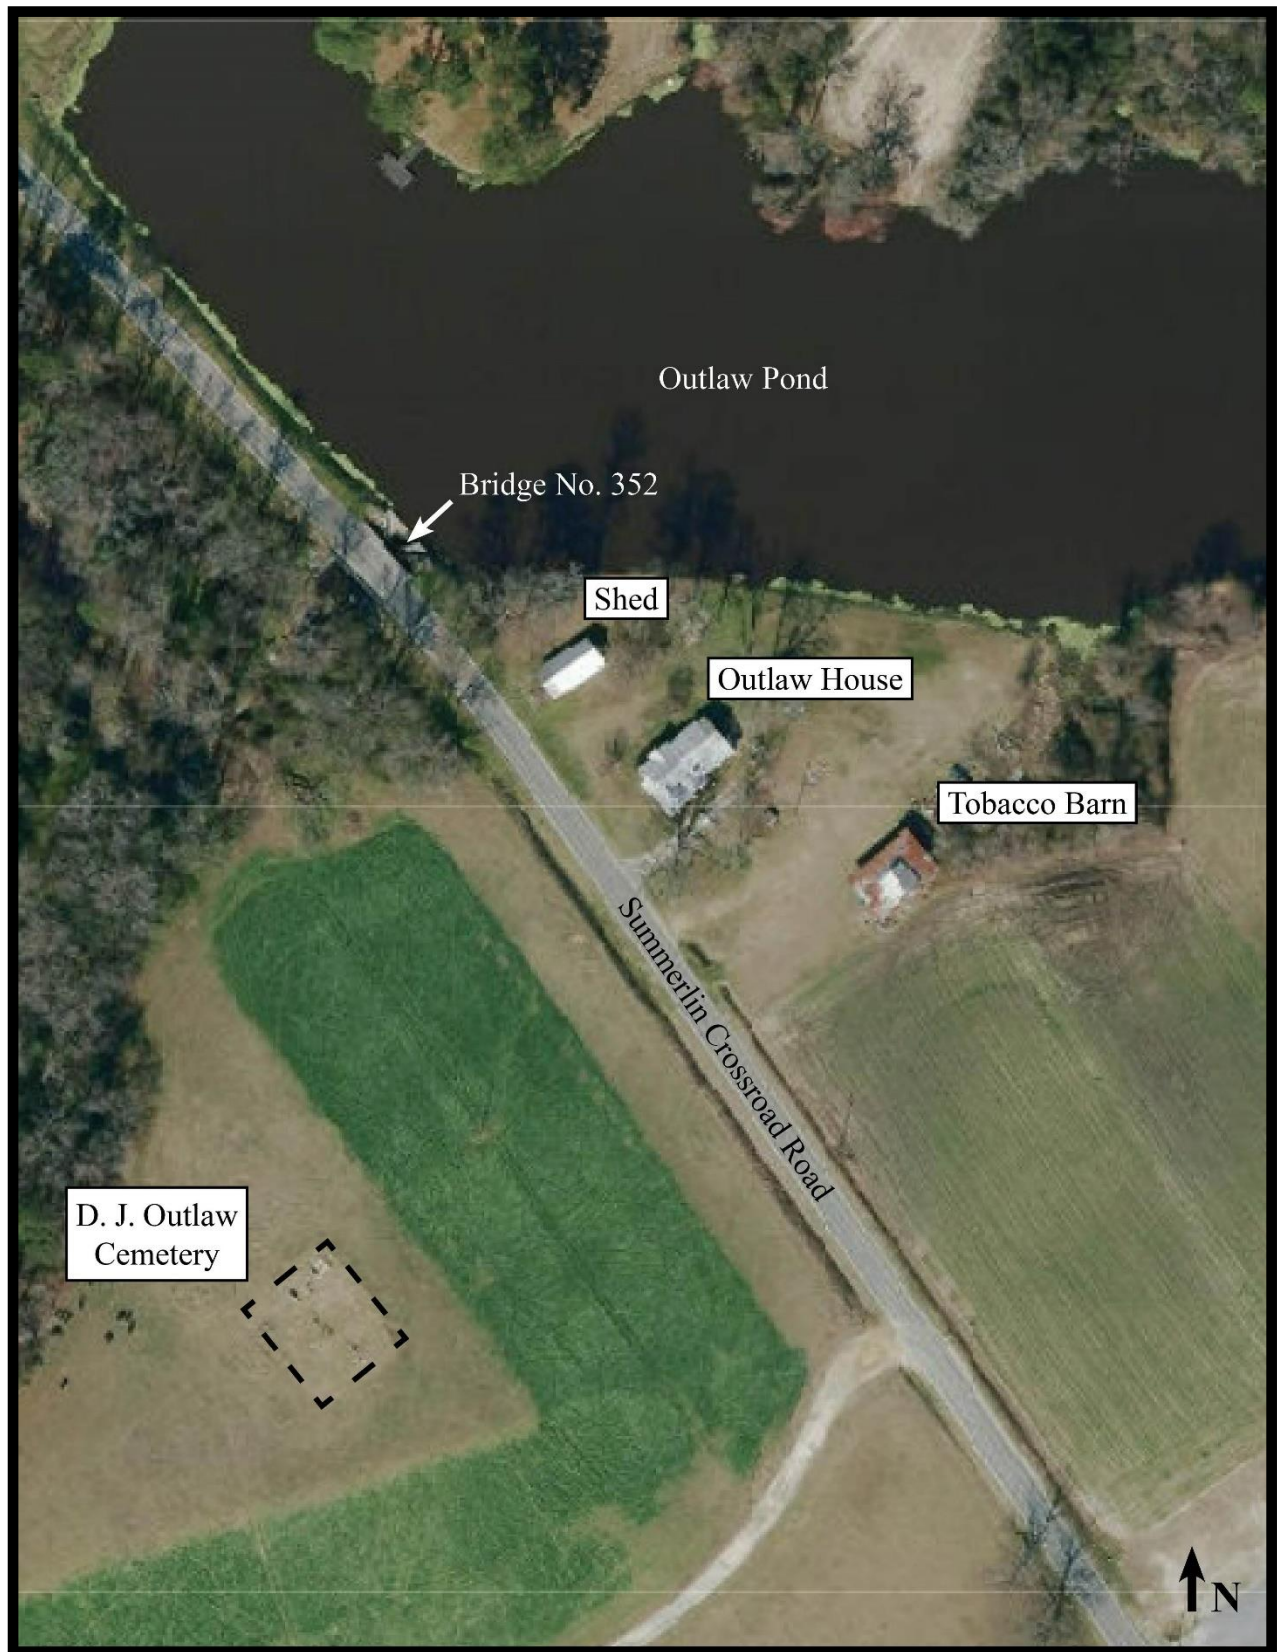
Figure 5: Site Plan of the Outlaw House.

The house and associated structures are located on the east side of Summerlin Crossroad Road (SR 1004) between Outlaws Pond to the north, plowed fields and a newly constructed fire station to the southeast, and additional plowed fields, a wooded area, and a family cemetery on the west side of Summerlin Crossroad Road (Figure 4). The three primary resources are oriented in a line that runs northwest-southeast with the store being the northern resource and closest to the road, the house in the middle, and the tobacco barn on the south edge of the domestic yard and farthest from the road. The store and house face Summerlin Crossroad Road and the barn faces northwest toward the domestic yard. Mature trees shade the yard around the house and store while the area north of the barn is clear and the area southeast of the barn is a plowed field. Bridge No. 352, the replacement of which prompted this study, is located northwest of the store

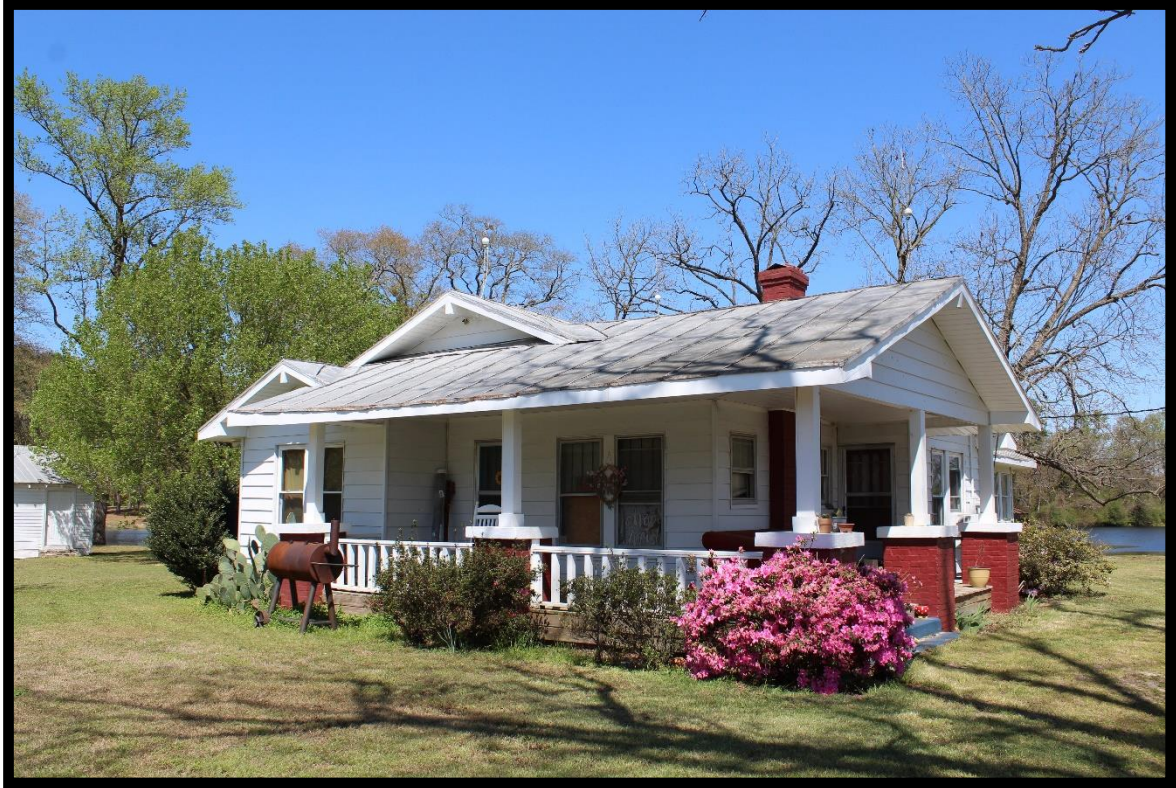
Figure 6: Outlaw House, Looking North.

The 1926 one-story, Craftsman-style dwelling has a front-gabled, standing seam metal roof and a roughly rectangular footprint (Figure 6). It rests on a continuous brick foundation that is painted red, and its exterior elevations are clad with metal siding. Features and materials that characterize each elevation of the dwelling include an extended ridge beam in each gable and closed eaves with flat soffits, both of which are wrapped with aluminum. The gable ends are oddly wrapped suggesting they were originally finished with extended purlins that are now encased in aluminum. All of the brick elements are painted red and each chimney is corbelled at the top. Multiple weathervanes rise from the roof including one above the front gable that has an arrow on one end and a flat plate within a decorative frame on the other end (Figure 7).

The dwelling has a three-bay façade that consists of, from north to south, a gable that projects forward a few feet and contains paired, one-over-one, vinyl sash windows; a screened entry door; and paired wooden sash windows with four vertical panes over single panes and aluminum-framed screens. A side-gabled porch intersects with the small gable and extends south sheltering the second and third bays before wrapping the south corner of the house. The porch is supported by five brick piers with concrete tops and wooden posts. A balustrade spans between the piers on the façade, but the porch is open on the southeast side and has concrete steps in the first bay.

The Craftsman-style house has been altered over the years with metal siding, vinyl wrapped soffits, and some vinyl replacement windows. Despite these changes, it also retains many original elements including its brick foundation, chimney, and piers; some original doors and windows; its standing seam metal roof; and its general form. Similarly, the store retains its wooden German siding, multi-pane front windows, entry door, and exposed rafter tails but has a modern door and vinyl window on its southeast and northeast elevations. Furthermore, it is missing its gas pumps, which aside from the store's general form, serve as a key character-defining element of small rural stores.

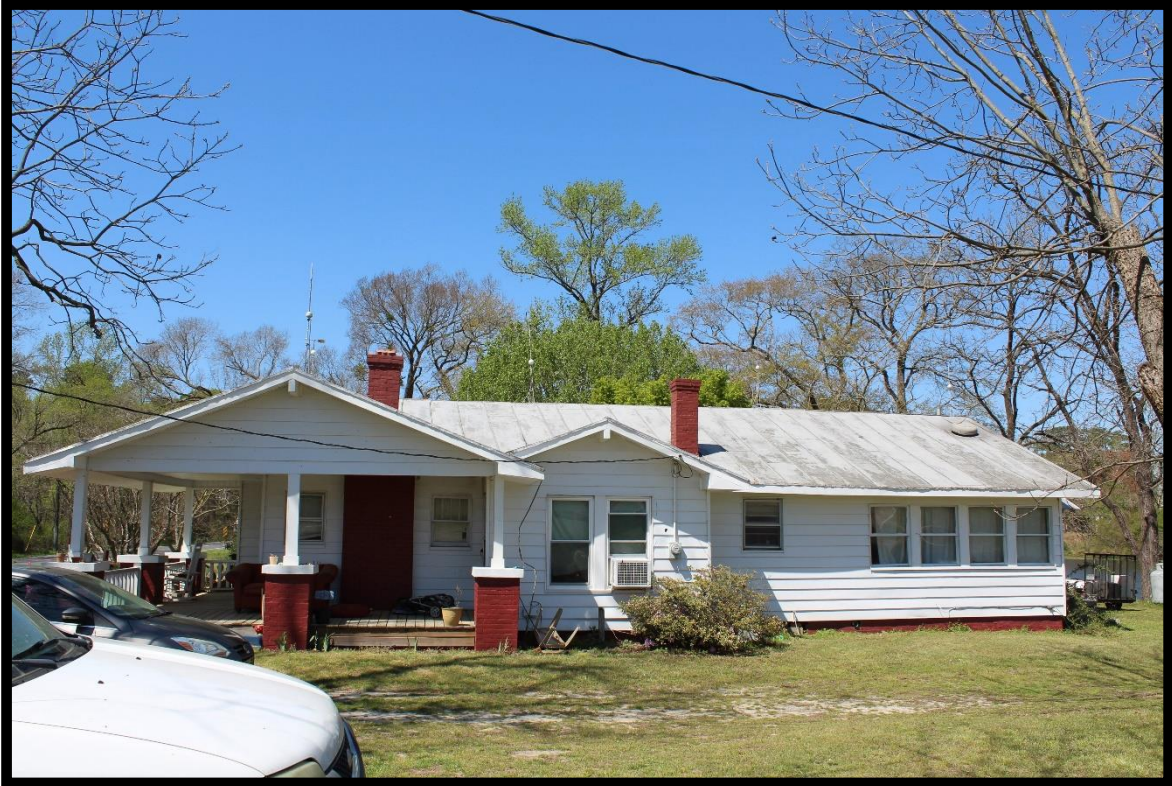
Figure 8: Outlaw House, Looking Northwest.

The southeast elevation of the house has four bays (Figure 8). The first bay is sheltered by the porch and contains two small wooden sash windows that flank an exterior brick chimney with a wide base and a narrow stack that rises through the porch roof. The windows have four vertical panes over single panes. The second bay is gabled and projects forward of the elevation. Due to projecting forward, the bay creates a small southwest elevation that is sheltered by the porch and contains a wooden entry door. The door is lit by four vertical panes and shielded by a screen door. The gabled bay contains paired one-over-one vinyl sash windows, one of which holds an air conditioner. An interior brick chimney, also painted red, rises from the main roof just beyond the gabled bay. The third bay contains a small wooden sash window with two horizontal panes in each sash, and the fourth bay contains a ribbon of four one-over-one, vinyl sash windows that extend to the east corner of the house. The fourth bay may represent an enclosed porch.

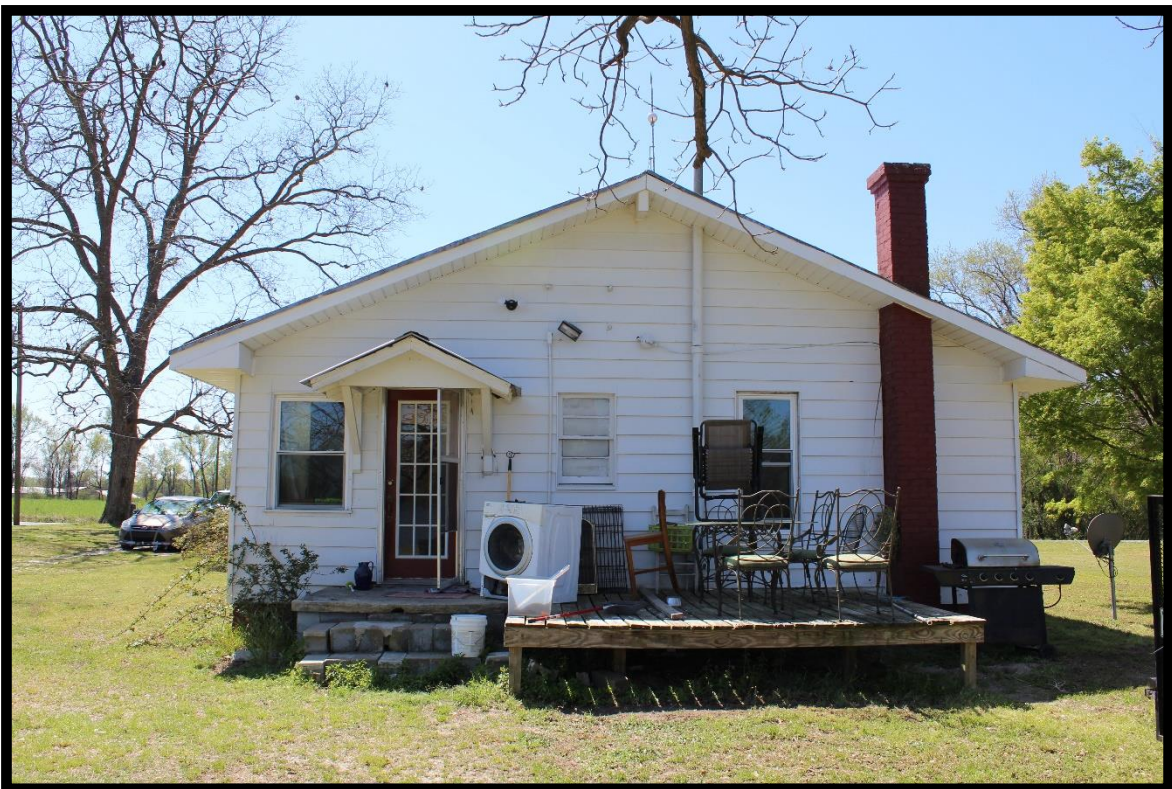
Figure 9: Outlaw House, Looking Southwest.

The south half of the northeast elevation contains a modern, multi-pane entry door sheltered by a small gabled roof with exposed rafter tails and large gables brackets (Figure 9). The door is accessed by a concrete block stoop topped with a slab of rusticated concrete and flanked by a one-over-one vinyl sash window and a smaller wooden sash window with two horizontal panes in each sash. The north half of the elevation contains a one-over-one, wooden sash window and a narrow exterior brick chimney that rises through the eave. A wooden deck spans between the stoop and the chimney.

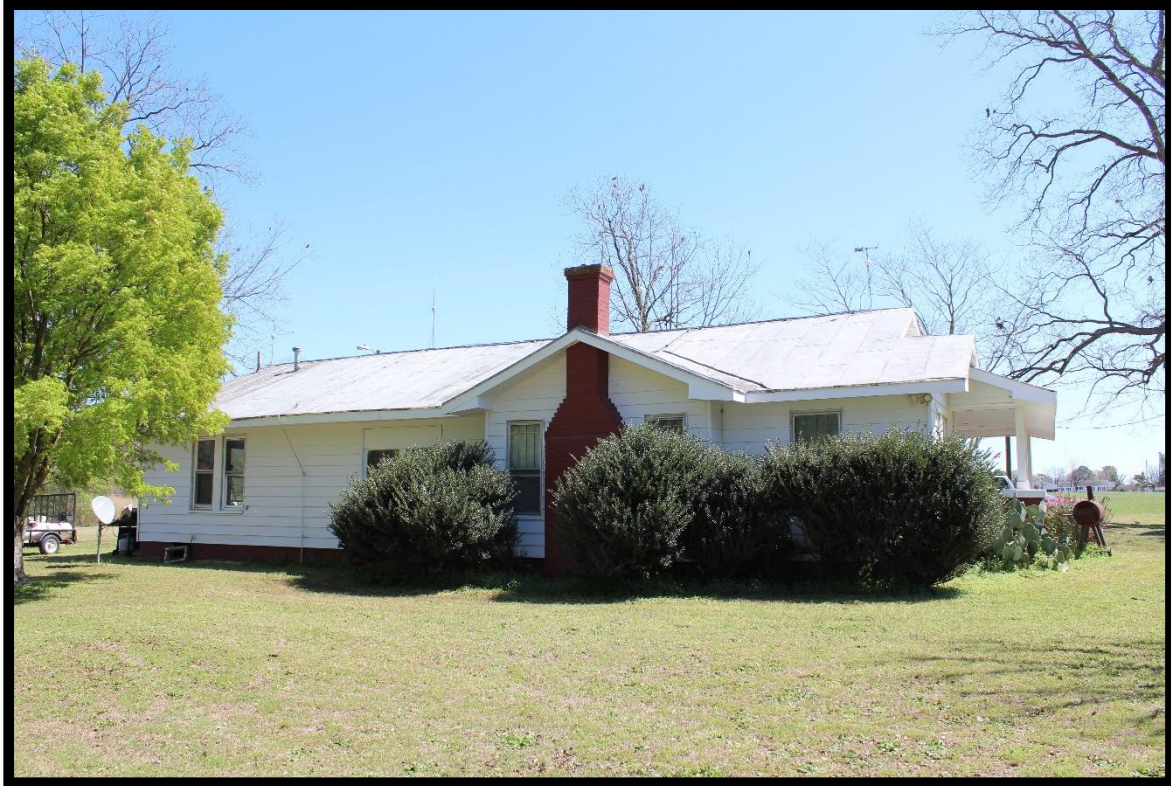
Figure 10: Outlaw House, Looking East-Southeast.

The northwest elevation has four bays (Figure 10). The first and second, east to west, contain paired, one-over-one wooden sash windows. Those in the second bay have been shortened and a panel fills the space above the windows. They also appear to have fixed sashes. The third bay is gabled and projects forward. It contains an exterior brick chimney with a large base and a narrow stack that rises through the peak of the gable. The chimney is flanked by two wooden sash windows with four vertical panes over single panes. The fourth bay contains an additional wooden sash window with four vertical panes over a single pane.

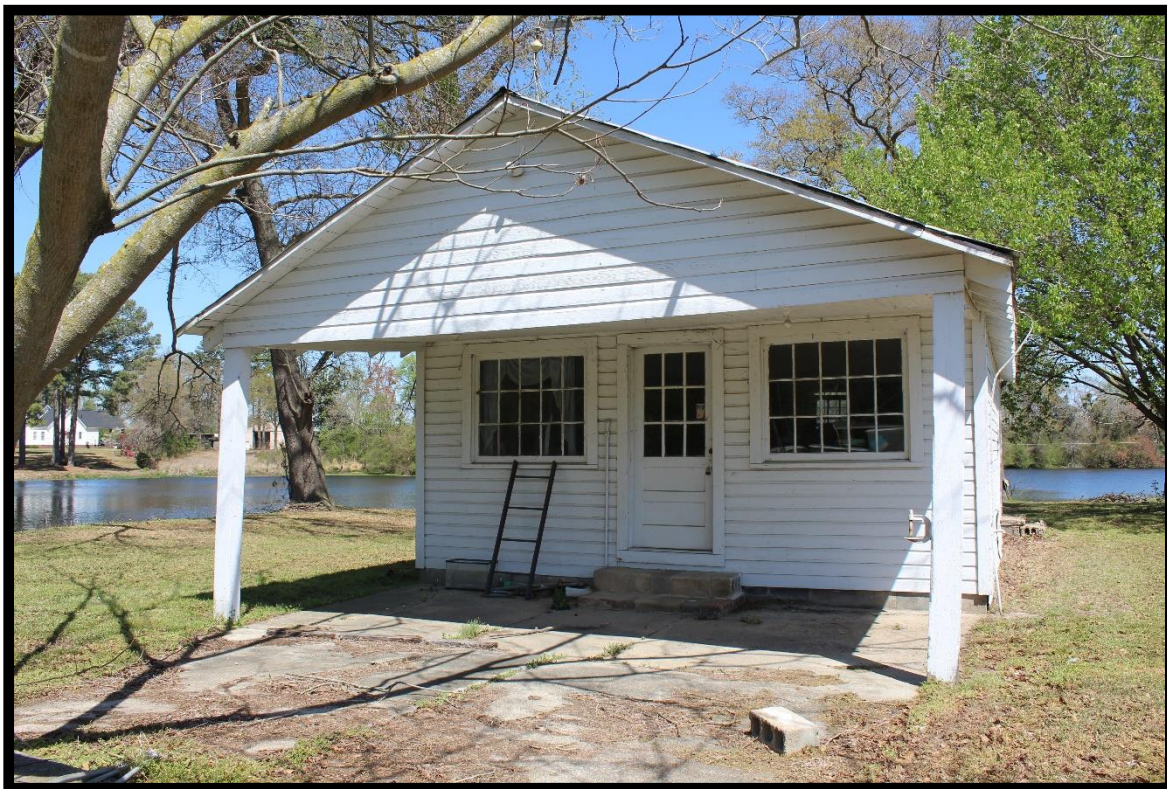
Figure 11: Outlaw Store, Looking Northeast.

The ca. 1926 one-story, Craftsman-style store has a rectangular footprint and a front-gabled, standing seam metal roof with exposed rafter tails (Figure 11). It rests on a continuous concrete block foundation and is clad with German siding. The symmetrical façade is deeply recessed below the store's front gable, which is supported by two wooden posts, and a concrete area spans the space below the gable. The wooden entry door has nine lights over two horizontal panels and is accessed by concrete block steps. It is flanked by 15-light wooden sash windows. Like the house, the store has multiple weathervanes placed along the peak of its roof. The weathervane above the front gable has an arrow on one end and an automobile on the other end, an ode to its use as a gas station (Figure 12). A concrete area that was likely poured at a different time than the concrete below the gable spans from the front edge of the sheltered concrete area to a small, slightly raised concrete base that once held gas pumps. A mature tree has grown from the center of the base.

Regarding the studied store, though its integrity has been lessened by the loss of its gas pumps, a key element in defining and recognizing rural stores, it also stands as one of the best-preserved examples of a typical, rural, frame store in the county due to its unaltered form and the number of stores already lost or slowly falling into disrepair. The nearby Summerlin Crossroads General Store stands in stark contrast to the smaller store with its larger form and brick construction. Study-Listed nearly 30 years ago, the building appears to have lost some material integrity but remains in good shape and is easily recognizable as a place of commerce. The general store has the added significance of being the reason Summerlin Crossroads became a named place.

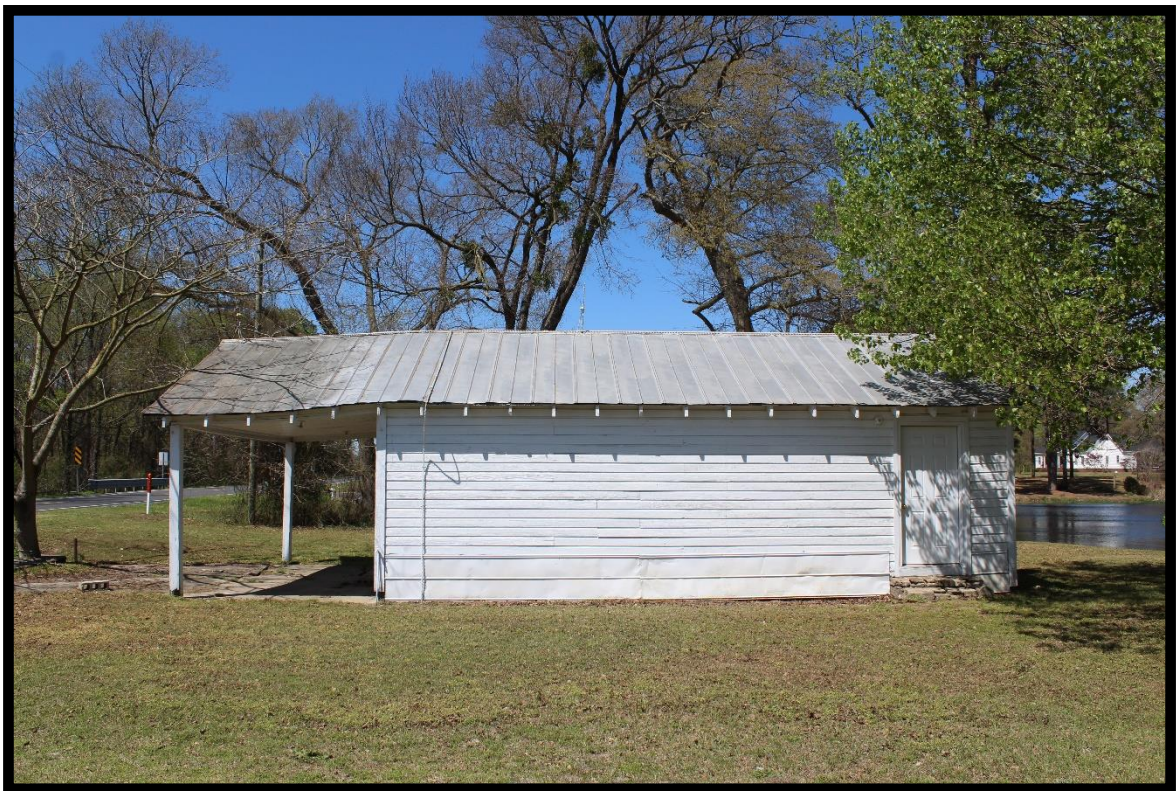
Figure 13: Outlaw Store, Looking Northwest.

The southeast elevation is blind except for a single, modern door at the east end (Figure 13). Concrete block steps with the remnants of a skim coat of concrete access the door and what appears to be strips of roughly two-foot-wide metal roofing covers the lower portion of the elevation. The northeast elevation contains a centrally placed, six-over-six vinyl sash window that is flanked on the south by a slender, exterior, brick chimney with concrete coping at the top (Figure 14). The northwest elevation is blind.

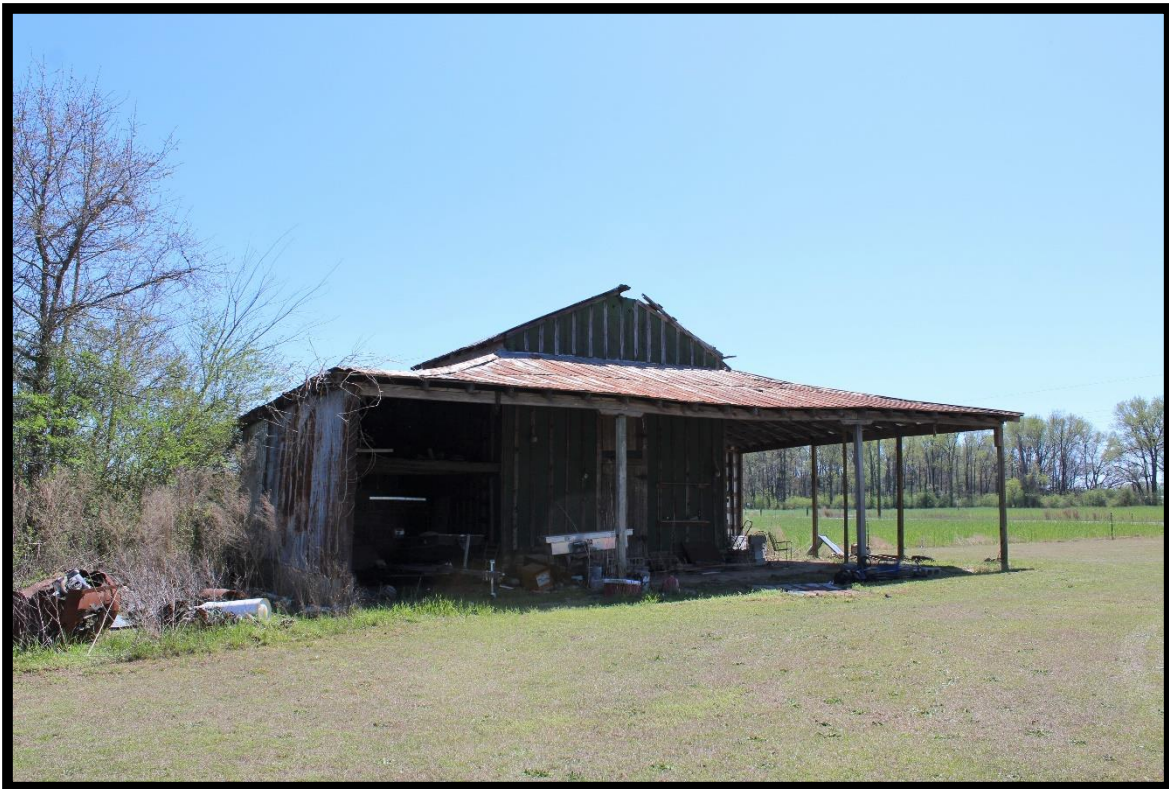
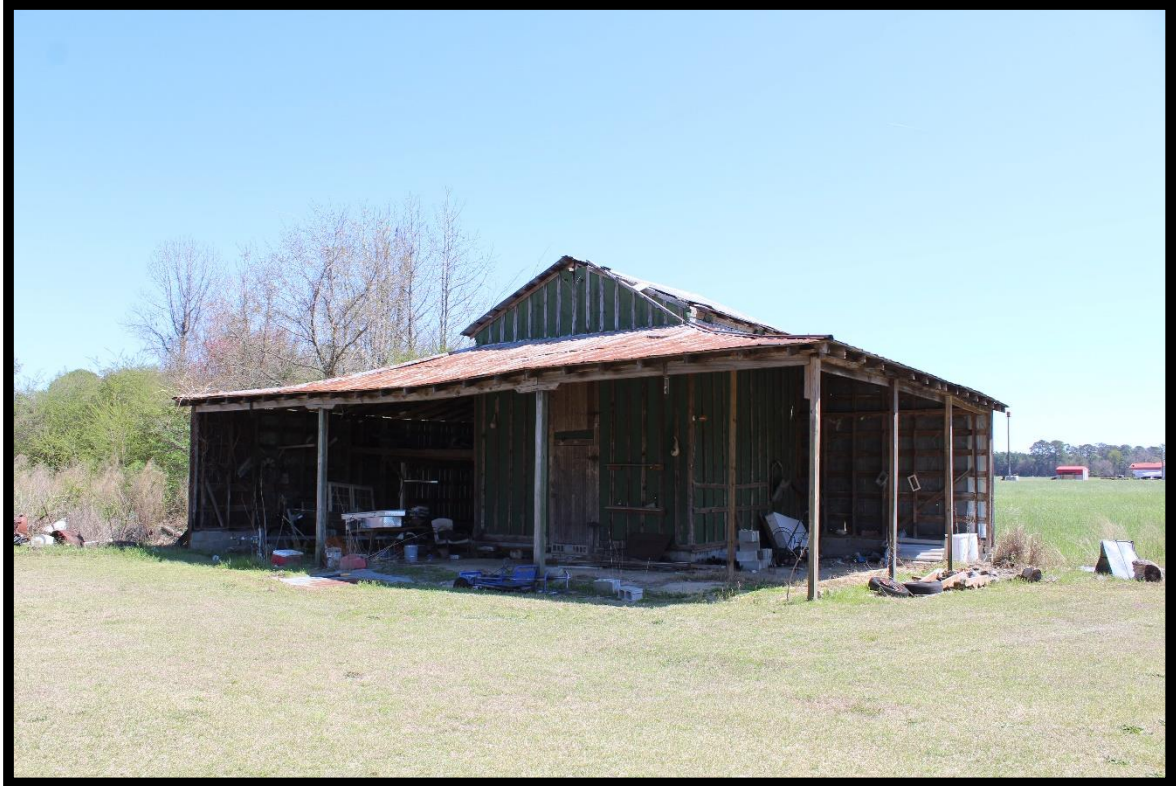
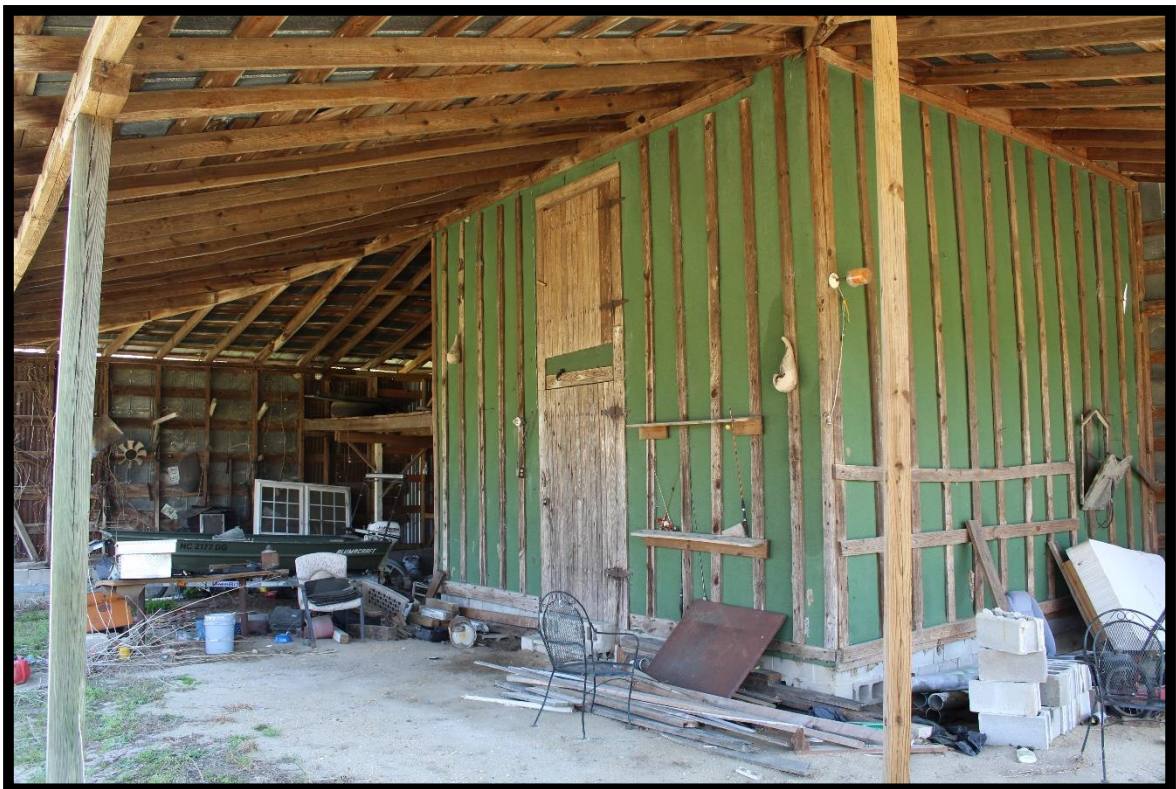
The ca. 1926 barn is composed of a front-gabled tobacco barn sheltered on the northeast, northwest, and southwest elevations by a hipped roof (Figures 15 through 17). Square, wooden posts support the hipped roof, and the southeast and northeast elevations are clad with corrugated and 5V crimp metal panels above a low concrete block wall. The opposite elevations are open. The tobacco barn sits on a concrete block foundation, and its exterior has wooden, batten-like framing that appears to hold down a green material, possibly weatherproofing, applied over the original exterior material. The northwest elevation of the tobacco barn has a batten door with strap hinges below a batten loft door that also has strap hinges. Both the gabled and hipped roofs are finished with 5V crimp metal roofing and have exposed rafter tails. The roofs and exterior panels are all weathered, and the framing of the tobacco barn's front gable is exposed and deteriorating due to missing a panel of roofing.

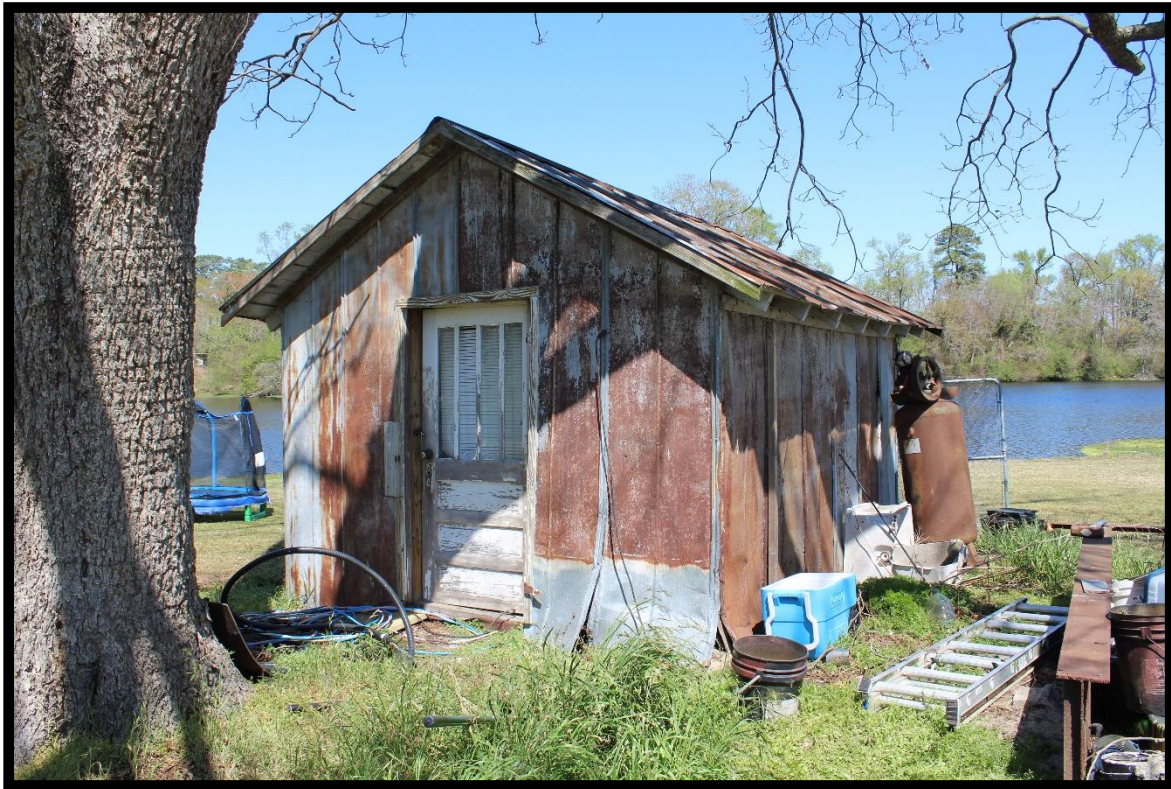
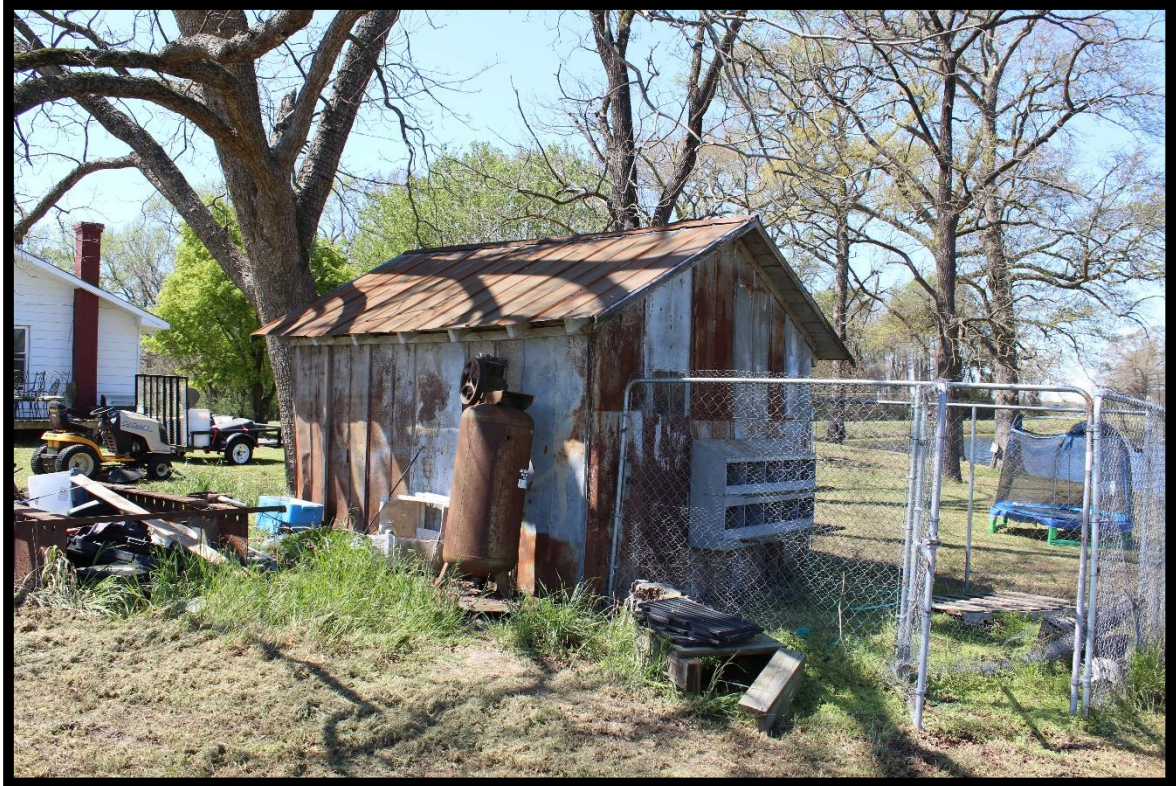
A small ca. 1926 shed stands northeast of the dwelling (Figures 18 and 19). It is front gabled, and both its roof and sides are covered with weathered, 5V crimp, metal panels. Exposed rafter tails are present below the eaves. The southwest (façade) elevation has a wooden door with four vertical lights over three recessed panels. A fenced in area extends from the northeast elevation and appears to have been used for chickens.

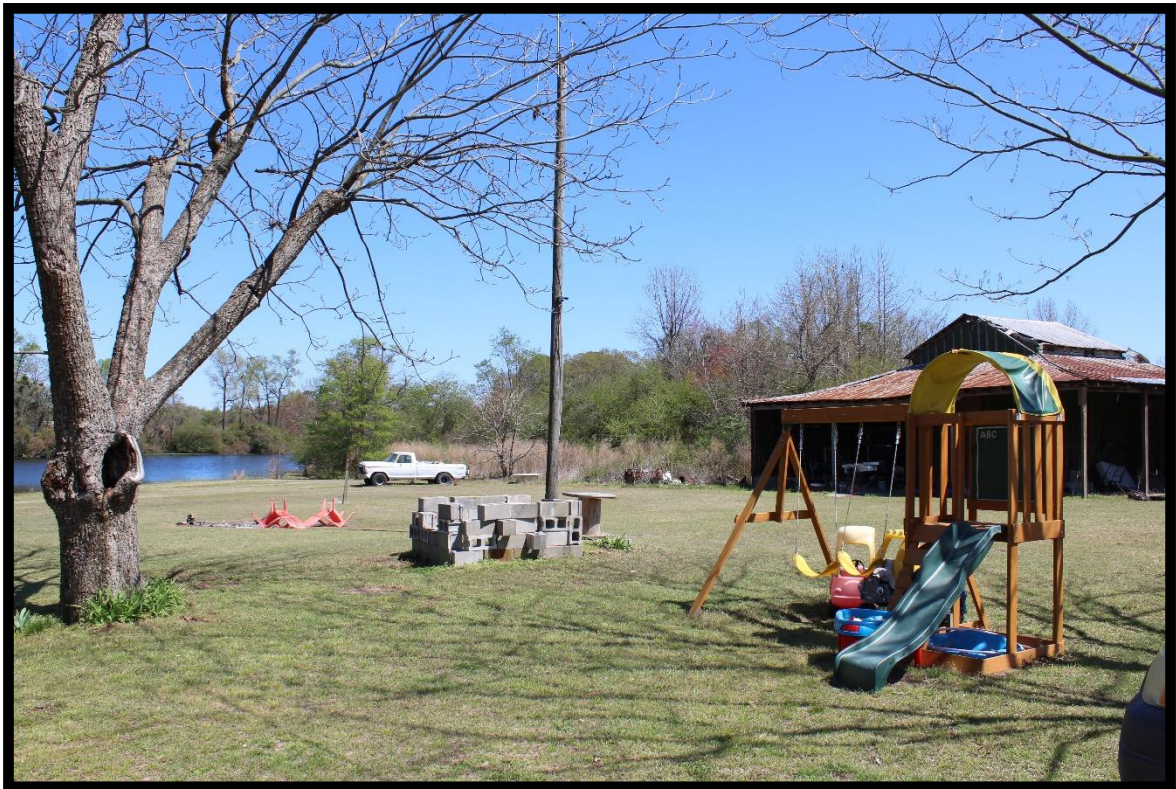
Figure 20: Playhouse and Setting, Looking East.

There is also a modern playhouse with swings, a slide, and an area for a sandbox that stands southeast of the house and northwest of the barn (Figure 20).

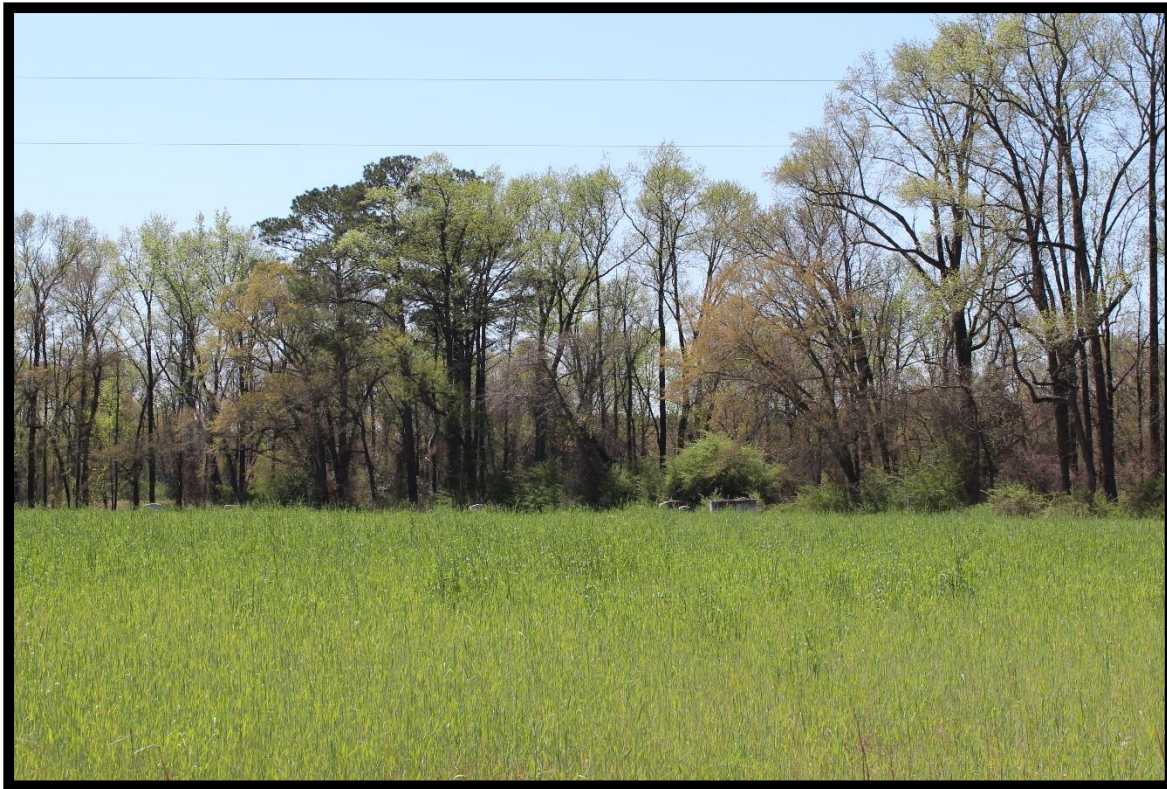
The 1889 D. J. Outlaw or Outlaw Cemetery is located on the opposite side of Summerlin Crossroad Road near the middle of a field (Figure 21). It contains at least 20 graves including those of Charlie David Outlaw, who most likely constructed the studied resources, and his father, David James Outlaw, who the cemetery is named after.<sup>10</sup>

Figure 21: Cemetery, Looking Southwest. Headstones are visible just above the tall grass.

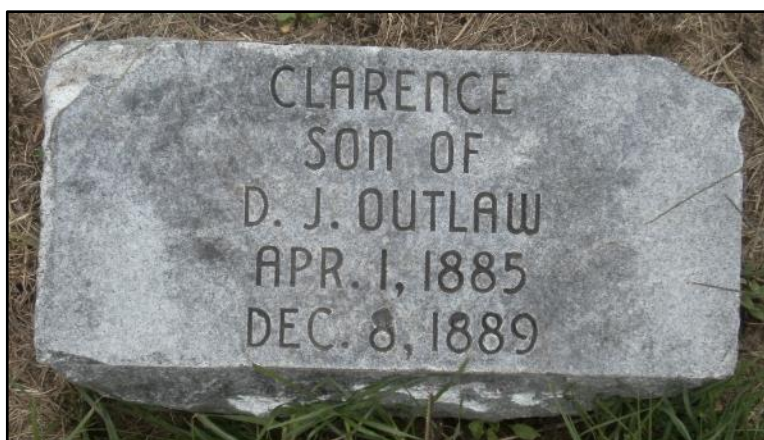
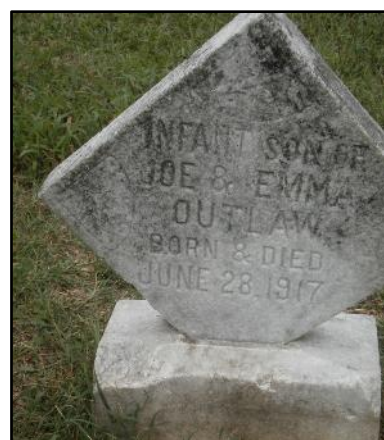
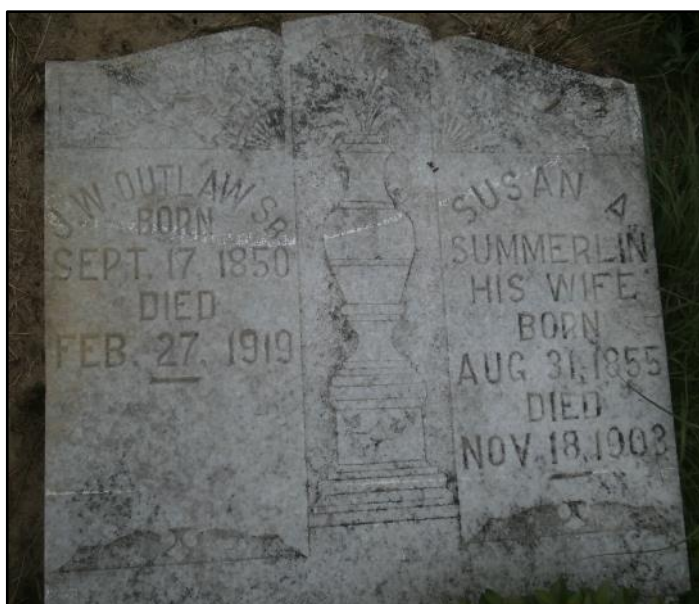
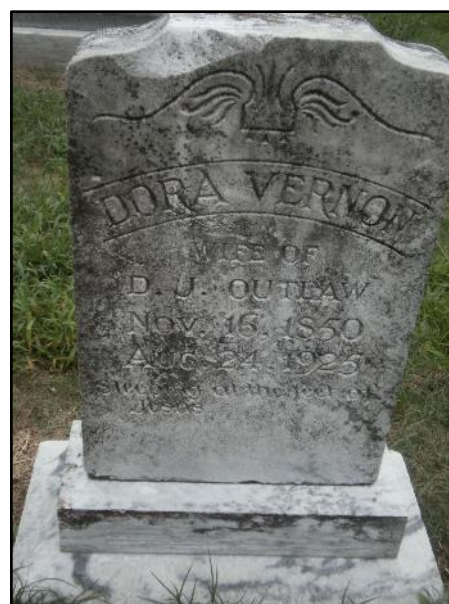
Figure 22: Representative Headstones and Markers from the D. J. Outlaw Cemetery (Findagrave.com (b)).

The headstones and markers date from 1889 to 1998 and all appear to be granite or marble (Figure 22). Over two-thirds represent individuals who died before 1950 and each headstone or marker appears contemporaneous with the death of the associated individual. The oldest marker (low to or flush with the ground) is for four-year-old Clarence Outlaw, who passed away in 1889, and is a simple block of granite with rusticated sides and a smooth top with neat lettering. The oldest headstone is that of John Warren Outlaw, Sr. and Susan Ann (Summerlin) Outlaw. It likely dates from Susan's death in 1903 with John's information added after his death in 1919. An urn or vase with leaves and flowers separates their names and fan-like details and ivy span the top. Other headstones include a roughly three-foot pillar erected for David James Outlaw; two pillar-like headstones with slanted tops for David Wesley Williams and Anna Davis Williams; an elaborate headstone with a wing-like design at the top and detailed lettering; and two small headstones composed of a square slab turned forty-five degrees and set in a base for an infant and a one-year-old. The later graves have markers or modern headstones.

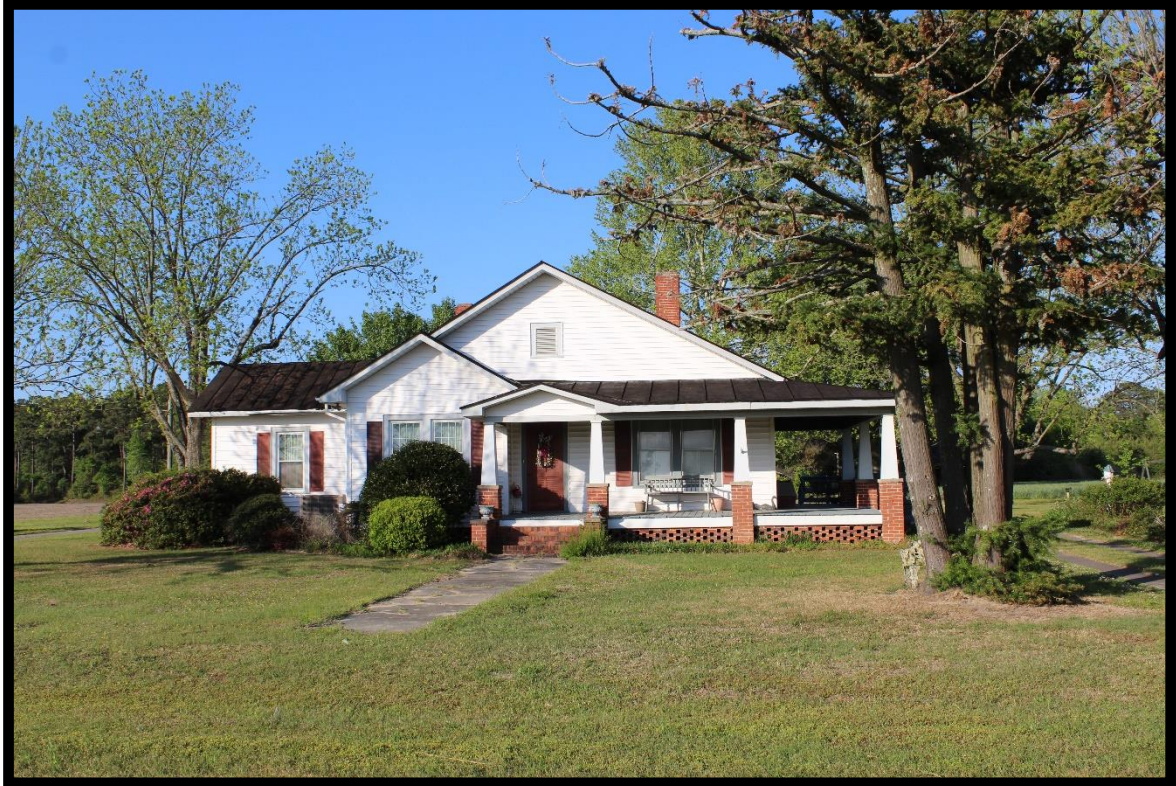
Figure 26: 2519 Tram Road, Looking Northeast.

Most interesting is that many of the Craftsman-style houses, as well as some with Colonial Revival elements, displayed forms and plans that resembled those of the Outlaw house. These elements include front gables, porches that wrap one corner, and smaller projecting gables. One similar property is located at 2519 Tram Road (Figure 26). The house is taller than the Outlaw House but has a front gable with a smaller projecting gable on the left and a wrap-around porch on the right. Both houses also have paired windows on both the small gable and the sheltered elevation. Differences include the porch being longer—four piers across instead of three—and a gable on the left elevation that projects far enough to create a small room versus those on the Outlaw House, which are an appropriate size to accommodate a window seat. The comparable house also has battered posts on piers, which are more characteristic of the Craftsman style than the Outlaw House's straight posts. Despite its slightly more sophisticated features, the comparable house has also been altered with replacement siding (vinyl) and at least a few vinyl windows.

In comparison with the impeccably well-maintained John Carter House as well as the well-maintained, but more vernacular house on Tram Road, the Outlaw House does not stand out as a NRHP-eligible resource. This conclusion is made despite the two houses having a similar level of material integrity—both diminished by replaced siding and vinyl windows—and the possibility that the Outlaw House's metal siding has gained its own significance as a common mid-twentieth century alteration. Per the siding, though newer, the house on Tram Road has thin vinyl siding that is a closer representation of the scale and repetition of original wooden siding and more in harmony with the house's c. 1910 construction. This along with its standing seam metal roof, battered posts on piers, and pierced brick foundation contribute to it being a better representation of the Craftsman style and the early twentieth-century period of construction.
