**SUBJECT:** Historic Structures Survey Report for BP3-R008, replacement of Bridge No. 352 on  
SR 1004 over Outlaws Pond Spillway, Duplin County, ER 22-1532

**HISTORIC STRUCTURES SURVEY REPORT  
REPLACE BRIDGE NO. 352 ON SR 1004 (SUMMERLIN CROSSROAD ROAD) OVER  
OUTLAWS POND SPILLWAY, DUPLIN COUNTY, NORTH CAROLINA**

**TIP PROJECT BP3-R008  
WBS NO. BP3.R008.1.1.1  
PA TRACKING NO. 22-03-0001**

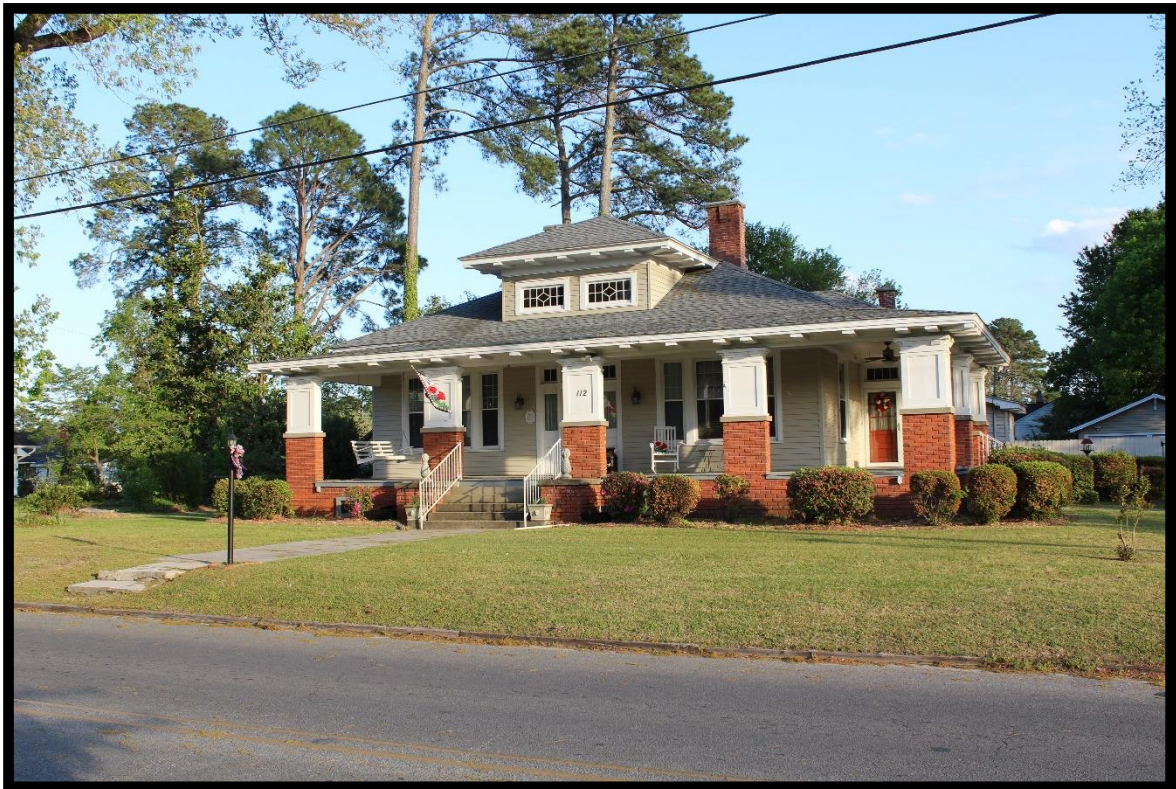
Figure 27: John Carter House (DP0523), Looking Southeast.

A more high-style, Craftsman-style dwelling is in the NRHP-listed Warsaw Historic District (DP0611). The form of the John Carter House (DP0523, Figure 27) is not as similar to the Outlaw House as the dwelling on Tram Road (DP0523). It has a hipped roof with a hip-roofed dormer on its forward slope, its porch spans the full width of the façade before wrapping the right corner, it has tripled windows (narrow sashes that flank a large sash), and it has an entry door with sidelights and a transom. It also appears to retain its wooden siding, though it does have a modern asphalt shingle roof. It may also have replacement windows, but care was taken to choose sashes with smaller panes over a single pane, a configuration that resemble Craftsman-style windows more accurately than the Outlaw House's one-over-one sash windows.

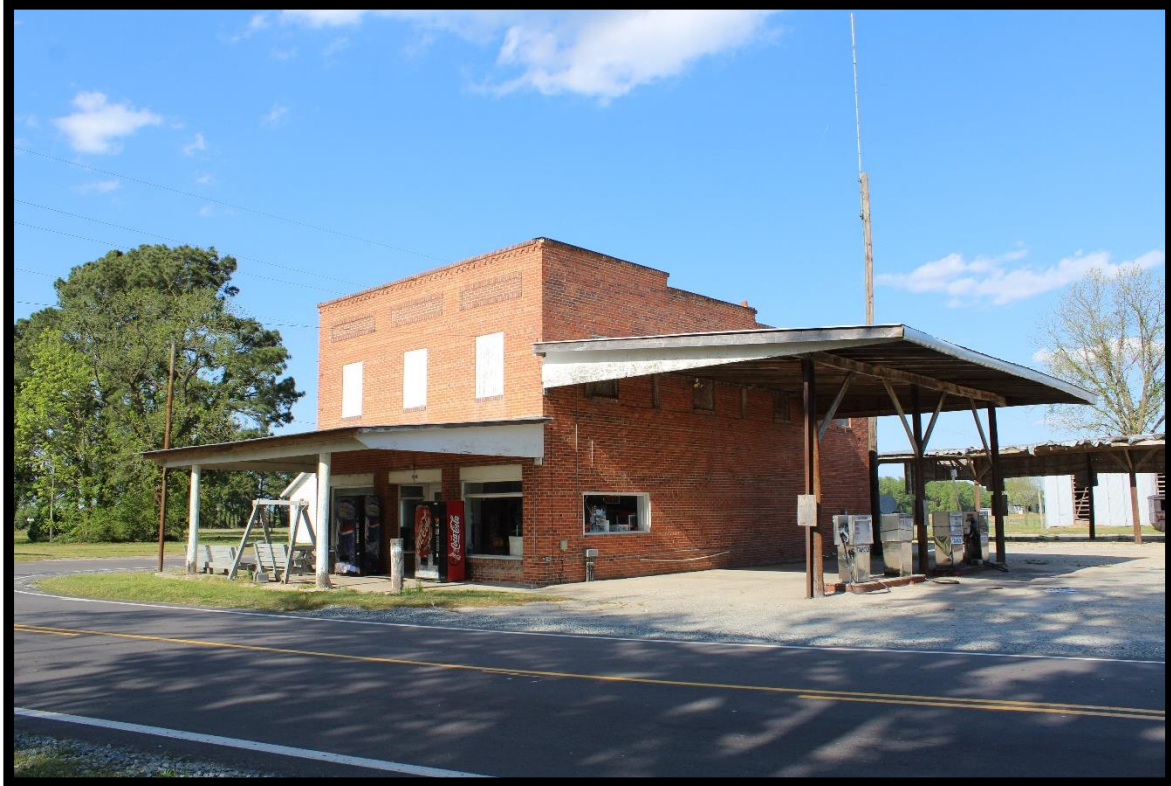
Figure 28: Summerlin Crossroads General Store (DP0097), Looking Northeast.

The study-listed store is Summerlin Crossroads General Store (DP0097, Figure 28). Though it bears little resemblance to the studied store, it is worth comparing as the only study-listed store in the county; its location, approximately 2.5 miles south of the studied property on the same road; and as the likely source of the community's name. The general store is a two-story, brick building with a shed-roofed porch supported by round posts on the façade and, despite standing alone on the corner, conveys the appearance of a downtown commercial building more than a rural store. The porch shelters two plate glass windows that flank a recessed glass entry door and the upper story windows (on the façade and secondary elevations) are covered with plywood concealing what may or may not exist of the original windows. A tall, shed-roofed drive-through extends from the south elevation and shelters four gas pumps. Currently, the building is used as a store and lunch counter with outside seating under the porch. The store was added to the study list in 1993, and while it is reasonable to think it may have undergone some changes in the nearly three decades since, such as covering the windows, it still appears to retain a high level of integrity.

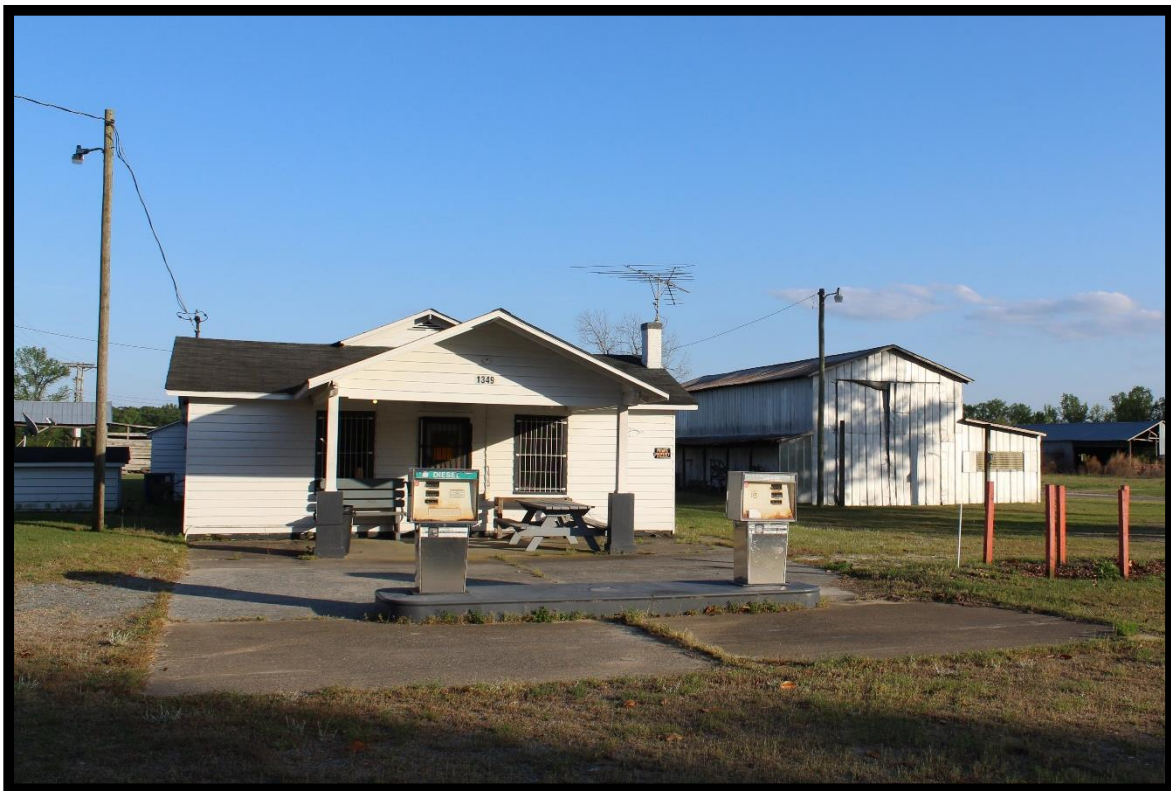
Figure 29: 1349 Veachs Mill Road, Looking South-Southeast.

Due to the low integrity of many of the county's extant stores, it was difficult to find a store with a similar form and adequate integrity to compare with the studied store. One, however, that appeared as a decent comparable is located at 1349 Veachs Mill Road (Figure 29). This store is larger than the studied store due to having a long, gabled wing at the rear and its front section is side gabled and wider than the studied store. Similar, however, is a large front gable that projects from the forward slope of the roof to shelter two barred windows that flank a barred door. The gable also shelters a concrete patio. A second concrete area spans from the patio to a concrete island with two gas pumps. This store also stands out for the concentration of agricultural buildings in its vicinity. Additionally, the structures are all owned by a member of the Veach family.

Furthermore, it still has gas pumps, continues to be used as a store, and was the only observed brick store outside of Duplin County's many towns. On the other hand, Veachs' Store has also undergone some alteration including the construction of its large rear addition and replacement of its original roofing with asphalt shingles. Veachs' store stands out from others observed in the county due to retaining gas pumps and being set in an area with a high concentration of agricultural buildings, though the use of those buildings at this time is questionable. Both stores convey significance in their own way, ways that differ from the studied store. With this in mind, the studied store stands as a rare example of a nearly unaltered, one-room, rural store in Duplin County and is a strong candidate for listing on the NRHP, even as an individual resource.

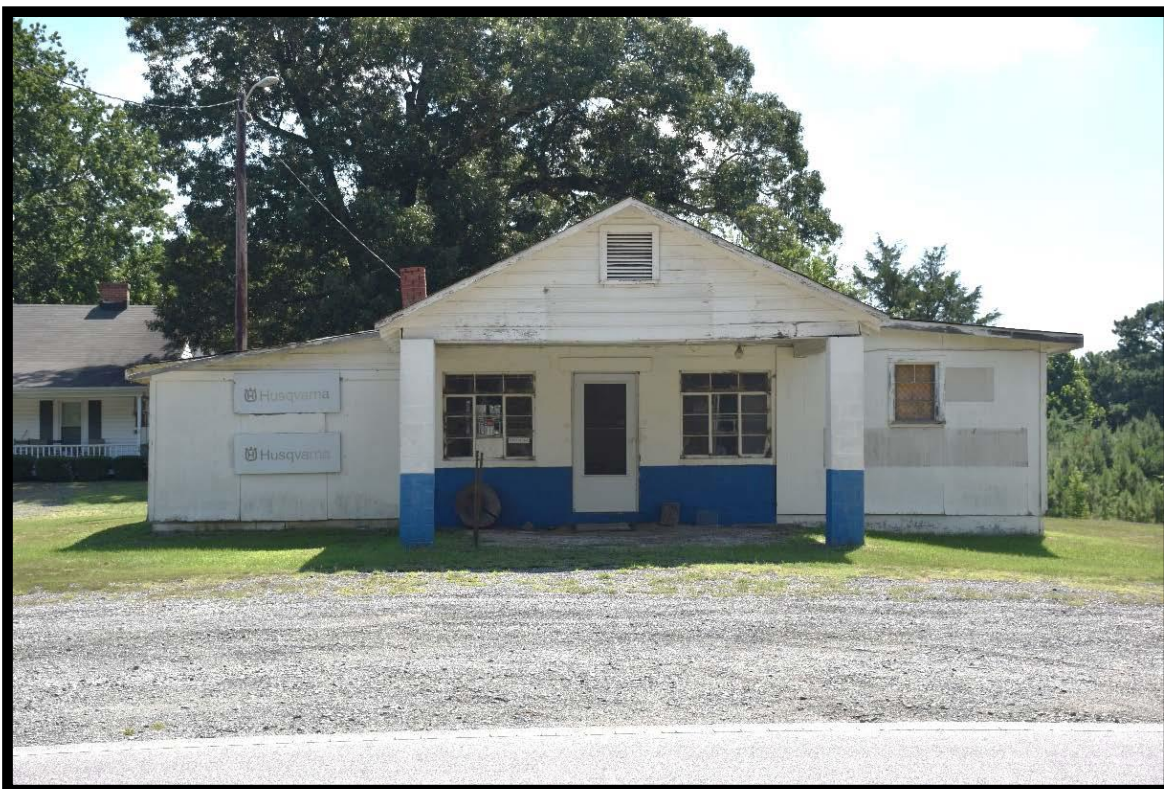
Figure 30: Yates Grocery & Farm Supply (WA7185), Looking East (Carpini, p. 32).

The greatest difference between the Yates store and the studied store is that it is constructed of concrete block and has plywood-clad, shed-roofed additions on each side elevation. Constructed roughly 20 years after the studied store, which is frame construction, the concrete block construction of the Yates store represents a second iteration of the rural, vernacular store form. Like the studied store, its core is front gabled and has a similar scale and form including a large front gable (a continuation of the main roof) that projects forward and shelters a concrete or gravel area and the store's façade. The symmetrical façade contains an entry door behind a modern screen door and is flanked by 12-pane, metal sash, industrial windows. The gable is filled with German siding like the studied store and exposed rafter tails are visible along the eaves of the canopy. Rafter tails like lined the full length of the eave before the additions were added. The Yates store also has a modern asphalt shingle roof versus the studied store's metal roof.<sup>37</sup>

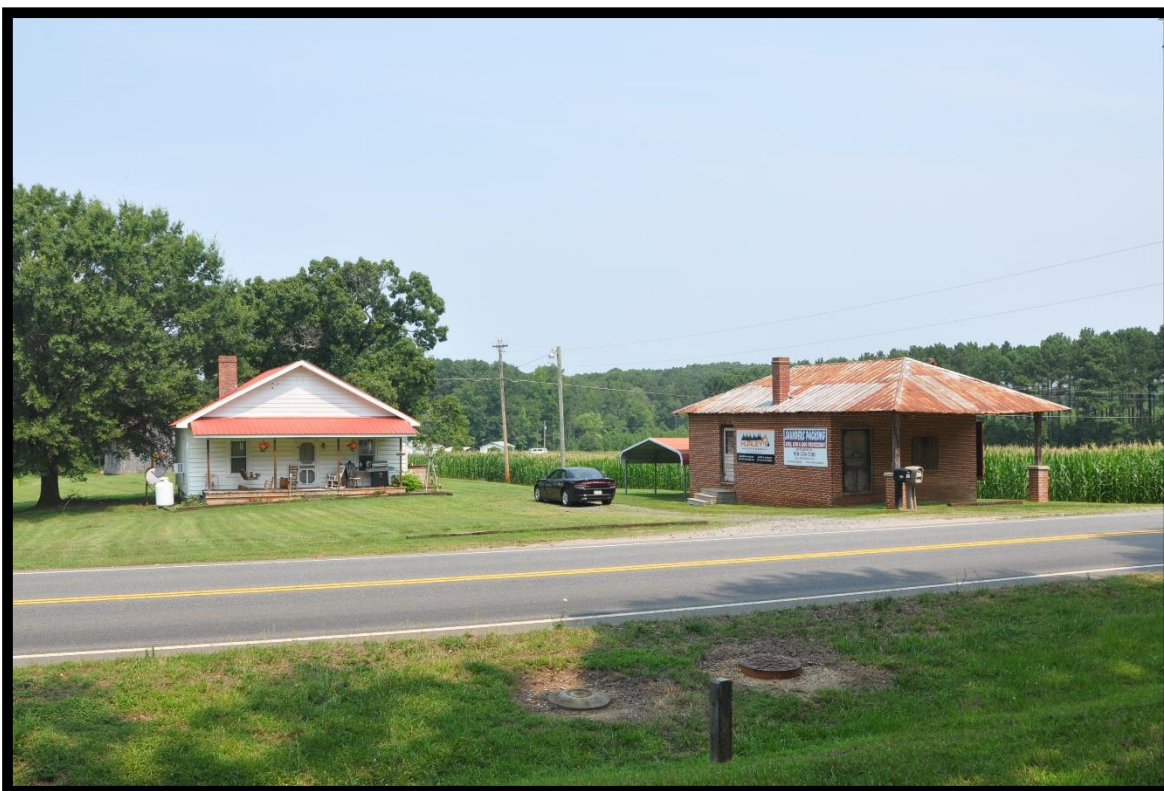
Figure 31: Morton House and Store (MG0160), Looking Northwest (Steely, p.4).

Lastly, the Morton House and Store, which was given a determination of eligibility in 2021, includes both a house and a store that were constructed in 1925.<sup>38</sup> The one-story frame house has a common vernacular form with a front-gabled roof, a full-width shed-roofed porch, and a brick pier foundation infilled with concrete block. The house is finished with a modern metal roof, vinyl siding, and vinyl windows. Though it appears to retain its original wooden entry door and wooden screen, its porch deck and columns are new. Like the dwelling on the Yates property, this dwelling has a low level of integrity regarding materials and workmanship and has less integrity than the Outlaw House.
