WAKE COUNTY ARCHITECTURAL SURVEY UPDATE: PHASE V

Long- and Short-Range Urban Service Areas of the Towns of
Knightdale, Rolesville, Wendell, and Zebulon and the contiguous
Little River Water Supply Watershed of Eastern Wake County

Jaime L. Destefano, MSHP
JLD Preservation Consulting, LLC

AUGUST 2019

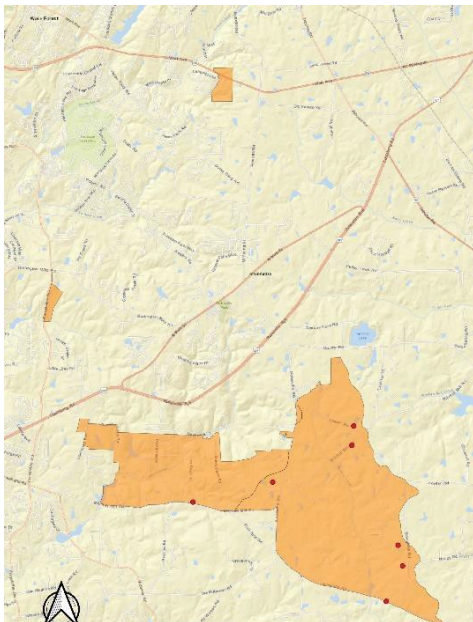
Figure 2. Distribution of Demolished Properties in the Rolesville Study Area

development. Figures 2 and 3 show the distribution of demolished and deteriorated properties within the Rolesville study area. The seven properties that retain their primary resources but have experienced outbuilding loss account for 28% of all previously recorded resources within this study area. The total loss of three farms and numerous outbuildings is indicative of the declining agrarian culture of the study area since the late twentieth century.

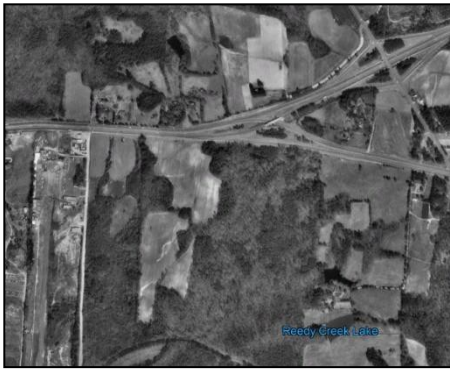
1993 Aerial Photograph of US 64
BUS and US 264

Among the most notable transformations to the agricultural landscape within the Wendell study area is the extension of the US Route 264 Bypass (Knightdale Bypass) across the US Route 64 Bypass and the construction of a large interchange. The highway extension and interchange dramatically altered the rural nature of the area. In addition, houses on the north side of US 64 were historically accessed from driveways leading from the highway. Since the construction of the interchange and the widening of the US 64 Bypass, Three Sisters Road has been constructed parallel to the highway to access these residences. Large car dealerships were erected directly east of the interchange beginning in the 1990s.

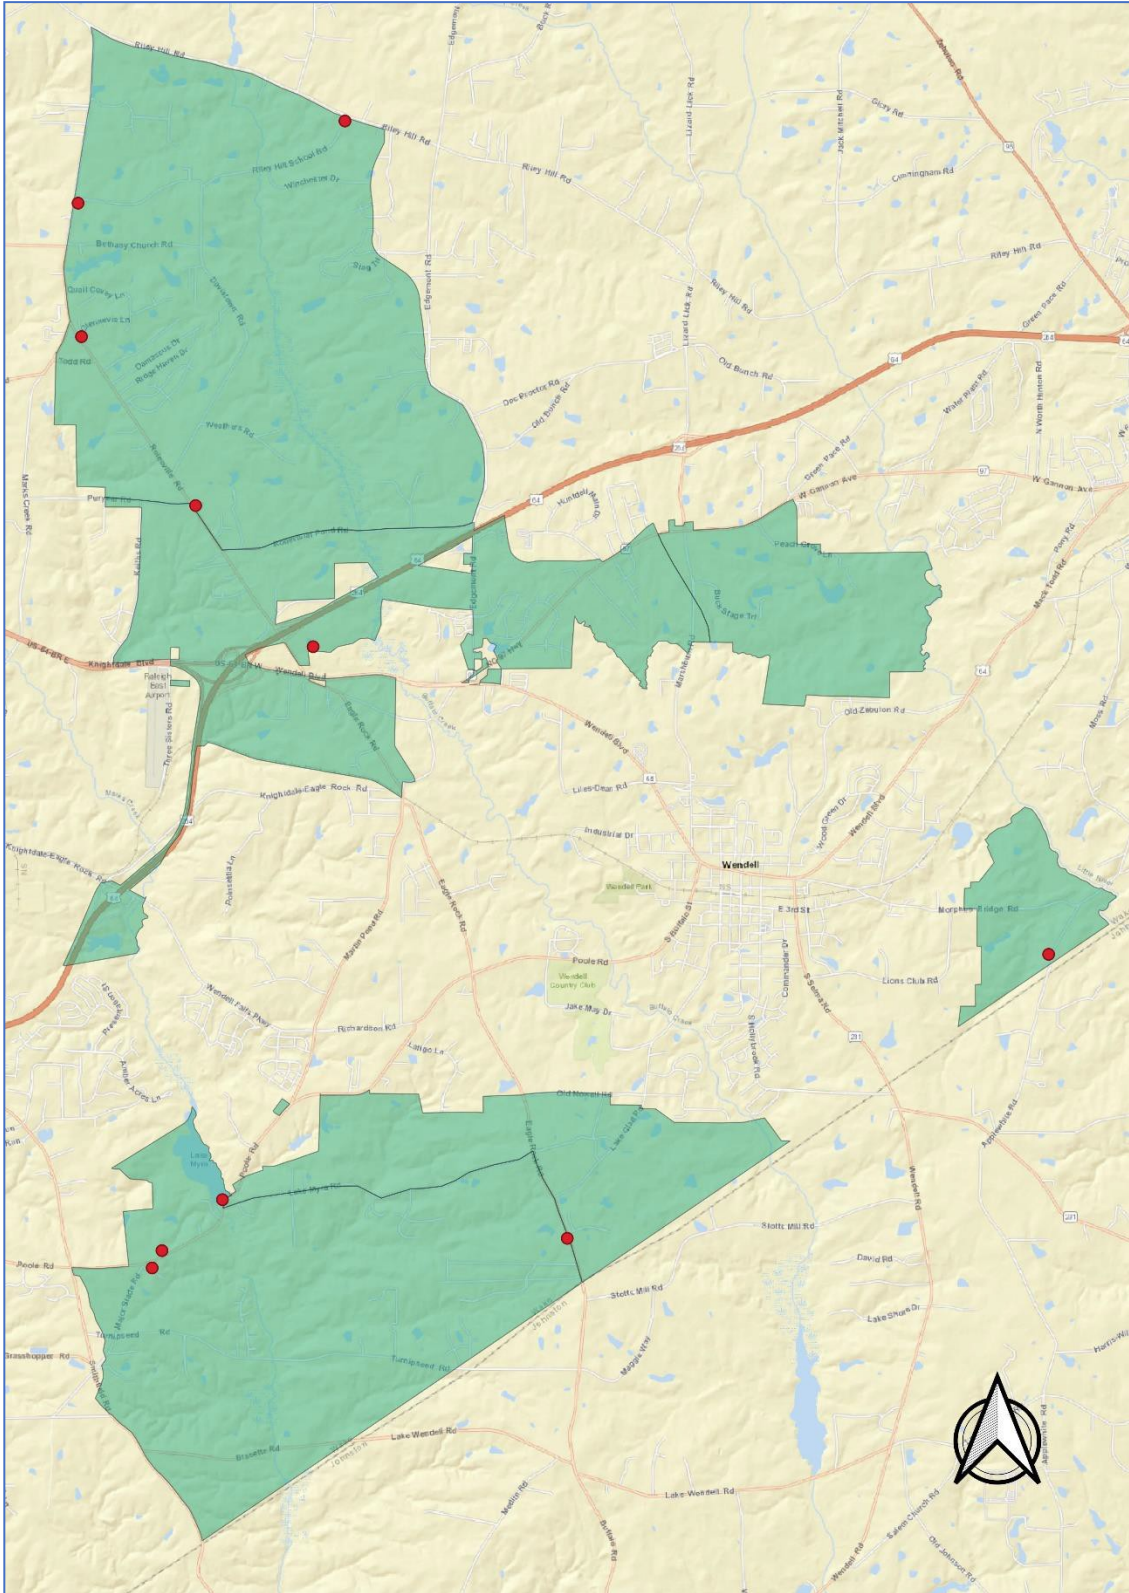
Figure 4. Distribution of Demolished Properties in the Wendell Study Area

Fifty-one (51) properties within the Wendell study area were previously surveyed. Among them, twelve (12) are demolished. This accounts for 23.5% of the previously surveyed historic properties. Four (4) additional properties are in a deteriorated or ruinous condition and six (6) exhibit outbuilding loss. As illustrated in Figure 4, demolished resources are generally distributed throughout the study area. About one-third of the demolished properties appear to be a direct result of modern residential development, whereas the others are most likely a result of abandonment. The relatively high number of demolished and deteriorated primary resources, as well as those properties experiencing loss of outbuildings, confirms the decline in farming and the increase in residential development since the late twentieth century. Only two properties within the Wendell study area were newly surveyed, including Vaiden Whitley (East Lake) High School.

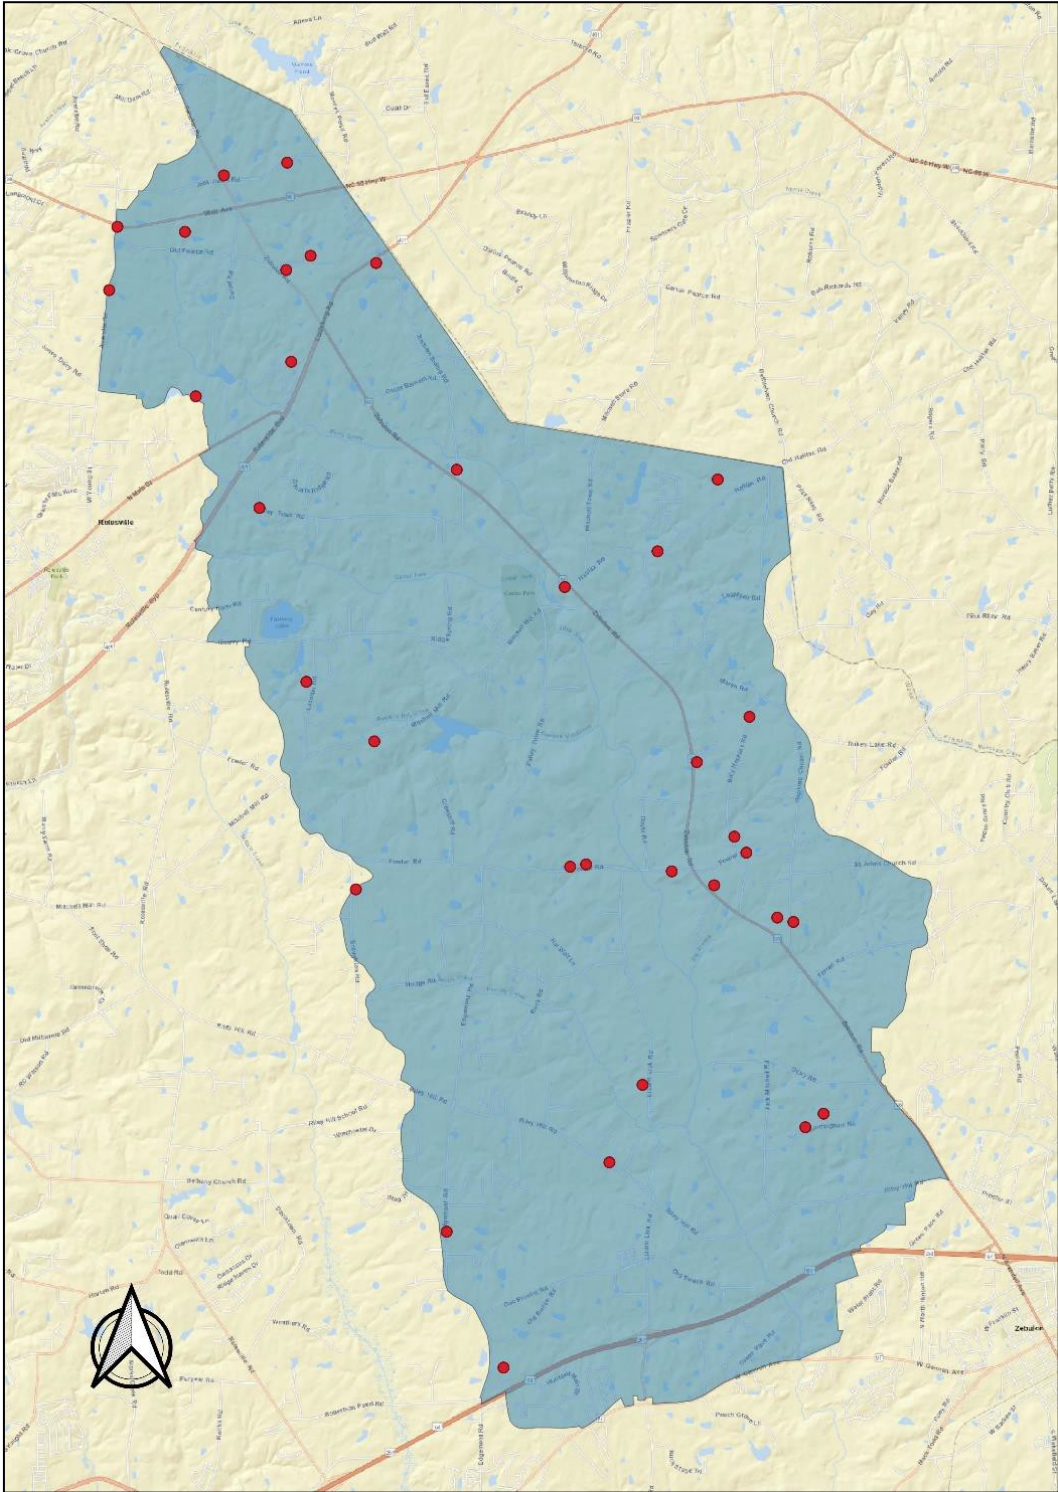
Figure 7. Distribution of Demolished Properties in the Little River Study Area

The Little River study area is by far the largest of the five. It includes 138 previously surveyed properties, of which 36, or approximately 25%, have been demolished since the 1988-1991 survey. Seven (7) of the properties classified as demolished are primary resources surveyed as part of multiple resource properties. Although the primary resource is no longer extant, support structures or agricultural buildings survive. The distribution of demolished properties is widespread; however, most tend to be clustered near principal roadways. Only a few are replaced by modern residential development and/or subdivisions. Similar to the study areas within closer proximity to towns, the high percentage of demolished buildings is evidence of abandonment of older residences and a decline in farming. This is especially the case when considering an additional ten (10) properties are deteriorated, and twenty-six (26) exhibit the loss of at least one outbuilding since the 1988-1991 survey.
