NATIONAL REGISTER OF HISTORIC PLACES

Bethlehem Baptist Church

Bethlehem vicinity, Hertford County, HF0458, Listed 01/10/2019

National Register of Historic Places Registration Form

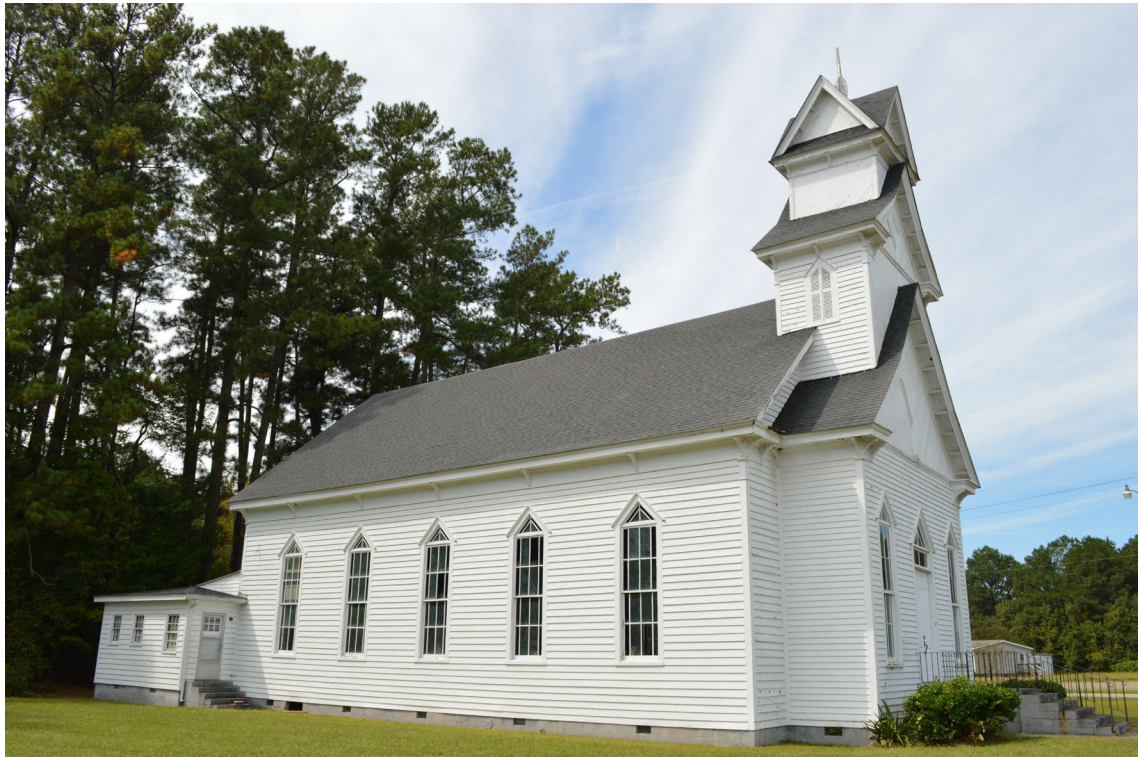
View of Bethlehem Baptist Church, looking southwest

Bethlehem Baptist Church is a gable-front, wood-frame church building that stands one-tall story capped by a two-tier steeple. The symmetrical gable-front façade has a central, projecting three-bay entrance vestibule composed of a central double-leaf door surmounted by two-light transom and triangular pointed-arch. The wooden entry doors each feature six panels: small at the top, large in the middle, and medium sized at the bottom. Tall and narrow windows, with similar triangle-arched windows with molded surrounds to match, flank the entrance. Each window is composed of two, four-light sashes of frosted glass surrounded by narrow strips of clear glass and capped by two triangular-shaped panes framed by strips of color glass. Plain weatherboard sheaths the first floor of the façade of the projecting portion. The gable is marked by corner posts and gable returns supported by a pair of decorative brackets on each side of the façade, marking a change in the façade sheathing from weatherboard to a v-shaped pattern of beadboard. An elongated diamond-shaped motif covers the original diamond-shaped window opening and is centered in the gable. This change was made at an unknown date. Gentle flares of the roof on the vestibule portion, add flourish to the architectural charm of the building. The main body of the church is sheathed with weatherboard and serves as the backdrop to the projecting entrance vestibule. The vestibule is blind on both side elevations. A concrete block foundation supports the church and an asphalt shingle roof protects it.

An ornate, two-part, steeple crowns the building. The first tier sits partially atop the projecting gable of the vestibule and the main body of the church. It is four-sided marked by corner posts and triangular pointed-arch ventilators on the side elevations. The front of the first tier is also a gable roof with flared eaves, molded cornice and paired decorative brackets, mimicking those on the façade of the vestibule. The lower portion of the first-tier façade is flush vertical sheathing under the eaves while above is beadboard laid in a v-shaped pattern around a framed diamond-shaped motif. Weatherboard sheathes the other three sides of this portion. A second rectangular-shaped tier sits atop the first and is crowned by a four-sided enclosed gable roof. The sides of the

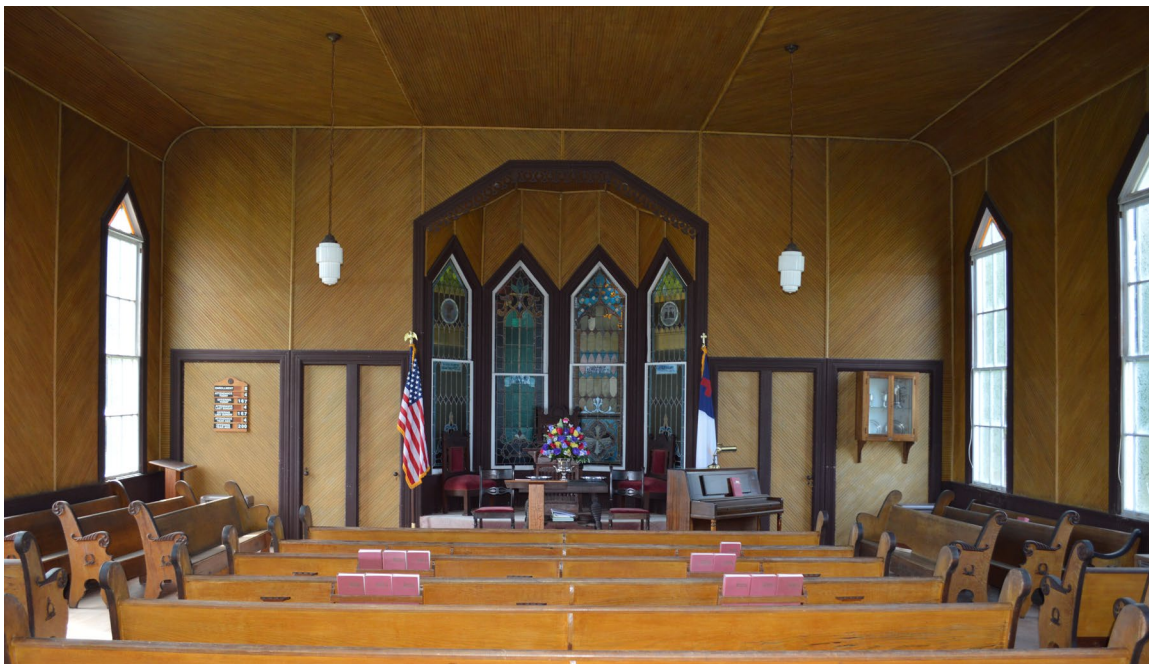
Interior view of altar and sanctuary, looking southwest

The sanctuary is an intact architectural composition. The doors open to two aisles that divide the floorplan into three sections of pews. The pews are all original pine, faux painted to resemble oak. Each pew has a wood-carved floral ornament stained a darker color applied to each side. The floors of the sanctuary are unfinished heart pine, which may have historically been waxed. The hardwood floor from the original 1858 church was reused in the 1902 church. Though the stoves are gone, the brick flues remain in place as a reminder of this earlier source of heat. Electricity was introduced to the church building 1944 and the original Art Deco, milk-glass light fixtures still illuminate the interior. The church was damaged by a lightning strike in 1948 and repairs and renovations were made in 1954. These included refinishing the floors and installing carpet in the aisles, repainting, refinishing the walls, and repairing the classrooms and roof (Bazemore, p. 6). The ceiling is sheathed in narrow beadboard with curved or coved corners

A polygonal-shaped apse is located at the southwest end of the sanctuary, behind the raised altar. The "v"-shaped wall sheathing pattern continues on the walls and ceiling of the apse. The apse is recessed in the rear wall of the sanctuary and is framed by a molded wood surround with a border at the top of Eastlake-style trim. The back wall of the apse contains four stained-glass windows with the following inscriptions: "In loving memory of Abraham Thomas and his wife Nancy"; "Mrs. Anne Wardmoore, 1834-1901"; "In loving memory of M.J. wife of A.B. Adkins, 1841-1901; and "J.O. Hoggard and wife Elizabeth." The windows are executed with colored pebble glass, trimmed in white, and surrounded with a molded surround stained or painted in dark brown.
